[Docket No. 2000–NM–93–AD; Amendment 39–11711; AD 2000–09–03]

#### Airworthiness Directives; Boeing Model 747–400 Series Airplanes Equipped With General Electric CF6–80C2 Series Engines

**2000-09-03 Boeing:** Amendment 39-11711.

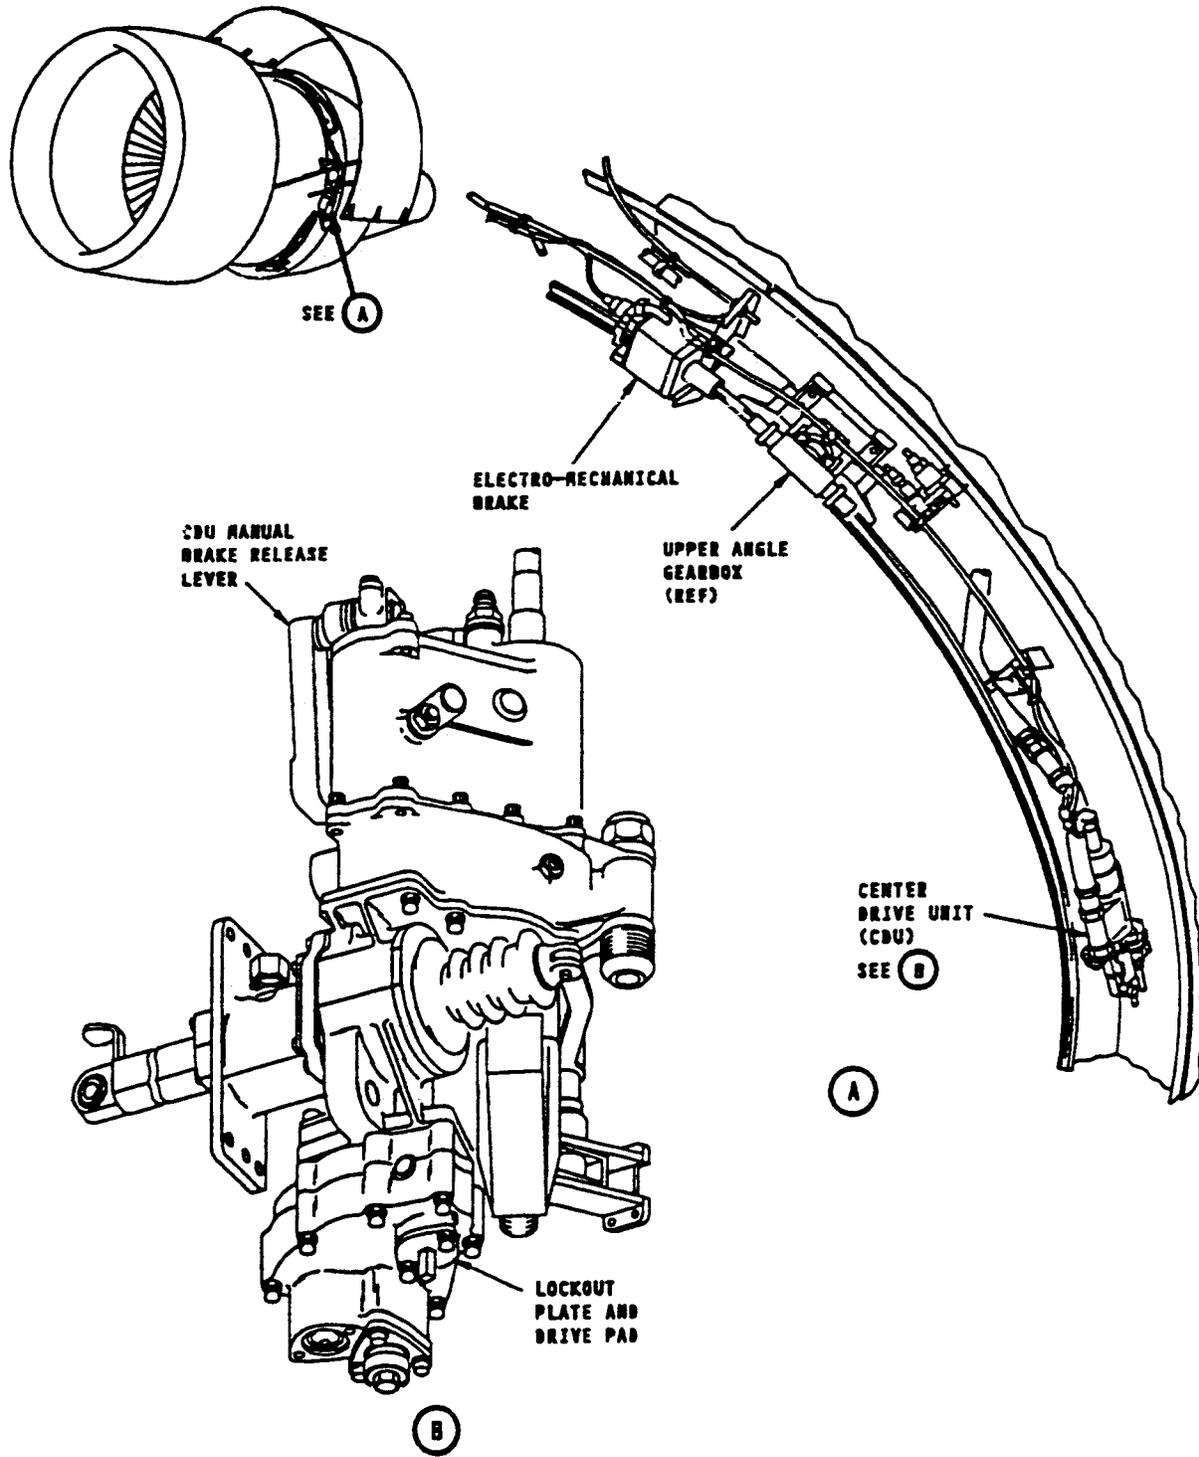
Electro-Mechanical Brake and CDU Cone Brake Torque Check  
Figure 1

- Completion of the functional test of the CDU cone brake as referenced in the existing AD is ineffective for Model 747–400 series airplanes having a third locking system installed on the thrust reversers. The test for those airplanes

requires an additional step to unlock the electro-mechanical brake prior to accomplishment of the functional test of the cone brake of the center drive unit. This step was omitted from the functional test described in the service bulletins and referenced in paragraph (a) of the existing AD. Therefore, Appendix 1 (including Figure 1) has been added to this AD to provide accurate instructions for airplanes that have a third locking system installed. Paragraph (a) of this AD has been revised to reference Appendix 1 (including Figure 1) as the appropriate source of service information for those airplanes.

**Note:** The cone brake prevents movement in the extend direction only. If you try to measure the holding torque in the retract direction, you will get a false reading.

2. CDU cone brake check (Figure 1):

(2) Pull up on the manual release handle to unlock the electro-mechanical brake.

(3) Pull the manual brake release lever on the CDU to release the cone brake.

(6) Install a 1/4-inch drive and a dial-type torque wrench into the CDU drive pad.

**CAUTION:** DO NOT USE MORE THAN 100 POUND-INCHES OF TORQUE WHEN YOU DO THIS CHECK. EXCESSIVE TORQUE WILL DAMAGE THE CDU.

(7) Turn the torque wrench to try to manually extend the translating cowl until you get at least 15 pound-inches.

(8) If the torque is less than 15 pound-inches, you must replace the CDU.
