[Docket No. 2000-NM-94-AD; Amendment 39-11712; AD 2000-09-04]

#### Airworthiness Directives; Boeing Model 767 Series Airplanes Equipped with General Electric Model CF6-80C2 Series Engines

**2000-09-04 Boeing:** Amendment 39-11712. Docket 2000-NM-94-AD. Supersedes AD 2000-02-20, Amendment 39-11538.

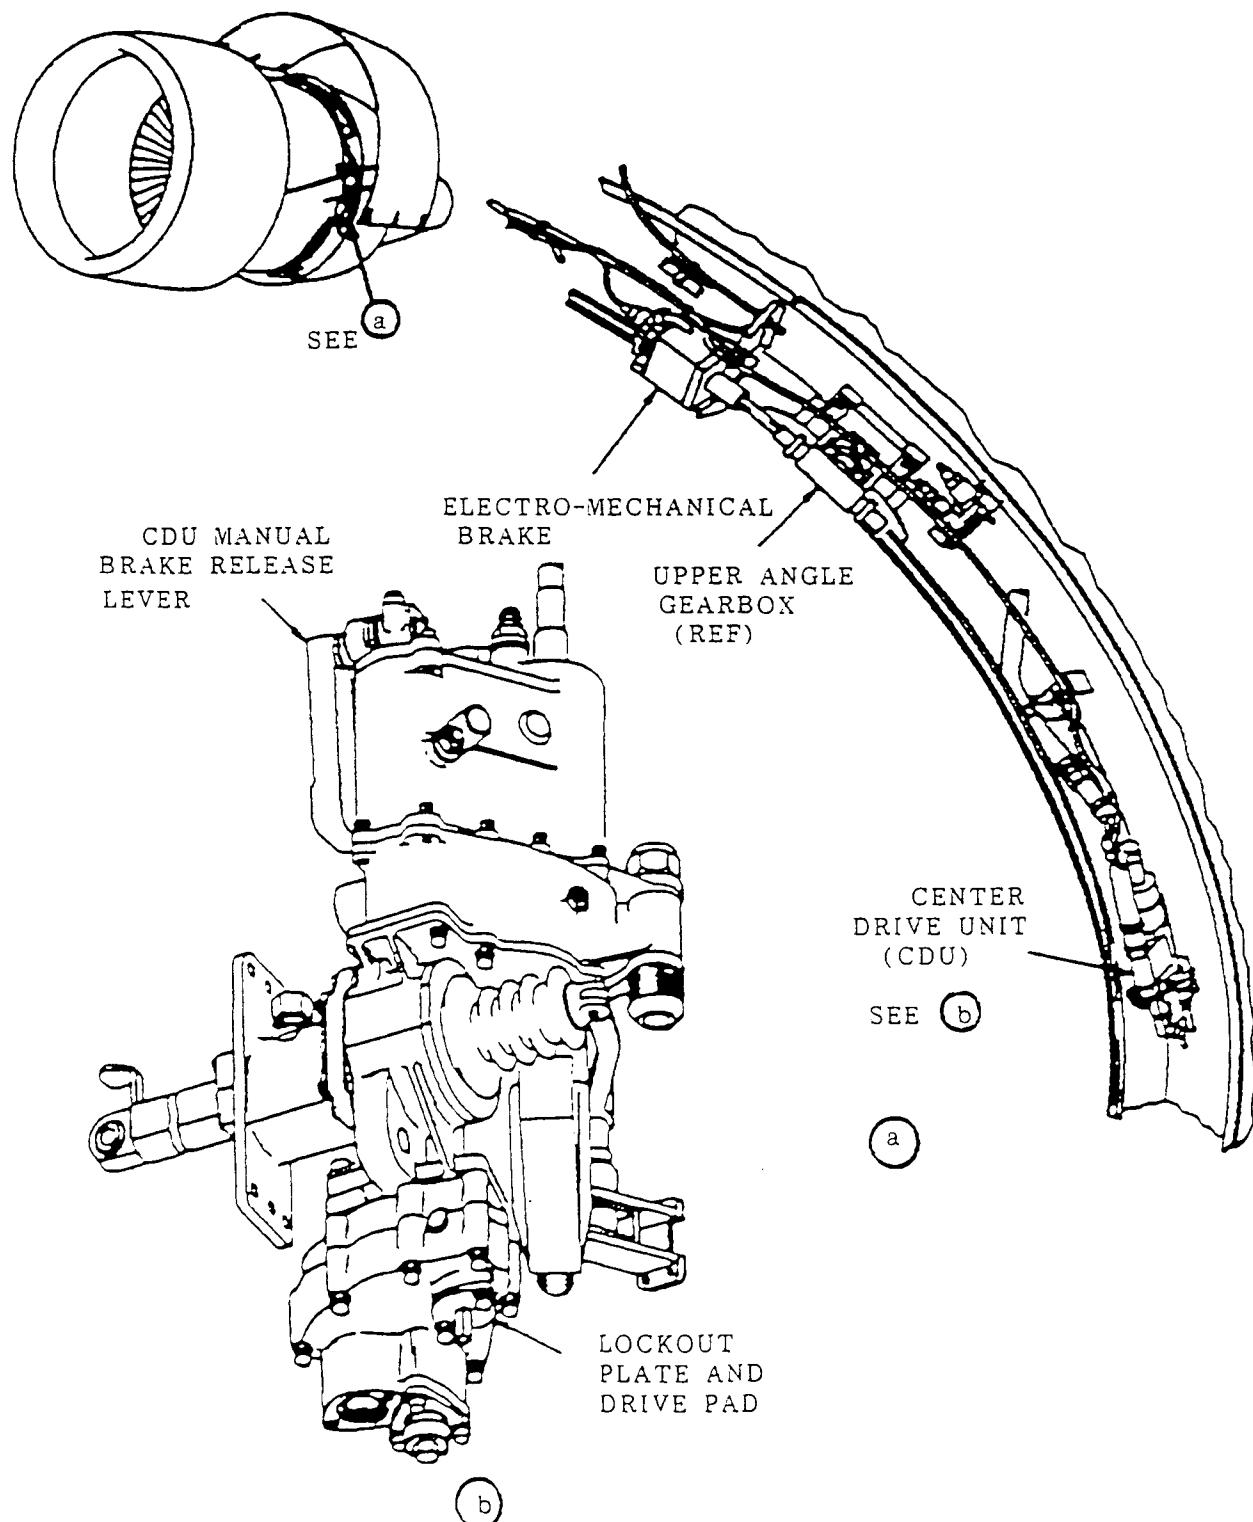
Electro-Mechanical Brake and CDU Cone Brake Torque Check  
Figure 1

Since the issuance of AD 2000-02-20, the FAA has received information indicating that the functional test that is described in Boeing Service Bulletin 767-78A0081, Revision 1, is not applicable to Model 767 series airplanes having a third locking system installed on the thrust reversers. For those airplanes, an additional step is necessary in order to unlock the electro-mechanical brake, prior to accomplishment of the functional test, as described in Appendix 1 (including Figure 1) of the existing AD. If the test is performed on airplanes with the third locking system installed, in accordance with the service bulletin, the system

will always pass the test, even if the cone brake has failed. Paragraph (d) of the existing AD does not specifically list which airplanes are required to do the functional test of the cone brake of the CDU, in accordance with Boeing Service Bulletin 767-78A0081, Revision 1; and which are required to do the test in accordance with Appendix 1 (including Figure 1) of the AD. Therefore, paragraph (d) of this AD has been revised to separate the service information requirements for accurate accomplishment of the functional test.

(1) The electro-mechanical brake system is working correctly if the torque is reached before you turn the wrench 450 degrees (1 1/4 turns).

(2) If the flexshaft turns more than 450 degrees before you reach the specified torque, you must replace the long flexshaft between the CDU and the upper angle gearbox.

(3) If you do not get 90 pound-inches of torque, you must replace the electro-mechanical brake.

(1) If the wrench does not return to within 30 degrees of initial starting point, you must

replace the long flexshaft between the CDU and upper angle gearbox.

(a) If the torque is less than 15-pound-inches, you must replace the CDU.
