[Docket No. 99-SW-34-AD; Amendment 39-11732; AD 2000-10-08]

Airworthiness Directives; Eurocopter France Model SA-365N1, AS-365N2, and SA-366G1 Helicopters

AD 2000-10-08 Eurocopter France:

Amendment 39-11732. Docket No. 99-SW-34-AD.

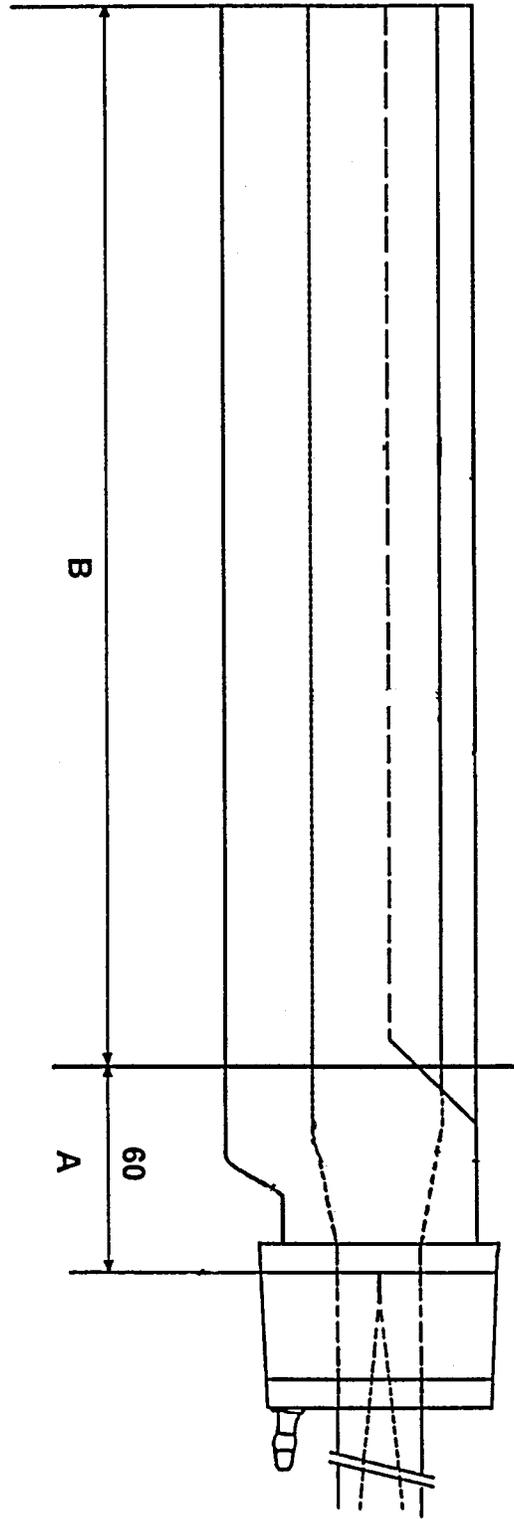
FIGURE 1

(a) Within 10 hours time-in-service (TIS) and thereafter prior to the first flight of each day, conduct the following visual inspection of each blade (see Figure 1):

(1) Zone A: If a blister is detected on the blade suction face, conduct a tapping test inspection on the whole blade for bonding separation. If bonding separation or a crack is found, replace the blade with an airworthy blade before further flight.

(2) Zone B: If a crack, wrinkling, or a blister is found, replace the blade with an airworthy blade before further flight.
