[Docket No. 99-SW-86-AD; Amendment 39-11737; AD 2000-10-13]

Airworthiness Directives; Eurocopter France Model SA-365N, SA-365N1, AS-365N2 and AS-365N3 Helicopters

AD 2000-10-13 Eurocopter France:

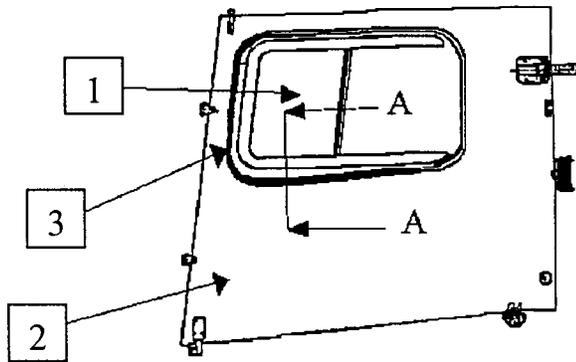
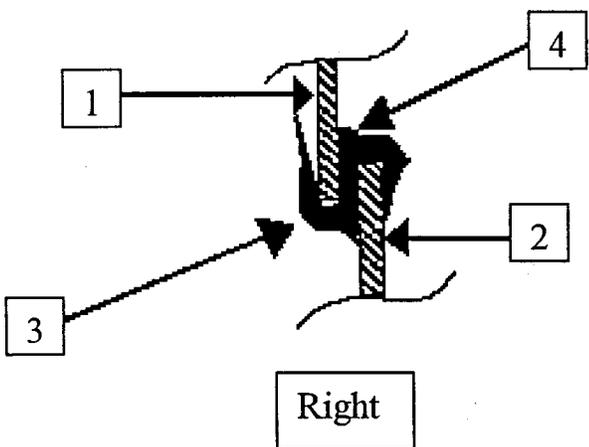
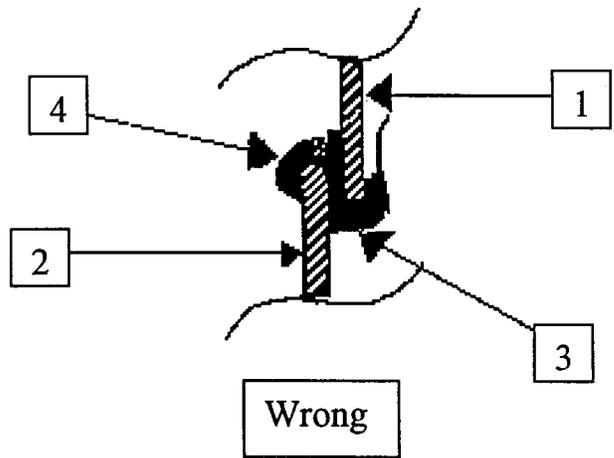
Figure 1

Eurocopter France has issued Telex Information No. 00097, dated November 9, 1999 (Telex). The Telex advises of the loss of a window panel in flight due to the window panel being sealed and positioned on the outside of the door. The Telex specifies visually inspecting the installation of each window panel

(a) Visually inspect each window panel in any enlarged sliding door (door) for correct positioning on the inside of the door. See Figure 1.

- 1 - Window
- 2 - Door Structure
- 3 - Seal
- 4 - Sealant

(2) If a window is installed on the outside, before further flight, remove the window and reinstall using a new seal.

a. From inside the door, cut the seal (see Figure 1, item 3). Push the window out and remove remnants of the seal from the window panel and door structure.

b. Remove all traces of the sealing compound (see Figure 1, item 4) with methyl ethyl ketone (MEK), acetone, or equivalent.

d. Fit the new seal to the window panel. The joint will be located in the lower center of the window panel. The clearance between the seal and the window panel should not exceed 0.04 inch.

h. Apply PR1222 sealant between the seal and the door structure. Wipe off any excess sealant.
