[Docket No. 99-SW-62-AD; Amendment 39-11766; AD 2000-11-18]

Airworthiness Directives; Eurocopter France Model SA-365C, C1, C2, N, and N1; AS-365N2 and N3; and SA-366G1 Helicopters

2000-11-18 Eurocopter France:

Amendment 39-11766. Docket No. 99-SW-62--AD. Supersedes AD 99-21-24, Amendment 39-11369, Docket No. 98-SW-75-AD.

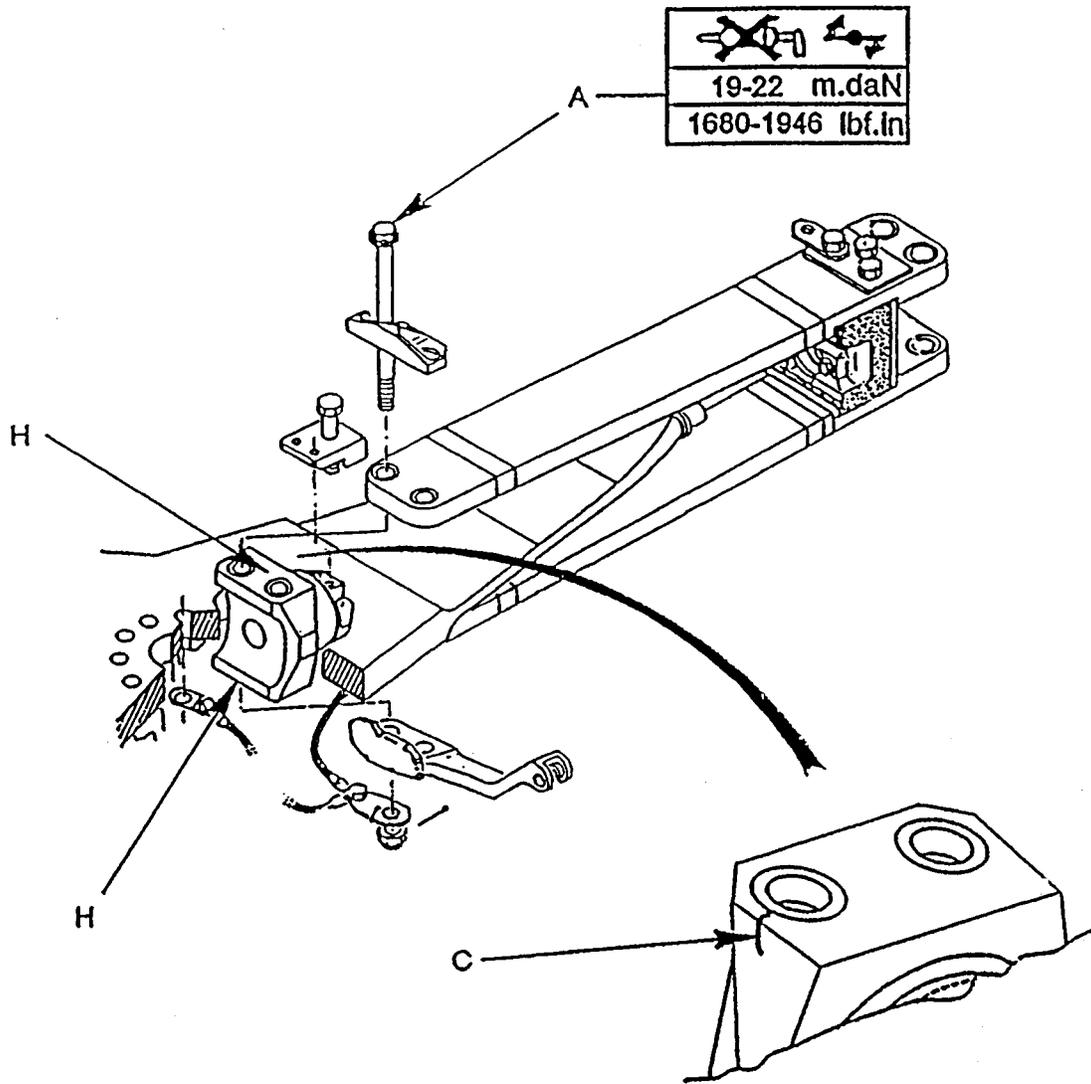
Figure 1

To prevent loosening of the main rotor hub blade attach beam spherical thrust bearing bolts (bolts), cracks in the metal components, failure of a spherical thrust bearing (bearing), and subsequent loss of control of the helicopter, accomplish the following:

(a) Inspect the tightening torque of the bolts as indicated by "A" in Figure 1.

(1) If tightening torque is equal to or less than 12 m.daN (88.4 lb-ft), remove the bearing and conduct a dye penetrant inspection for cracks on the two contact surfaces identified as "H" in Figure 1.

(i) If a crack is detected, replace the bearing with an airworthy bearing.

(ii) If no crack is detected, reinstall the bearing.

(2) If the tightening torque is greater than 12 m.daN (88.4 lb-ft), then tighten the torque to 19-22 m.daN (140-162.2 lb-ft).
