[Docket No. 99-SW-81-AD; Amendment 39-11901; AD 2000-18-14]

Airworthiness Directives; Sikorsky Aircraft-Manufactured Model CH-54A Helicopters

2000-18-14 Siller Helicopters; Aviation International Rotors, Inc. (AIR, INC); Columbia Helicopters, Inc.; Chet Raspberry, Inc. (CRI); Silver Bay Logging, Inc.: Amendment 39-11901. Docket No. 99-SW-81-AD. Supersedes AD 99-07-16, Amendment 39-11102, Docket No. 97-SW-60-AD.

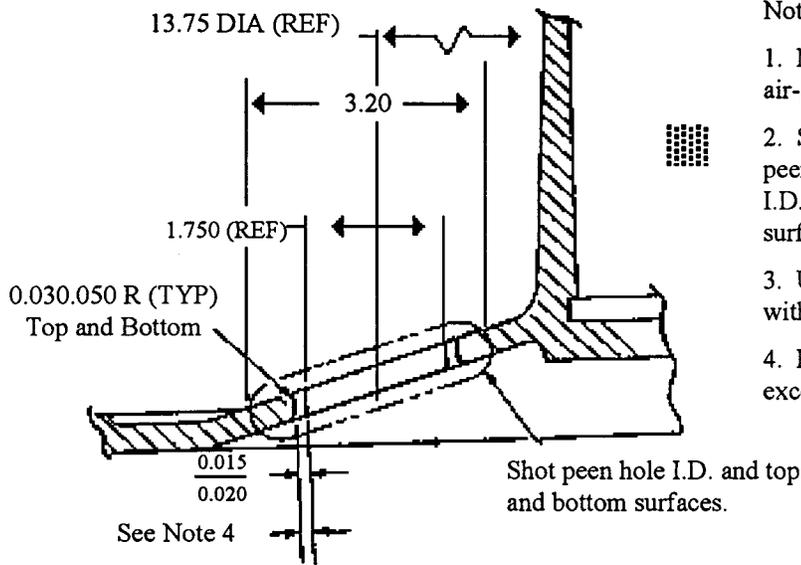
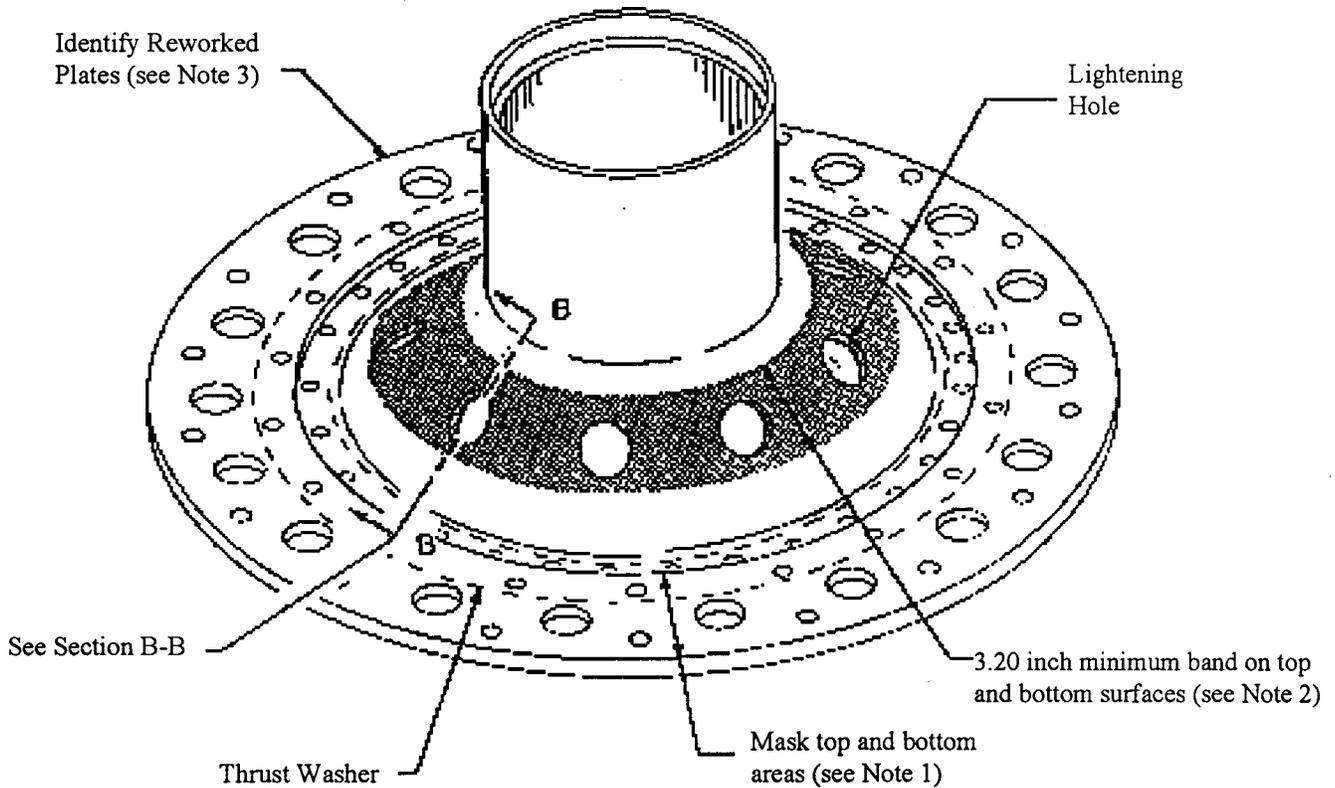
Rework of Second Stage
Lower Planetary Plate (6435-20229-102)
Figure 1

To prevent failure of the second stage lower planetary plate (plate), P/N 6435-20229-102, due to fatigue cracking, which could lead to failure of the main gearbox, failure of the drive system, and subsequent loss of control of the helicopter, accomplish the following:

(a) On or before accumulating 1,300 hours time-in-service (TIS), conduct a fluorescent magnetic particle inspection of the plate, P/N 6435-20229-102, in the circumferential and longitudinal directions using the wet continuous method. Pay particular attention to the area around the 9 lightning holes.

1. Mask top and bottom areas to protect from liquid air-grit and shot peen.
2. Shaded area to be liquid air-grit blasted and shot peened includes plate top and bottom surfaces and I.D. of all lightening holes. Feather shot peened surface edges.
3. Use low-stress depth controlled impression-stamp with full fillet depth of no more than 0.003 inch.
4. Reworked machined surface roughness shall not exceed 63 microinches AA rating.

(i) Locate the center of each 1.750 inch-diameter lightning hole and machine holes 0.015 to 0.020 oversize on a side (0.030 to 0.040 diameter oversize). Machined surface roughness must not exceed 63 microinches AA rating (see Figure 1).

(ii) Radius each hole 0.030 to 0.050 inches on each edge as shown in Figure 1.

(iii) Mask the top and bottom surfaces of the plate to expose 3.20 inch minimum width circumferential band as shown in Figure 1.

(iv) Vapor blast or bead exposed surfaces to remove protective finish. Use 220 aluminum oxide grit at a pressure of 80 to 90 pounds per square inch.

(v) Shot peen exposed surfaces and inside and edges of lightning holes to 0.008—0.012A intensity. Use cast steel shot, size 170; 200 percent coverage is required. Use the tracer dye inspection method to ensure the required coverage. Also, visually inspect the shot peened surfaces for correct shot peen coverage. Inspect the intensity of the shot by performing an Almen strip height measurement.

(vi) Clean reworked surfaces using acetone. Touch up the reworked areas using Presto Black or an equivalent touchup solution. Ensure that the touchup solution is at a temperature between 70° F to 120° F during use. Keep the reworked surfaces wet with touchup solution for 3 minutes to obtain a uniform dark color. Rinse and dry the reworked areas.

(vii) Polish the reworked surfaces with a grade 00 or finer steel wool and polish with a soft cloth. Coat the reworked surfaces with preservative oil.

(viii) Identify the reworked plate by adding "TS-107" after the part number using a low-stress depth-controlled impression-stamp with a full fillet depth of not more than 0.003 inch (see Figure 1).
