## DEPARTMENT OF TRANSPORTATION

#### Denial of Motor Vehicle Defect Petition, DP00-001

#### Appendix—Petition Analysis—DP00-001

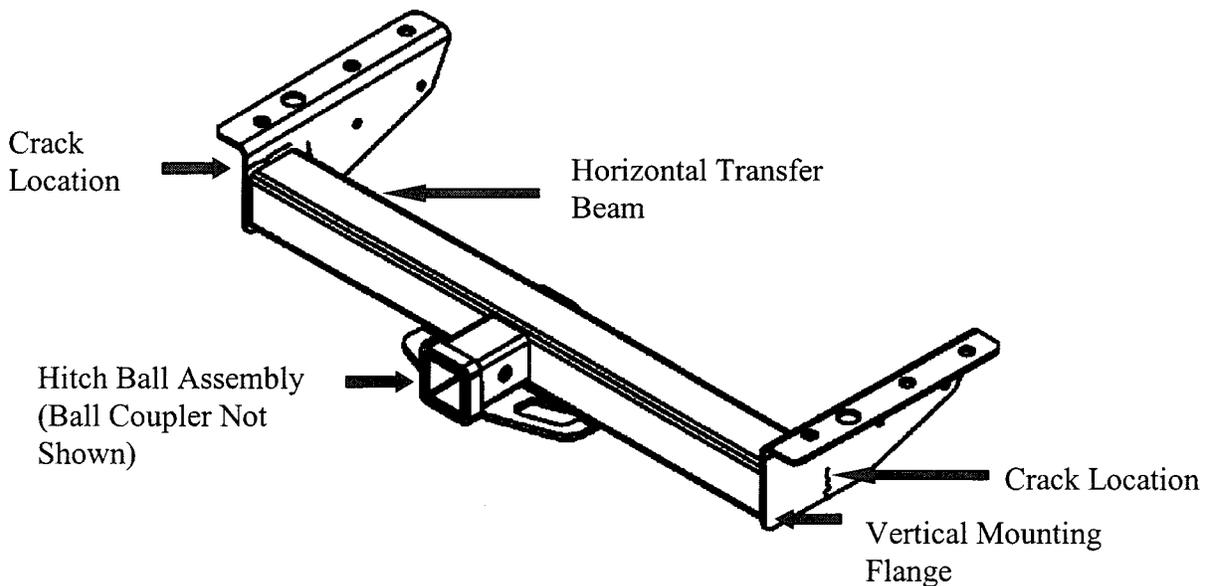
Figure 1. Typical Class III/IV towing Hitch Receiver

Figure 1 shows a diagram of a typical frame mounted Class III/IV type hitch receiver.

and (3) the vertical mounting flanges for attachment to the vehicle frame. Note that the diagram also shows the typical crack patterns found as reported by the petitioner.

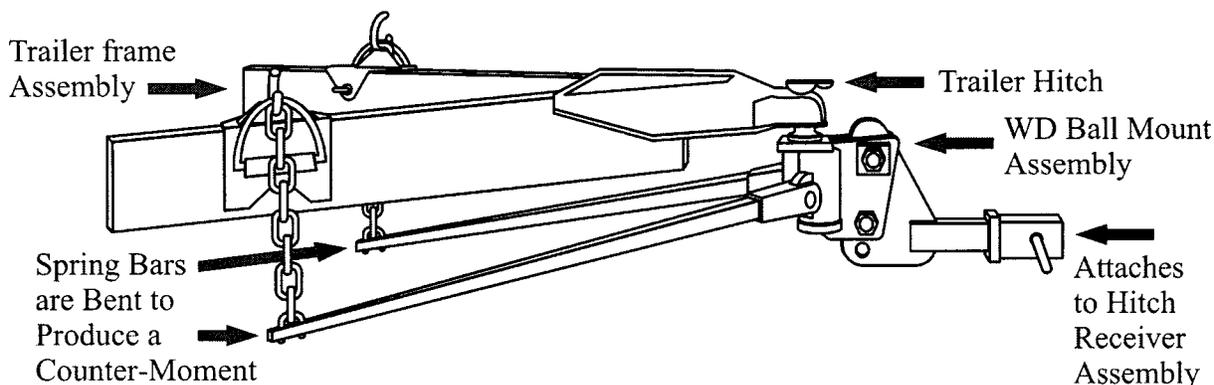
**Figure 2. Typical Weight Distributing Hitch System Setup**

shown in the set up of Figure 2, the two spring bars are bent upward to apply a counter moment torque to the WD hitch ball mount assembly and redirect or redistribute the point load tongue weight further forward in the tow vehicle. The subject vehicles' hitch receiver has a decal specifying 10,000 lb. towing and 1,000 lb. maximum tongue weight limits when used with the WD hitch system.
