[Docket No. 2000-NM-136-AD; Amendment 39-11962; AD 2000-22-15]

Airworthiness Directives; Boeing Model 747-100, -200B, -200C, -200F, and -300 Series Airplanes Delivered In or Modified Into the Stretched Upper Deck Configuration

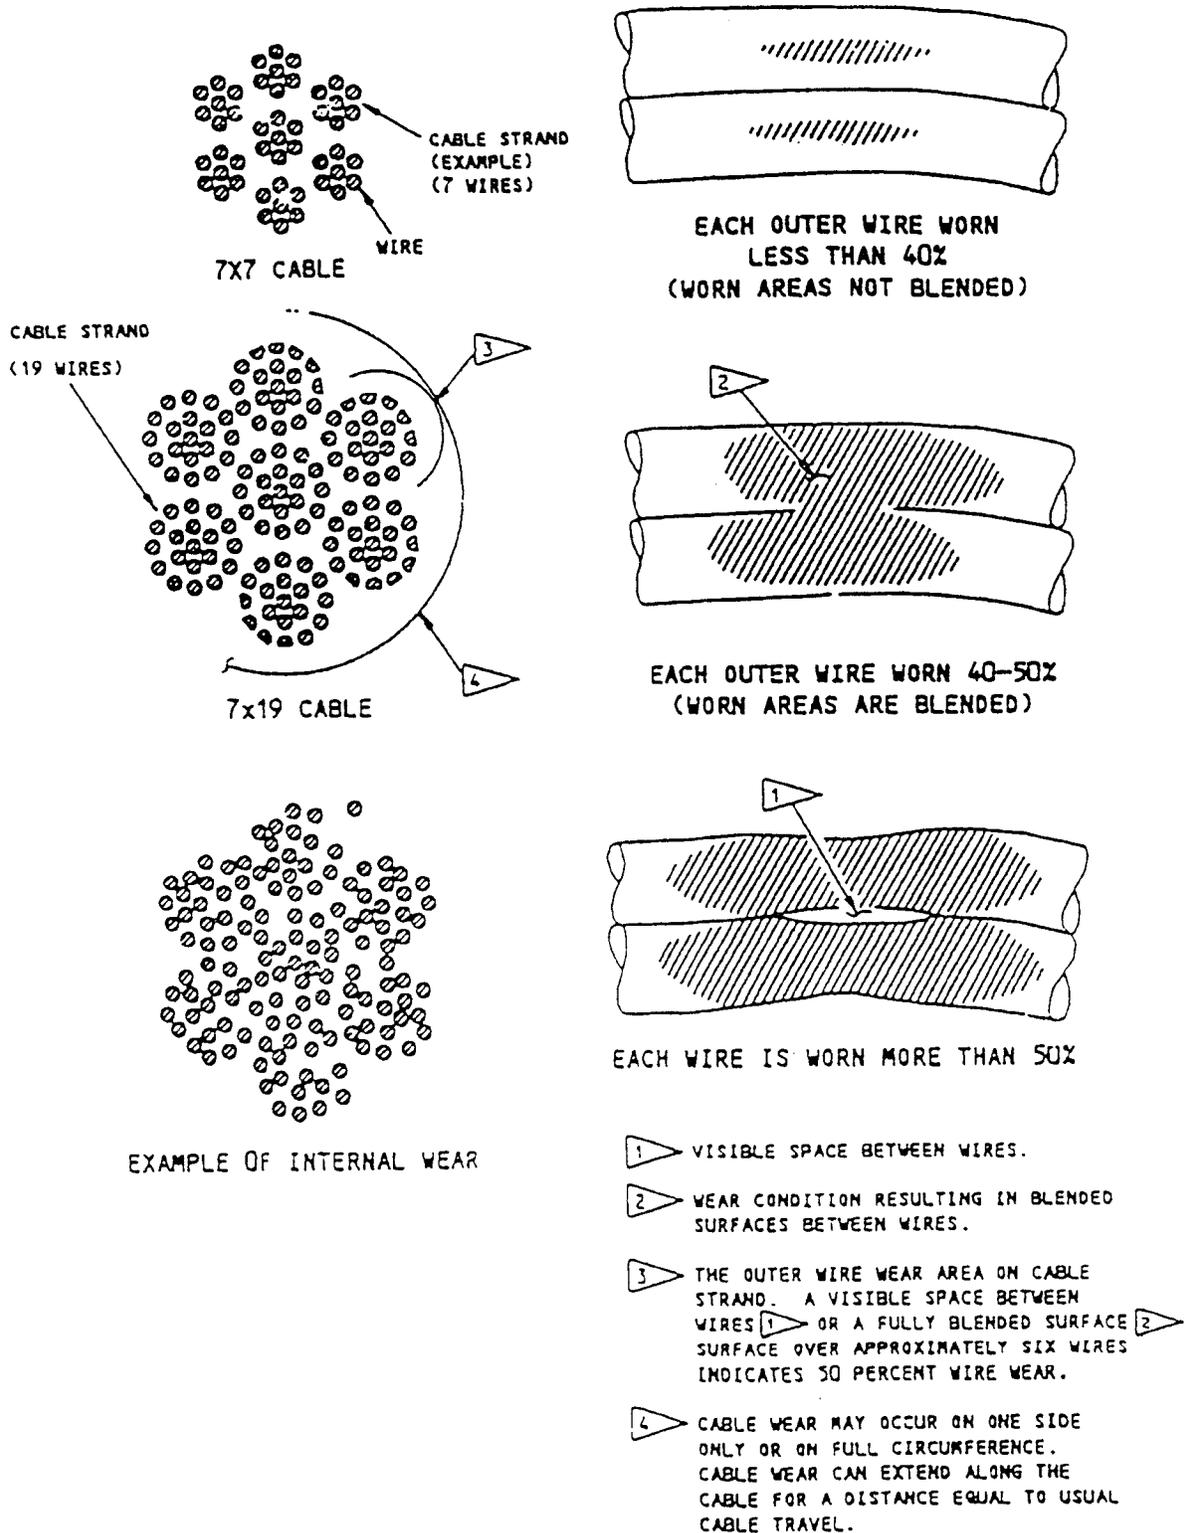
FIGURE 1

- A. Perform a detailed visual inspection of the engine thrust control cables in the area of the plate to detect wear.
- B. Replace the cable assembly if any of the following criteria are met:
- (1) One cable strand had worn wires where one wire cross section is decreased by more than 40 percent (see Figure 1).
 - (2) A kink is found.
 - (3) Corrosion is found.

(2) Perform a detailed visual inspection of the engine thrust control cables in the area of the plate to detect wear and broken wires in accordance with Appendix 1 (including Figure 1) of this AD. If any wear is within the criteria contained in Appendix 1 (including Figure 1) of this AD, no further action is required by this paragraph. If any wear outside the criteria contained in Appendix 1 (including Figure 1) of this AD is found, prior to further flight, replace the cable with a new cable, in accordance with the procedures described in the Boeing 747 Maintenance Manual.
