[Docket No. 2000-SW-51-AD; Amendment 39-11960; AD 2000-20-51]

Airworthiness Directives; Robinson Helicopter Company Model R22 Helicopters

2000-20-51 Robinson Helicopter Company:
Amendment 39-11960. Docket No. 2000-SW-51-AD.

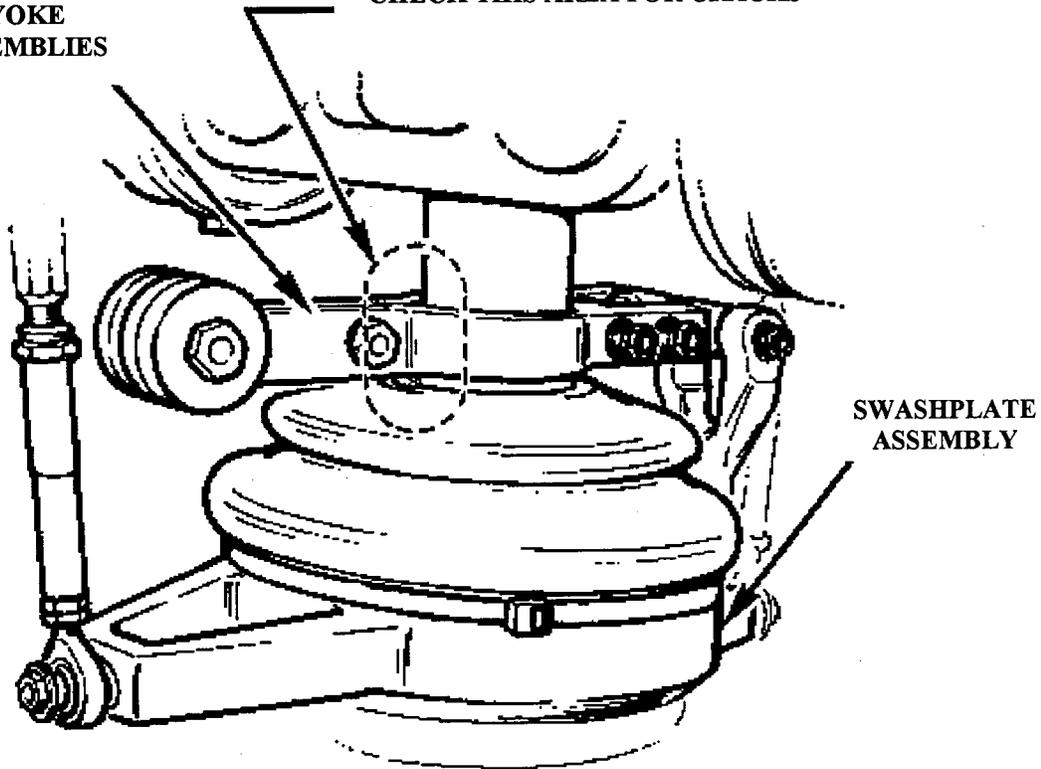
Figure A

yoke half assembly (yoke) for any crack and replacing a cracked yoke assembly before further flight. This AD also requires replacing certain yokes with airworthy yokes before further flight after January 1, 2001. This AD is prompted by the discovery of cracks in the yoke. The actions specified by this AD are intended to detect crack formation and growth, which could result in separation of the yokes from the main rotor drive shaft and subsequent loss of control of the helicopter.

(a) Before further flight and thereafter before the first flight of each day, check each yoke for a crack. See Figure A.

**A203-5 YOKE
HALF ASSEMBLIES**

CHECK THIS AREA FOR CRACKS

(b) If a yoke is cracked, before further flight, replace the yokes with airworthy yokes, P/N A203-7. Both yokes must be replaced with yokes, P/N A203-7.

(2) If the Lot identifier is from 24 through 43, if it is a letter code, or if it is illegible, replace yokes, P/N A203-5, with airworthy yokes, P/N A203-7. Yoke, P/N A203-7, cannot be installed with yoke, P/N A203-5.
