Federal Register

[Docket No. 2000-SW-60-AD]

Airworthiness Directives; Bell Helicopter Textron, Inc., Model 412 Helicopters

ACTION: Notice of proposed rulemaking (NPRM).

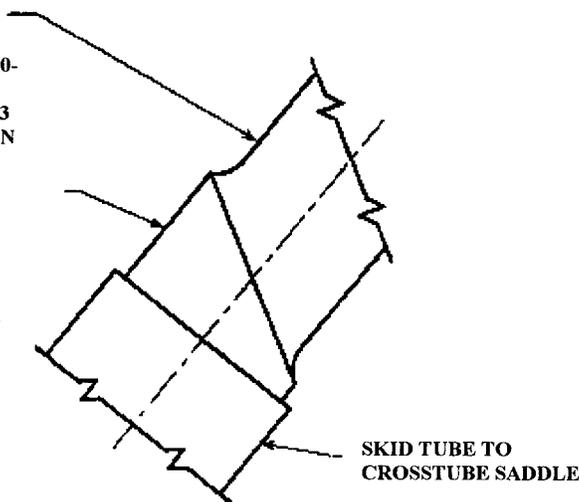
FIGURE 1

THE FACTORY HAS INK STAMPED THE SUBASSEMBLY AND SYNTHETIC P/N 412-050-044-101, -101A, OR -103 IN THIS GENERAL AREA.

CROSTUBE ASSEMBLY P/N 412-050-045-107 HAS THE NEXT LOWER (SUBASSEMBLY) P/N 412-050-044-103 VIBRO-ETCHED IN THIS LOCATION FROM THE FACTORY. THE S/N IS POSITIONED UNDER THE P/N.

VIBRO-ETCH 412-050-011-107 FM AND A COMPANY CONTROLLED S/N IN THIS AREA AS REQUIRED TO TRACK REMAINING HIGH AFT CROSTUBE LIFE. VIBRO-ETCHING DEPTH SHALL NOT EXCEED 0.005 INCH.

(3) Vibro-etch the P/N on the crosstube assembly adjacent to the skid tube saddle in accordance with Figure 1 for any crosstube assembly not displaying a visible P/N. Identify the crosstube assembly as P/N 412-050-011-107 FM.

(4) Vibro-etch a serial number (S/N) on the crosstube assembly below the P/N in accordance with Figure 1. The S/N must be unique for each crosstube assembly.
