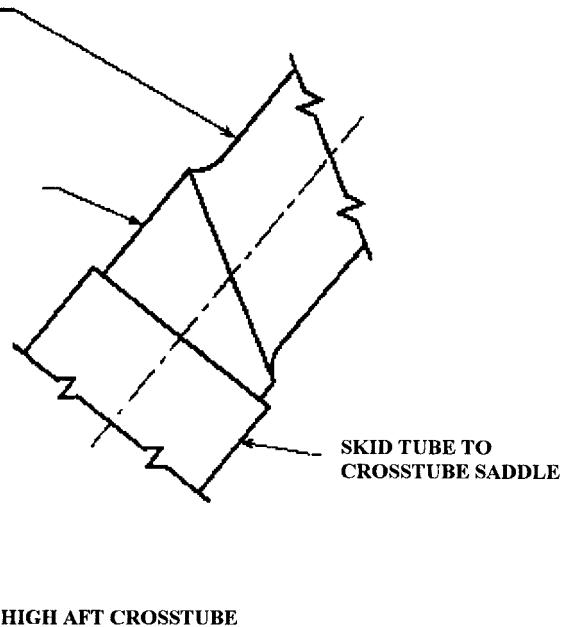
**FIGURE 1**

THE FACTORY HAS INK  
STAMPED THE SUBASSEMBLY  
AND SYNTHETIC P/N 412-050-  
044-101, -101A, OR -103 IN THIS  
GENERAL AREA.

CROSSTUBE ASSEMBLY P/N 412-050-  
045-107 HAS THE NEXT LOWER  
(SUBASSEMBLY) P/N 412-050-044-103  
VIBRO-ETCHED IN THIS LOCATION  
FROM THE FACTORY. THE S/N IS  
POSITIONED UNDER THE P/N.

VIBRO-ETCH 412-050-011-107 FM  
AND A COMPANY CONTROLLED  
S/N IN THIS AREA AS REQUIRED  
TO TRACK REMAINING HIGH AFT  
CROSSTUBE LIFE. VIBRO-  
ETCHING DEPTH SHALL NOT  
EXCEED 0.005 INCH.

HIGH AFT CROSSTUBE

(b) For a crosstube assembly, P/N 412-050-010-101 or 412-050-011-107 FM, on or before accumulating 10,000 landings or within 25 hours TIS after the effective date of this AD, whichever occurs later, replace the crosstube assembly with an airworthy crosstube assembly.

(c) For a crosstube assembly, P/N 412-050-045-107, on or before accumulating 20,000 landings or within 25 hours TIS after the effective date of this AD, whichever occurs later, replace the crosstube assembly with an airworthy crosstube assembly.

(d) This AD revises the Airworthiness Limitations section of the Maintenance Manual by establishing a life limit of 10,000 landings for the crosstube assembly, P/N 412-050-010-101 and 412-050-011-107 FM, and 20,000 landings for the crosstube assembly, P/N 412-050-045-107.
