[Docket No. 2000-NM-299-AD; Amendment 39-12107; AD 2001-03-04]

Airworthiness Directives; Bombardier Model CL-600-2B19 Series Airplanes

2001-03-04 Bombardier, Inc. (Formerly Canadair): Amendment 39-12107. Docket 2000-NM-299-AD.

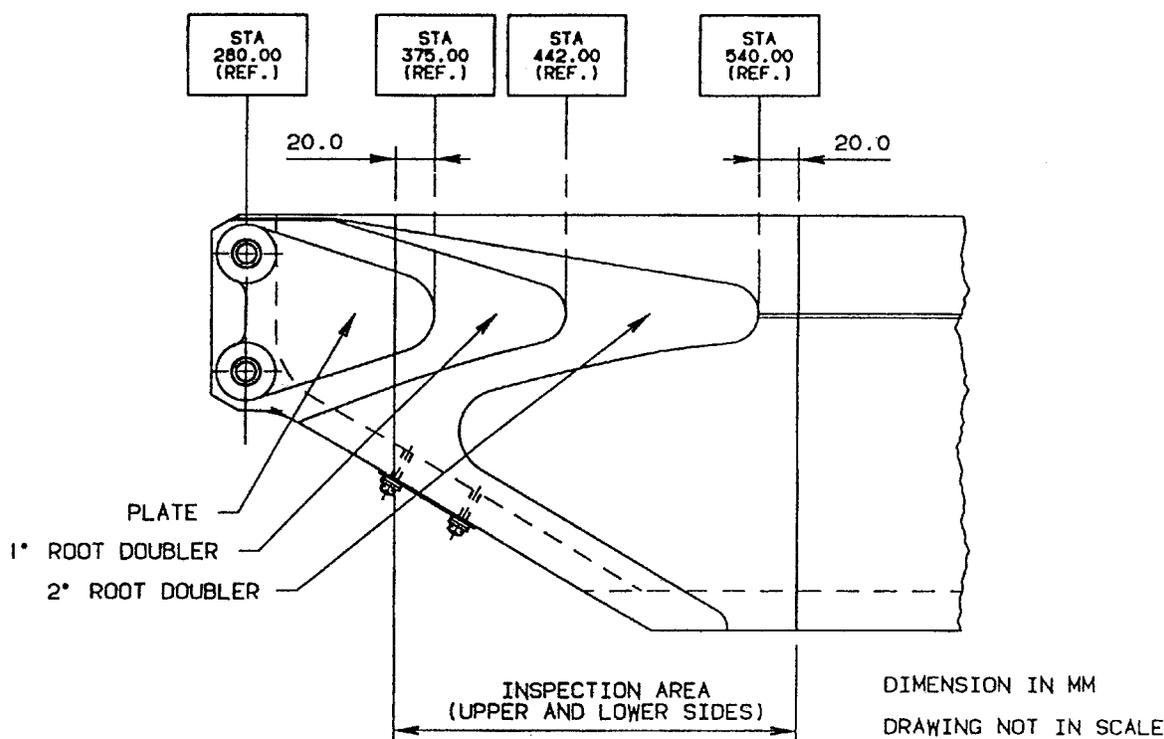
FIGURE 1

Note: Paint irregularities may be due to cracks.

(b) Within 10 hours time-in-service (TIS) and thereafter at intervals not to exceed 10 hours TIS or before the next flight after any abnormal tail rotor vibration, inspect each blade for a crack using a 5-power or higher magnifying glass in accordance with the Compliance Instructions, Part II, of Agusta S.p.A. Alert Bollettino Tecnico No. 109EP-14, dated October 11, 2000 (ABT).

(c) Within 25 hours TIS and thereafter at intervals not to exceed 25 hours TIS, dye-penetrant inspect each blade for a crack in accordance with the Compliance Instructions, Part III, of the ABT.

(d) If a crack is found, replace the blade with an airworthy blade before further flight.
