[Docket No. 2000-SW-38-AD]

Airworthiness Directives; Marathon Power Technologies Company

ACTION: Notice of proposed rulemaking (NPRM).

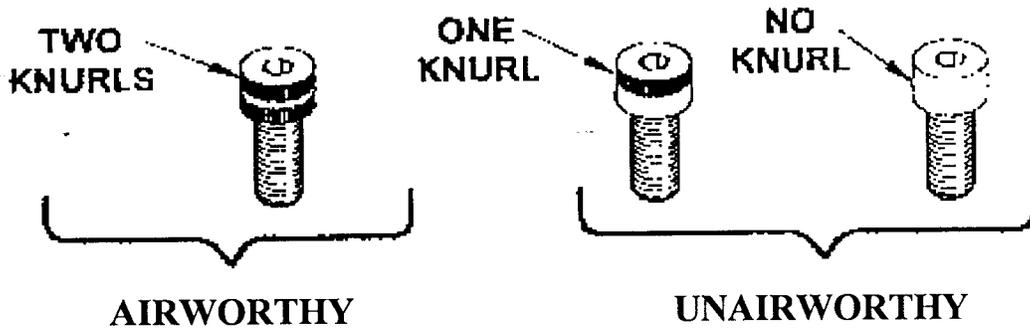
Figure 1

This document proposes adopting a new AD for certain nickel cadmium batteries produced by Marathon. The AD would require inspecting any affected battery to verify that each #10-32 socket head cap screw (screw) is part number (P/N) 10488-020 with two rows of straight knurls, which is the correct screw hardware. This AD also requires, before further flight, replacing any screw found with only one knurl or no knurl with a screw, P/N 10488-020, with two knurls. This proposal is

prompted by an explosion of a G.E./Saft battery during routine maintenance on a McDonnell Douglas DC-9 aircraft. Marathon battery, P/N 27183-001, is similar to the GE/Saft battery that exploded. A battery cell screw head broke off causing an electrical short circuit between the internal battery cell positive and negative posts. This resulted in a rapid discharge of energy, heat, and gases. Investigation revealed unapproved screws were installed, and maintenance procedures did not comply with the manufacturer's recommendations. Metallurgical tests cited chloride as a factor in causing the heads of the failed screws to shear and the eventual explosion of the battery. The actions specified by the proposed AD are intended to prevent an explosion of a battery, structural damage, and subsequent loss of power to the electrical systems.

We have identified an unsafe condition that is likely to exist or develop on other aircraft with Marathon batteries installed that are similar in design to the GE/Saft battery that exploded. Both are designed with similar #10-32 screws, P/N 10488-020. The proposed AD would require visually inspecting each #10-32 screw in certain Marathon batteries within 12 months or the next scheduled battery maintenance and, before further flight,

(a) Visually inspect each #10-32 screw in the battery at the terminals to verify that each screw has two (2) rows of straight knurls (see Figure 1). If a screw is found with only one knurl or no knurl (see Figure 1), before further flight, fully discharge the battery, remove the unairworthy screw and replace it with an airworthy screw, P/N 10488-020.
