[Docket No. 2001-SW-13-AD]

Airworthiness Directives; Bell Helicopter Textron, Inc. Model 47B, 47B-3, 47D, 47D-1, 47G, 47G-2, 47G2A, 47G-2A-1, 47G-3, 47G-3B, 47G-3B-1, 47G-3B-2, 47G-3B-2A, 47G-4, 47G-4A, 47G-5, 47G-5A, 47H-1, 47J, 47J-2, 47J-2A, and 47K Helicopters

ACTION: Notice of proposed rulemaking.

Bell Helicopter Textron, Inc.: Docket No. 2001-SW-13-AD. Supersedes AD 2000-18-51, Amendment 39-11983, Docket No. 2000-SW-35-AD.

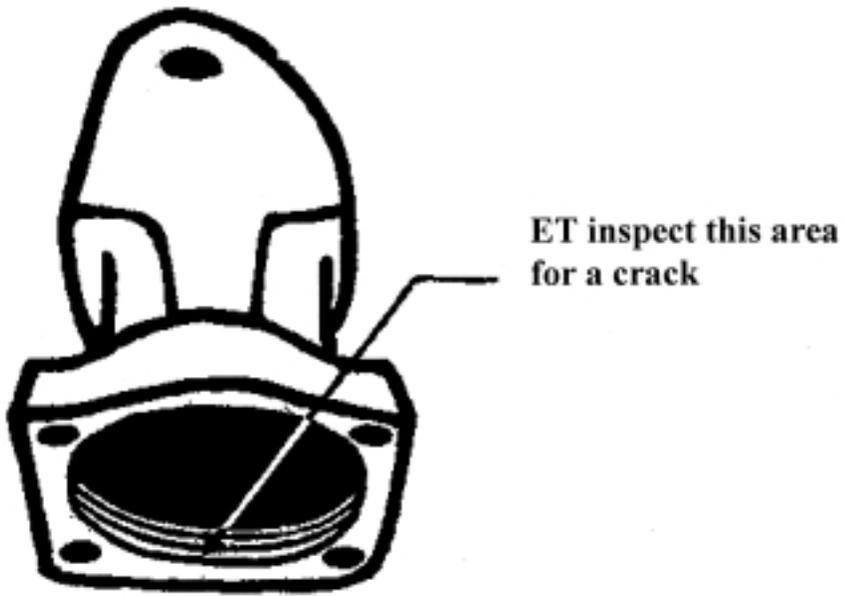
Figure 1, Appendix 1

1.1 The inboard inside diameter machined threads (reference figure 1).

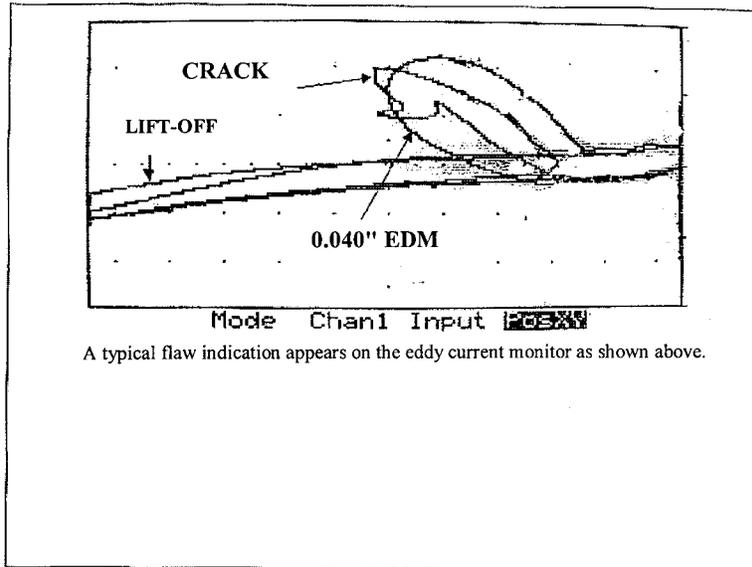
Figure 2, Appendix 1

6.1 Place the probe into the threaded area and slide it in the same direction as was done on the standard while monitoring the screen for root cracks. Moving the probe in the same direction produces a repeatable display that allows for more accurate flaw size determination. Scan the probe along each individual thread until all the threads are inspected. (See Figures 2 and 3.)

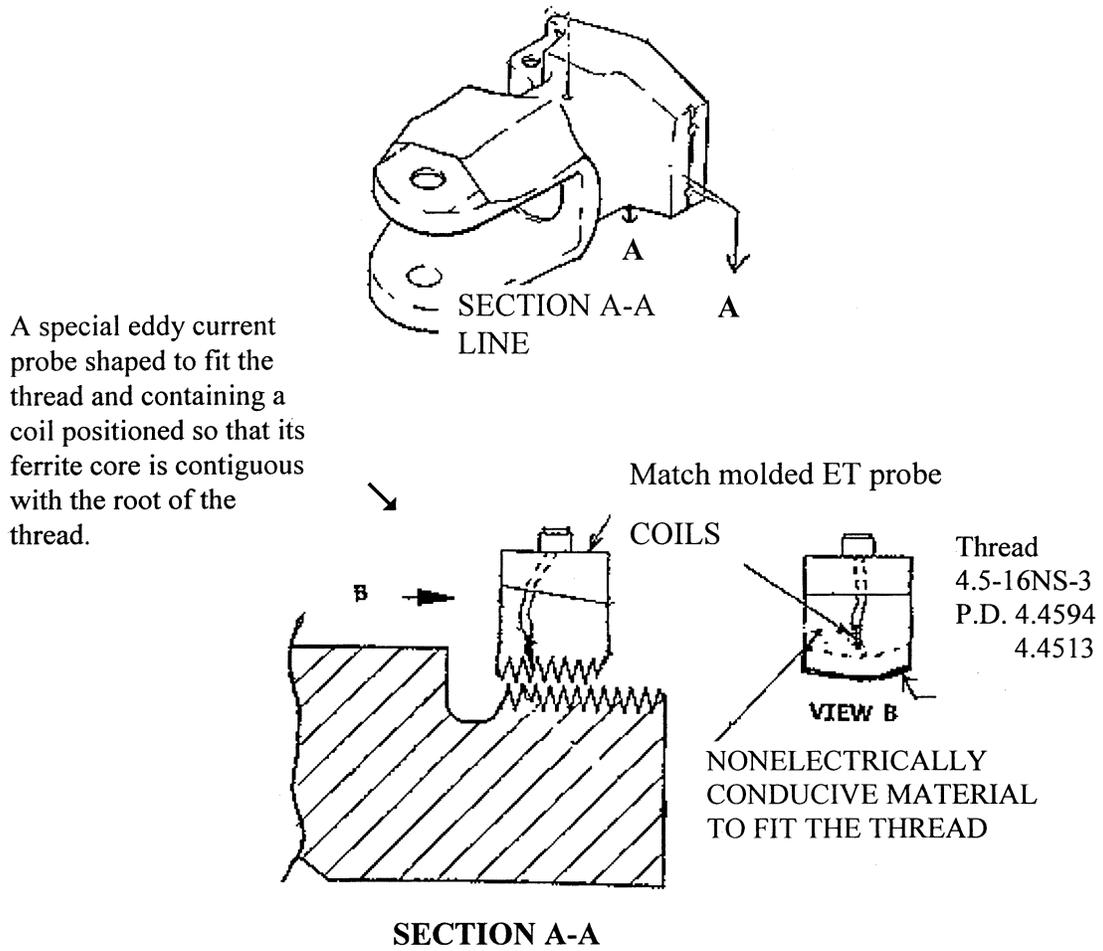
Figure 3, Appendix 1

2.2 Match molded ET probe SPC-193 (100kHz) or equivalent. (See Figure 3.)

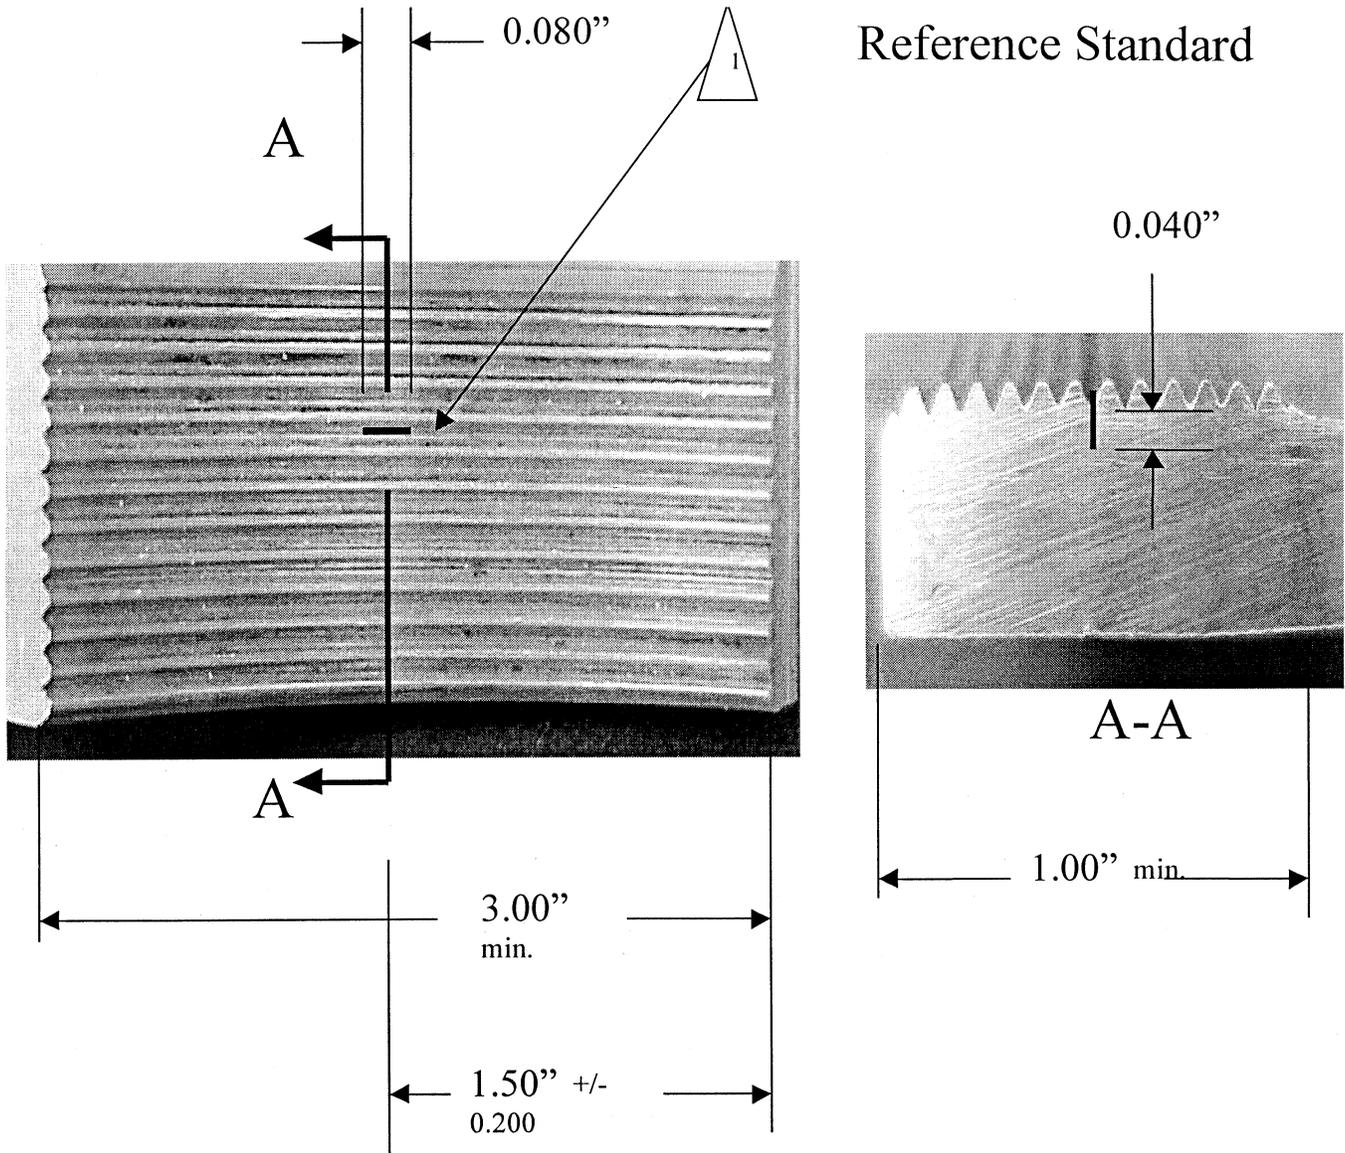
Figure 4, Appendix 1

2.3 Reference standard EC-010-021, or equivalent. (See Figures 4 and 5.)

EDM 1 place only in thread root.
 Notch width shall be 0.004 max.
 All other dimensions to be +/- 0.004 from indicated.
