[Docket No. 2000-SW-12-AD]

#### Airworthiness Directives; Eurocopter France Model AS350B, B1, B2, B3, BA, C, D, D1, and AS355E, F, F1, F2, and N Helicopters

**ACTION:** Notice of proposed rulemaking (NPRM).

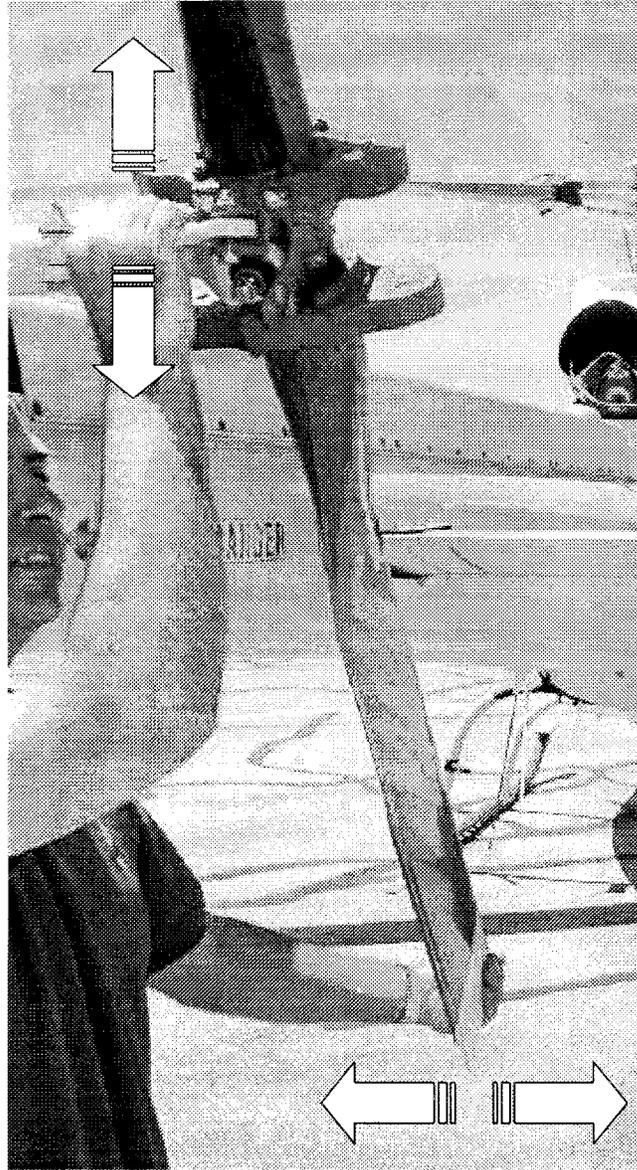
Figure 1: Manual Inspection for play of the Tail Rotor Pitch Control Rod

To prevent separation of the outboard spherical bearing (bearing) ball from its outer race, rubbing of the body of the control rod against the tail rotor blade pitch horn clevis, failure of the control rod, and loss of control of the helicopter, accomplish the following:

(a) Before the first flight of each day, configure the helicopter by ensuring the tail rotor pedals are in neutral position. If the helicopter is fitted with a tail rotor load compensator, discharge the accumulator as described in the flight manual. Inspect the bearing for play (Figure 1) on the helicopter, by observation and feel, by slightly moving the tail rotor blade in the flapping axis while monitoring the bearing for movement.

(1) If the Teflon cloth is found to be coming out of its normal position within the bearing, totally or partially, replace the control rod with an airworthy control rod before further flight.

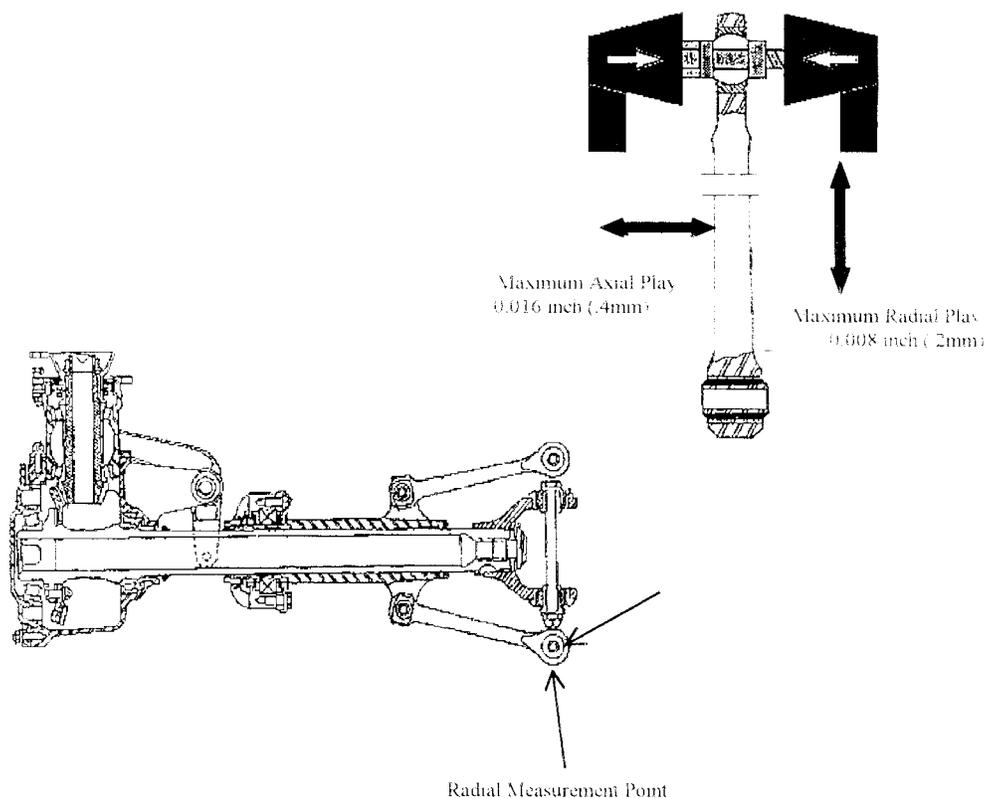
Figure 2. Play Measurement on Tail Rotor Pitch Control Rod

(2) If play is detected, measure the bearing wear using a dial indicator as shown in Figure 2. Perform the following steps (Figure 2) unless they were accomplished within the last 30 hours TIS.

(vii) If the radial play exceeds 0.008 inch or axial play exceeds 0.016 inch, replace the

control rod with an airworthy control rod before further flight.

(4) At intervals not to exceed 30 hours TIS, remove the control rod and measure the bearing wear with a dial indicator (Figure 2) using steps (a)(2)(i) through (a)(2)(vii).
