[Docket No. 2001-SW-24-AD; Amendment 39-12407; AD 2001-17-16]

#### Airworthiness Directives; Agusta S.p.A. Model A109E Helicopters

**2001-17-16 Agusta S.p.A.:** Amendment 39-12407. Docket No. 2001-SW-24-AD. Supersedes AD 2000-25-54, Amendment 39-12106, Docket No. 2000-SW-65-AD.

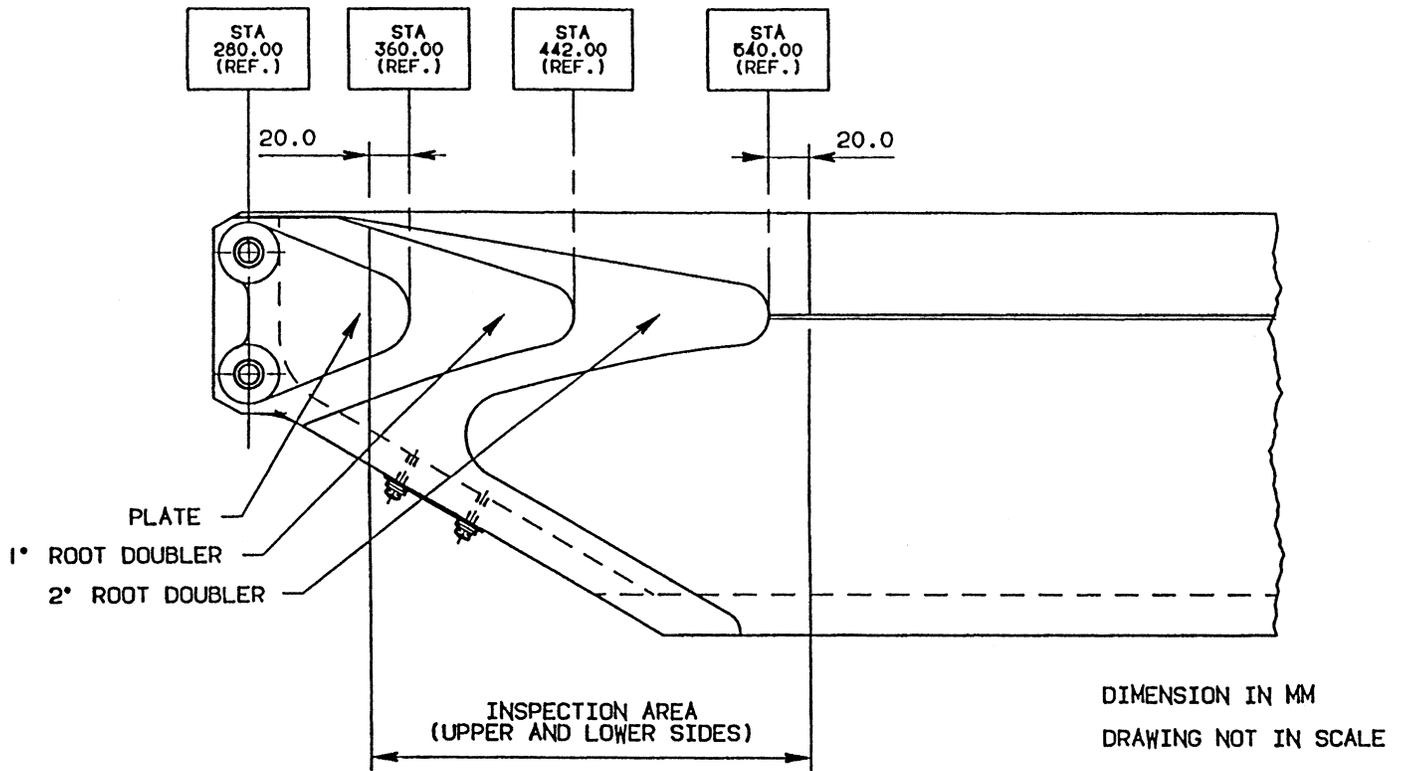
**FIGURE 1**

(a) Before each start of the engines, visually check both sides of each blade for a crack in accordance with Figure 1 of this AD for blade, P/N 109-8132-01-107, or Figure 2 of this AD for blade, P/N 109-8132-01-109. An owner/operator (pilot), holding at least a private pilot certificate, may perform the visual check required by this paragraph and must record compliance with paragraph (a) of this AD in the aircraft maintenance records in accordance with 14 CFR 43.11 and 91.417(a)(2)(v).

P/N 109-8132-01-107 T/R BLADE

(d) If a crack is found, replace the blade with an airworthy blade before further flight.

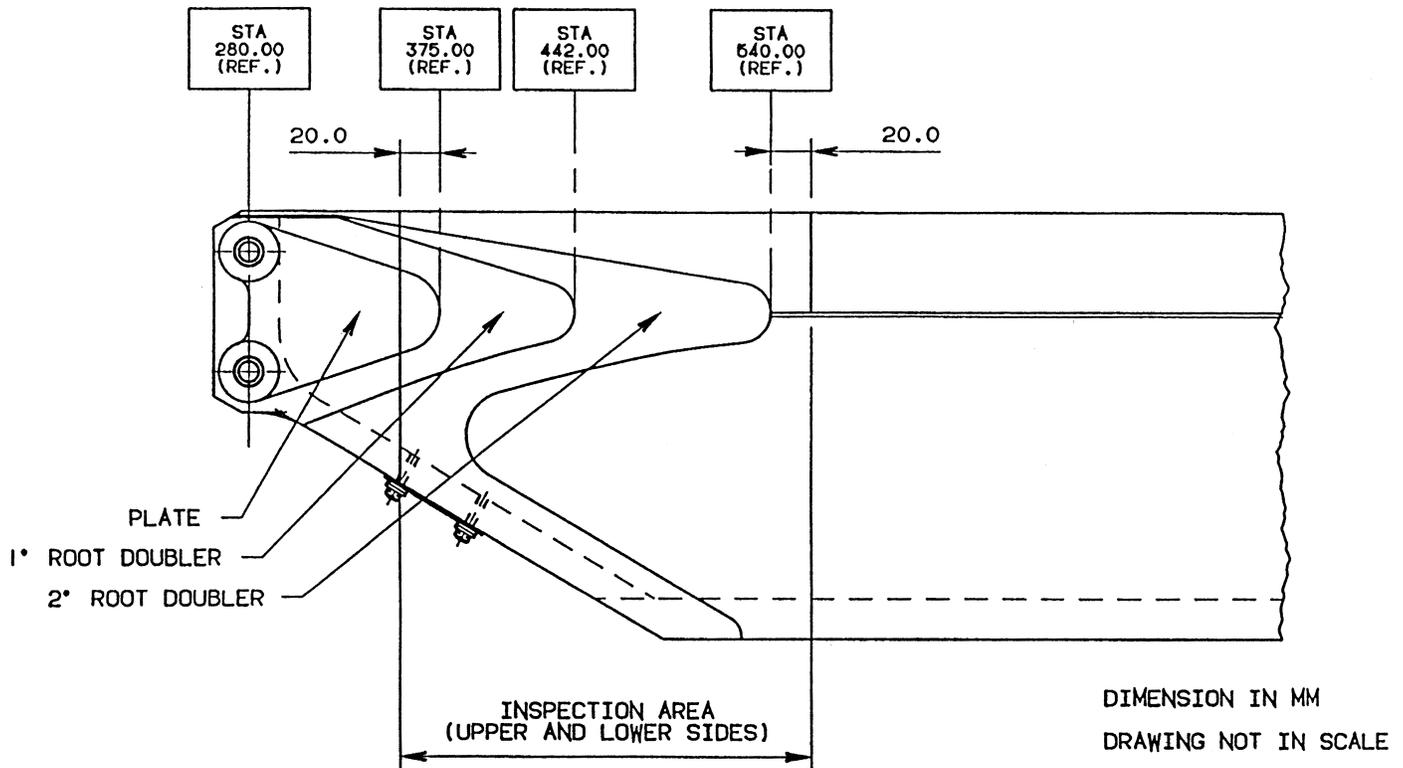
**FIGURE 2**

P/N 109-8132-01-109 T/R BLADE
