14 CFR Part 39

[Docket No. 99-CE-85-AD]

Airworthiness Directives; EXTRA Flugzeugbau GmbH Models EA-300, EA-300L, and EA-300S Airplanes

ACTION: Notice of proposed rulemaking (NPRM).

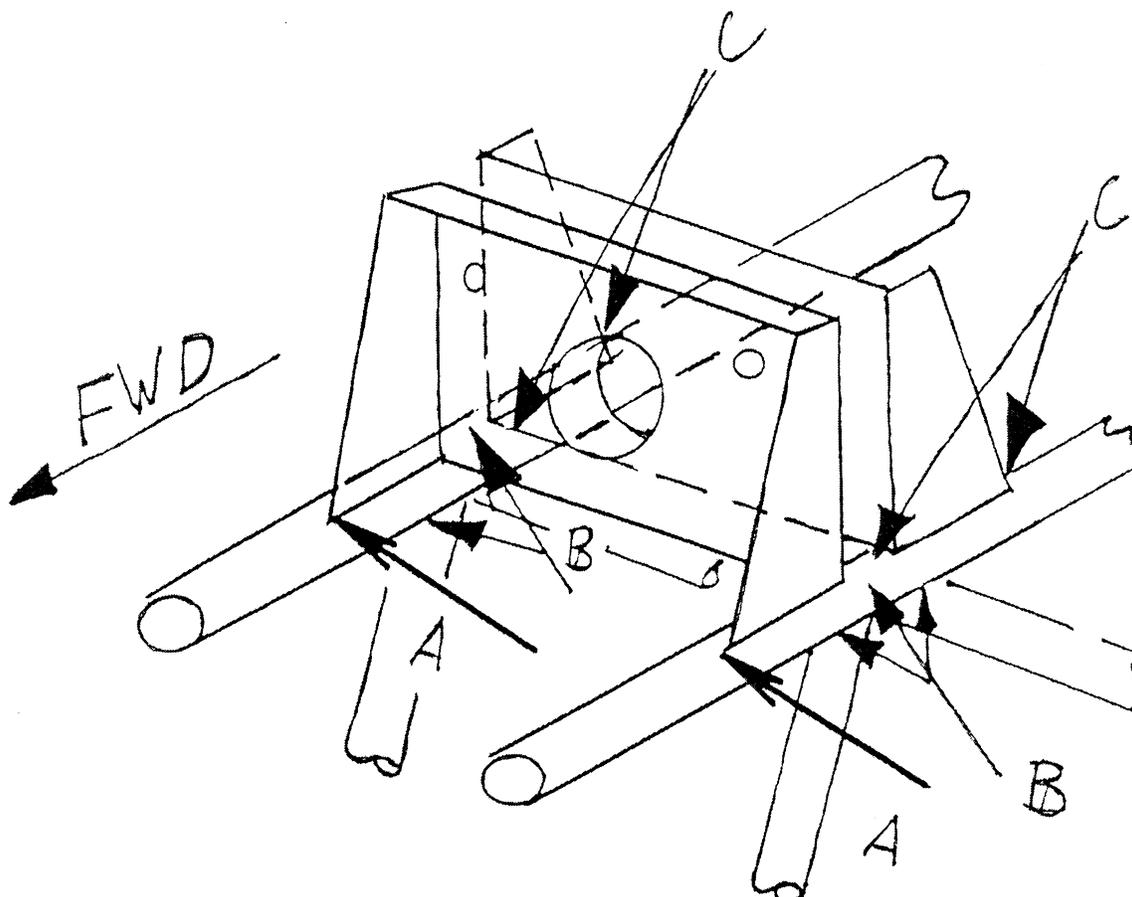
Actions	Compliance	Procedures
(1) For all affected airplanes, inspect, using a fluorescent dye penetrant method, the upper longeron at the horizontal stabilizer attachment for cracks in the areas depicted in Figure 1 of this AD.	Upon accumulating 250 hours time-in-service (TIS) or within the next 50 hours TIS after the effective date of this AD, whichever occurs later.	In accordance with Part I of Extra Service Bulletin No. 300-2-95 (pages 2-6 at Issue: C, dated July 15, 1998; and pages 1 and 7 through 11 at Issue: D, dated January 30, 2001). No further action is required by this paragraph if the modification is already accomplished in accordance with Part II of Extra Service Bulletin No. 300-2-95 (all pages at Issue: C, dated July 15, 1998).

(3) For all affected airplanes, if any crack is found during the inspection required by this AD and the crack(s) is(are) in Area A or Area B as depicted in Figure 1 of this AD, accomplish the following: (i) Repair and modify the upper longeron at the horizontal stabilizer attachment; and (ii) Weld the cracks tight during repair.	Prior to further flight after the inspection where any crack is found in Area A or Area B as depicted in Figure 1 of this Ad.	In accordance with Part II of Extra Service Bulletin No. 300-2-95, Issue: D, dated January 30, 2001. No further action is required by this paragraph if already accomplished in accordance with Part II of Extra Service Bulletin No. 300-2-95 (all pages at Issue: C, dated July 15, 1998).

(4) For all affected airplanes, if any crack is found during the inspection and the crack(s) is(are) in Area C as depicted in Figure 1 of this AD, accomplish the following: (i) Obtain a repair scheme from the manufacturer; (ii) Incorporate this repair scheme; and (iii) Accomplish any follow-up actions as directed by the FAA.	Prior to further flight after the inspection where any crack is found.	In accordance with a repair scheme obtained from EXTRA Flugzeugbau GmbH, Flugplatz Dinslaken, D-46569 Hünxe, Federal Republic of Germany; telephone: (0 28 58) 91 37-00; facsimile: (0 28 58) 91 37-30. Obtain this repair scheme through FAA at the address specified in paragraph (f) of this and AD.

(2) For all affected air planes, if no crack(s) is(are) found during the inspection required by this AD, modify the upper longeron at the horizontal stabilizer attachment.	Prior to further flight after the inspection required by paragraph (d)(1) of this AD.	In accordance with Part II of Extra Service Bulletin No. 300-2-95 (pages 2-6 at Issue: C, dated July 15, 1998; and pages 1 and 7 through 11 at Issue: D, dated January 30, 2001). No further action is required by this paragraph if already accomplished in accordance with Part II of Extra Service Bulletin No. 300-2-95 (all pages at Issue: C, dated July 15, 1998).
