[Docket No. 2001-SW-09-AD; Amendment 39-12450; AD 2001-20-04]

Airworthiness Directives; Agusta S.p.A. Model A109E Helicopters

2001-20-04 Agusta S.p.A.: Amendment 39-12450. Docket No. 2001 SW-09 AD.

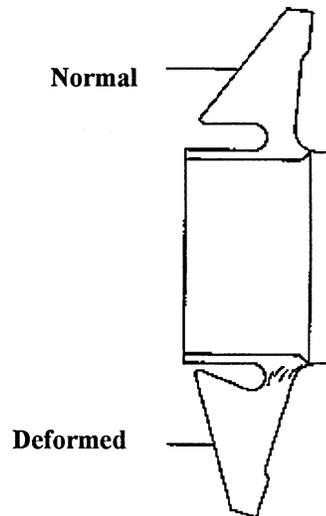
Figure 1

**Normal and Deformed (damaged) Indications of the
High Altitude Tail Rotor Static Stop Yield Indicator (P/N 206-011-752-101)**
