[Docket No. 99-SW-34-AD; Amendment 39-12452; AD 2000-10-08 R1]

Airworthiness Directives; Eurocopter France Model SA-365N1, AS-365N2, and SA-366G1 Helicopters

ACTION: Final rule.

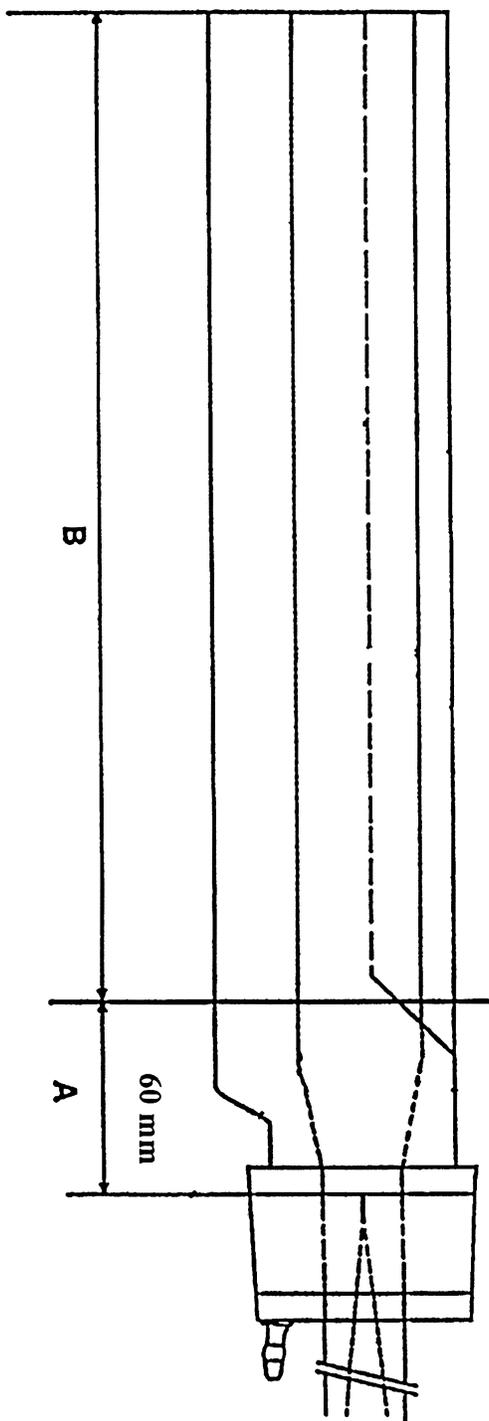
FIGURE 1

(a) Within 10 hours time-in-service (TIS) and thereafter before the first flight of each day, visually check each blade (see Figure 1) for a crack, blister, or wrinkling. An owner/operator (pilot), holding at least a private pilot certificate, may perform the visual check and must enter compliance into the aircraft maintenance records in accordance with 14 CFR sections 43.11 and 91.417(a)(2)(v).

(b) If a crack, blister, or wrinkling is found as a result of the visual check, accomplish the following before further flight (see Figure 1):

(1) *Zone A:* If a blister is detected on the blade suction face, conduct a tapping test inspection on the whole blade for bonding separation.

(2) *Zone B:* If a crack, wrinkling, or a blister is found, replace the blade with an airworthy blade before further flight.

(i) For blades, P/N 365A33-2131—all dash numbers, 365A12-0010—all dash numbers, and 365A12-0020-00, and -01, if bonding separation or a crack is found, replace the blade with an airworthy blade before further flight.

(ii) For blades, P/N 365A12-0020-02, and -03, if bonding separation exceeds 900 mm² in a 30 × 30 mm square or if there is a crack, replace the blade with an airworthy blade before further flight.
