Vol. 66, No. 209

[Docket No. 2001-SW-17-AD]

#### Airworthiness Directives; Bell Helicopter Textron, Inc.—Manufactured Model OH-13E, OH-13H, and OH-13S Helicopters

**ACTION:** Notice of proposed rulemaking (NPRM).

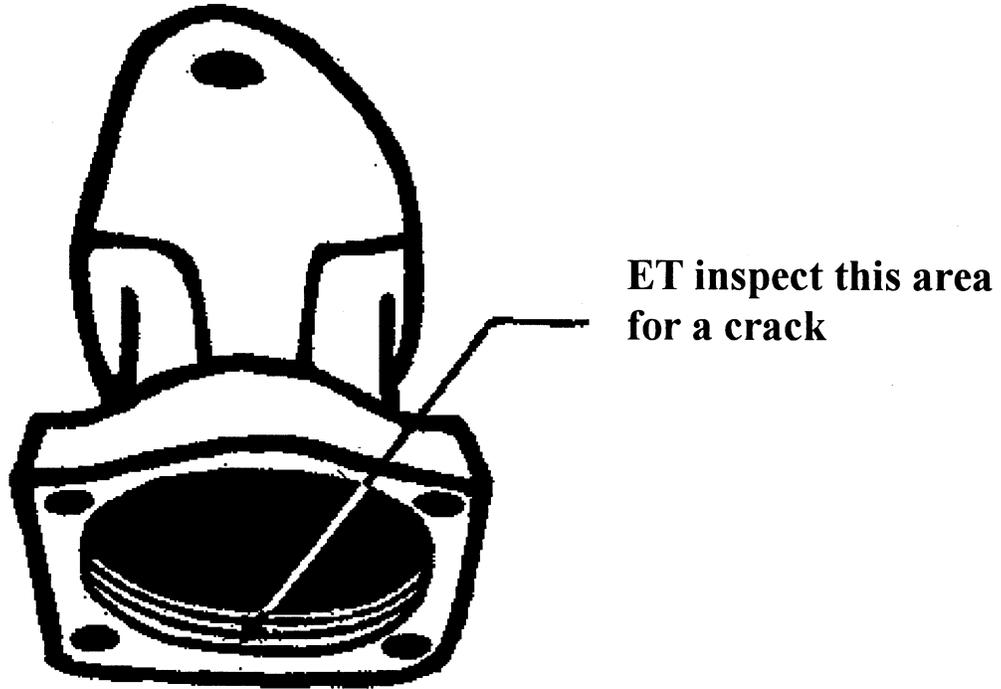
**Figure 1, Appendix 1**

1.1 The inboard inside diameter machined threads (reference Figure 1).

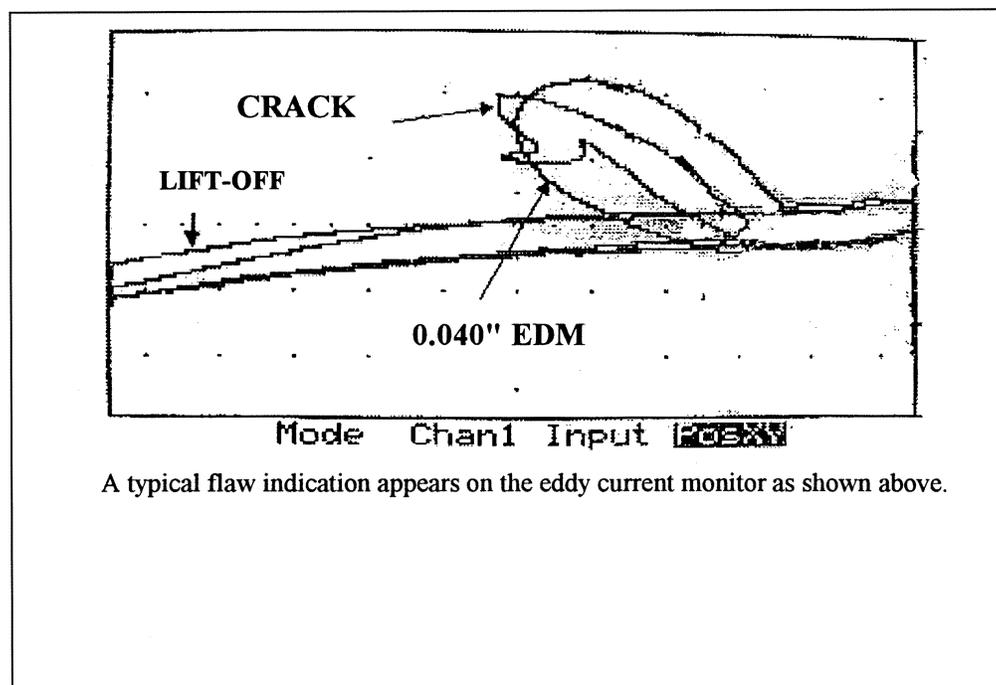
**Figure 2, Appendix 1**

6.1 Place the probe into the threaded area and slide it in the same direction as was done on the standard while monitoring the screen for root cracks. Moving the probe in the same direction produces a repeatable display that allows for more accurate flaw size determination. Scan the probe along each individual thread until all the threads are inspected. (See Figures 2 and 3.)

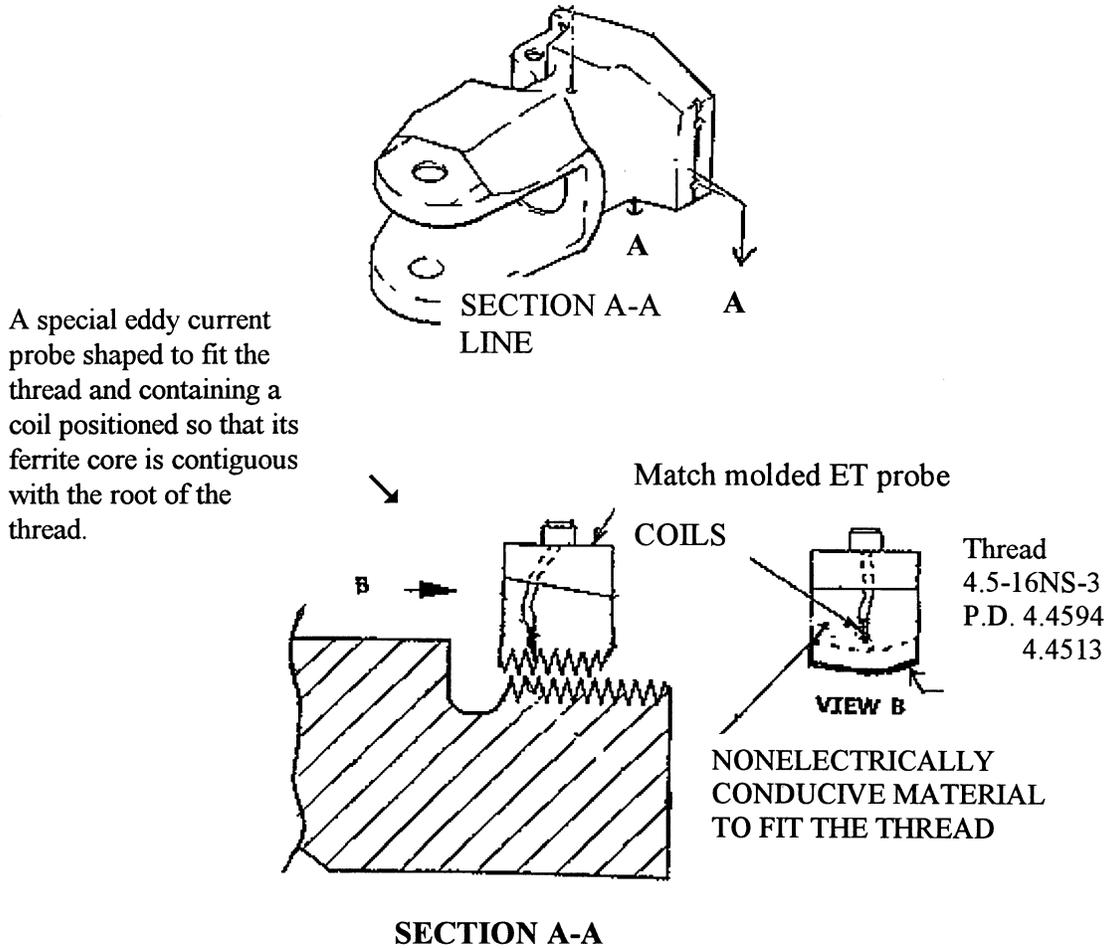
Figure 3, Appendix 1

2.2 Match molded ET probe SPC-193 (100kHz) or equivalent. (See Figure 3.)

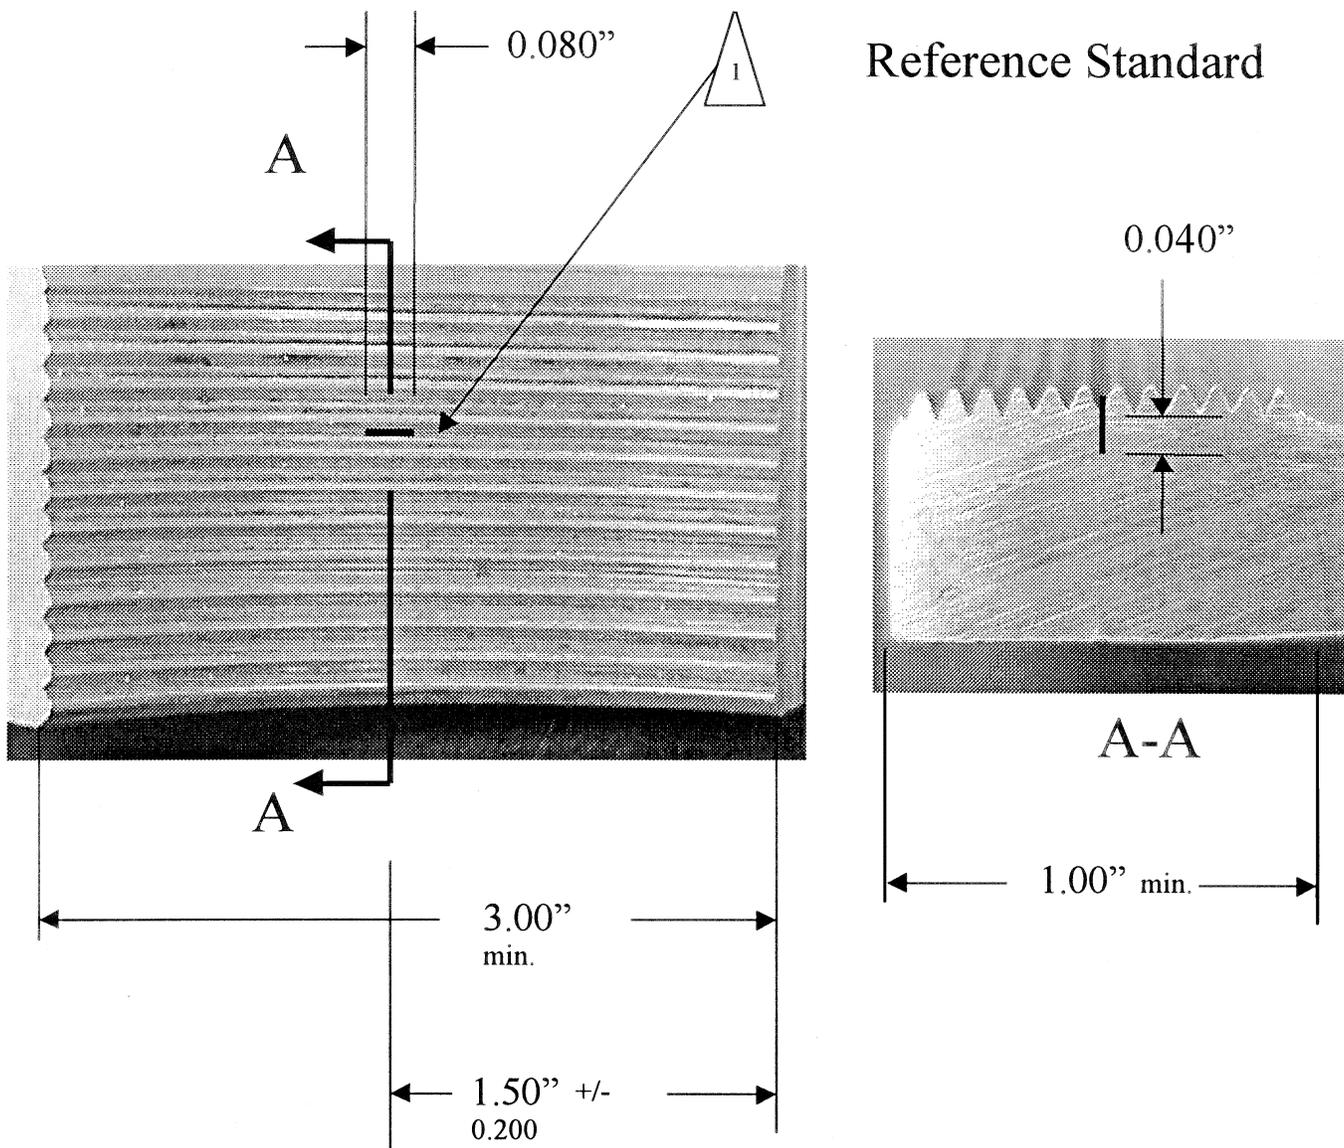
**Figure 4, Appendix 1**

2.3 Reference standard EC-010-021, or equivalent. (See Figures 4 and 5.)

EDM 1 place only in thread root.  
 Notch width shall be 0.004 max.  
 All other dimensions to be +/- 0.004 from indicated.

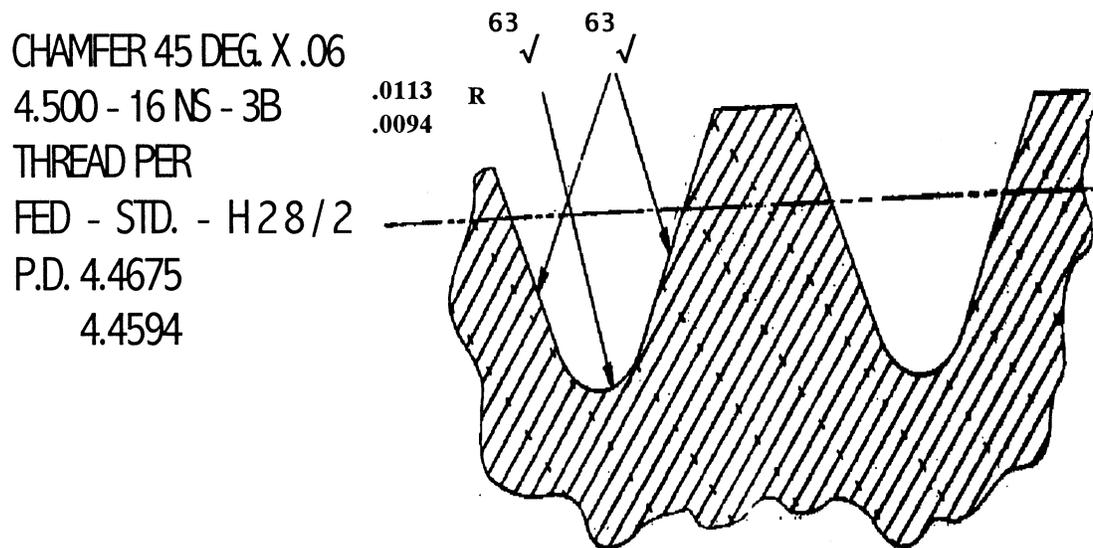
**Figure 5, Appendix 1**

1. Standard may be machined from aluminum tube stock.
2. The standard shall contain a minimum of four teeth per the tooth dimensions specified.
3. The EDM notch shall be placed in the center most tooth root as measured across the width of the standards. There shall be no less than two teeth and one root on either side of the EDM notch.
