[Docket No. 2001-SW-39-AD]

Airworthiness Directives; MD Helicopters Inc. Model MD-900 Helicopters

ACTION: Notice of proposed rulemaking (NPRM).

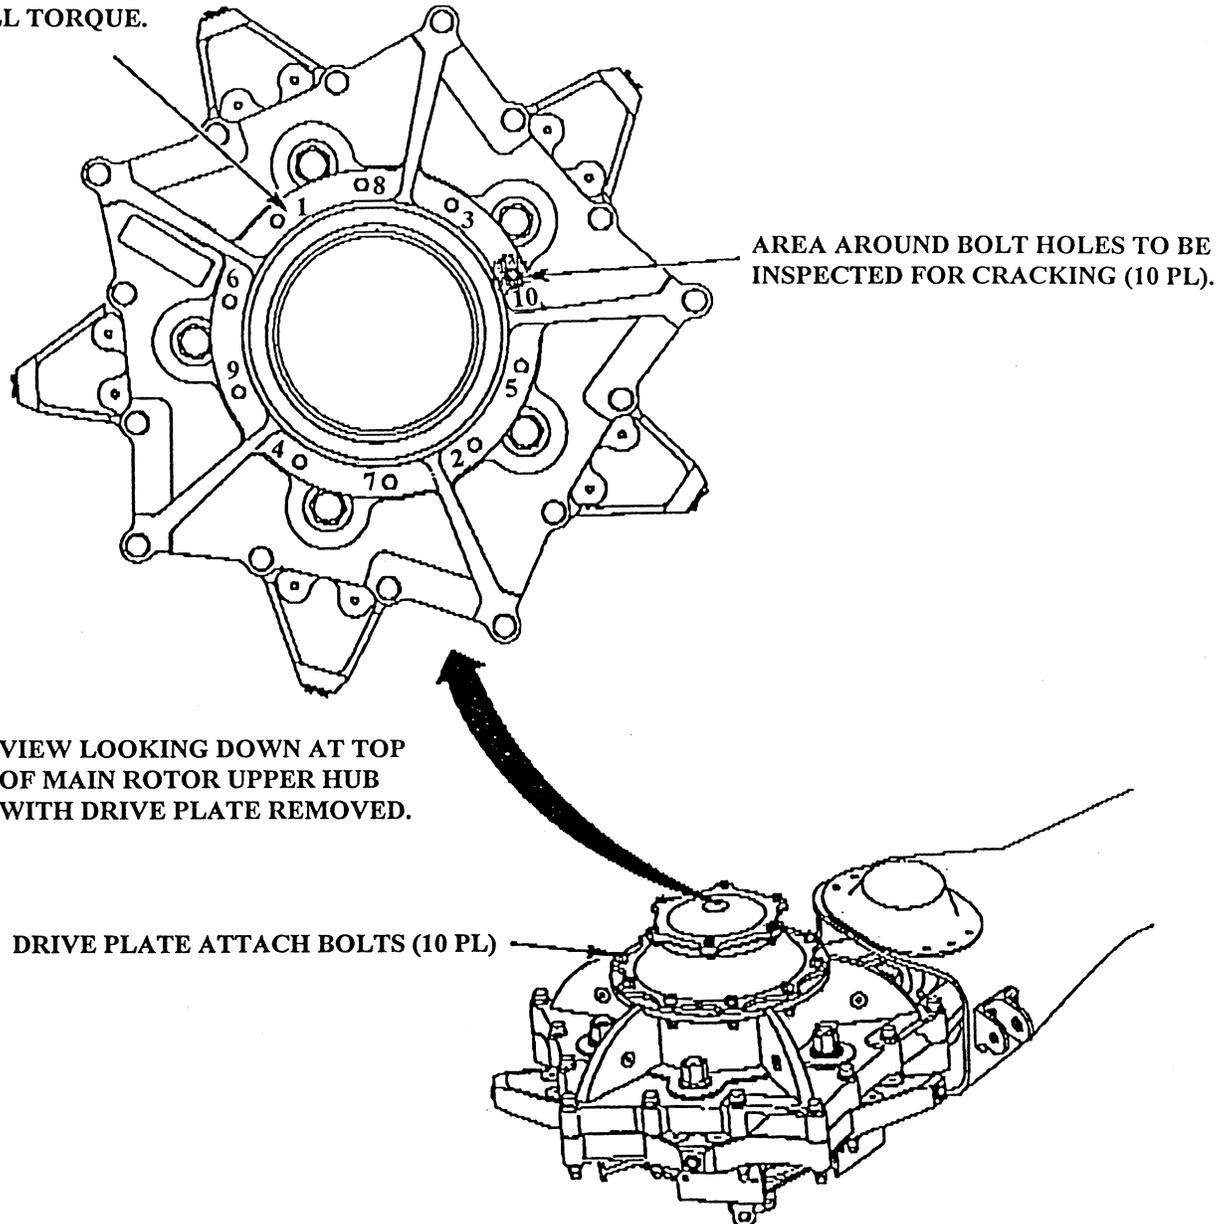
Figure 1. Main Rotor Upper Hub Assembly Inspection.

(ii) Mark the main rotor hub holes to correspond with the drive plate hole numbers (see Figure 1 of this AD).

(v) Using paint stripper (Consumable Item List C313 or equivalent) and cleaning solvent (C420 or equivalent), remove the paint from the upper mating surface of the hub assembly to enable an accurate visual inspection of each drive plate attachment bolt hole (bolt hole) area for cracking (Figure 1). Ensure the paint stripper and solvent DO NOT contaminate the upper bearing and upper grease seal areas.

(vi) Using a 10 × or higher magnifying glass and light, inspect the mating surface area and the area around and inside the 10 boltholes of the hub assembly for a crack. If a crack is found, prior to further flight, replace the hub assembly with an airworthy hub assembly.

(viii) Reinstall the main rotor drive plate using 10 new sets of replacement attachment hardware. Torque the nuts to 160 inch pounds above locknut locking/run-on torque in the sequence shown (Figure 1). Record in the rotorcraft logbook, or equivalent record, the locknut locking/run-on torque for each nut.

1. MAIN ROTOR DRIVE PLATE ATTACHMENT HARDWARE TORQUE SEQUENCE.
2. NUMBERING MAY START AT ANY HOLE.
3. TORQUE NUTS TO 1/2 TOTAL TORQUE, THEN FULL TORQUE.
