[Docket No. 2001-SW-40-AD]

**Airworthiness Directives; MD Helicopters, Inc. Model 369D, 369E, 369F, and 369FF Helicopters**

**ACTION:** Notice of proposed rulemaking (NPRM).

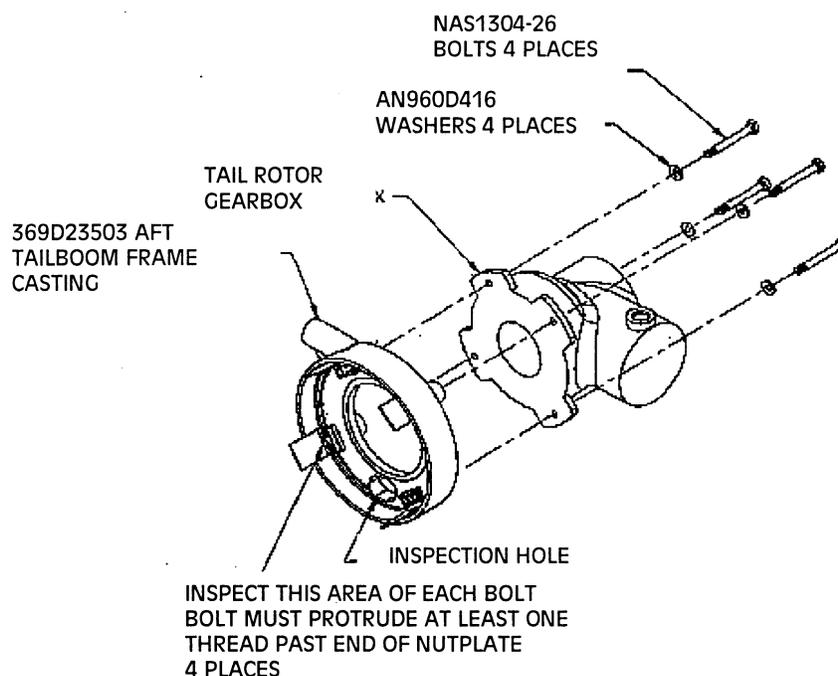
**Figure 1 – Inspection Location**

(2) Remove the tailboom control rod and determine the number of bolt threads protruding from each nutplate on the internal surface of the aft tailboom frame casting, P/

N 369D23503, as shown in Figure 1. At least one thread must protrude. If more than four threads protrude, add an additional washer, P/N AN960D416, under the bolt head. Torque the bolt to 100-110 in-lbs., and reapply a slippage mark.

(b) Between 2 and 10 hours TIS after accomplishing the requirements of paragraph (a) of this AD, inspect the torque on each bolt by applying 100 in-lbs. If any bolt movement occurs, retorquer the bolt to 100-110 in-lbs. and reapply a slippage mark. Reinspect the torque between 2 and 10 hours TIS thereafter until no bolt movement occurs.
