DEPARTMENT OF TRANSPORTATION

National Highway Traffic Safety Administration

[Docket No. NHTSA 2001–11041; Notice 1]

Toyota Motor Corporation; Receipt of Application for Decision of Inconsequential Noncompliance

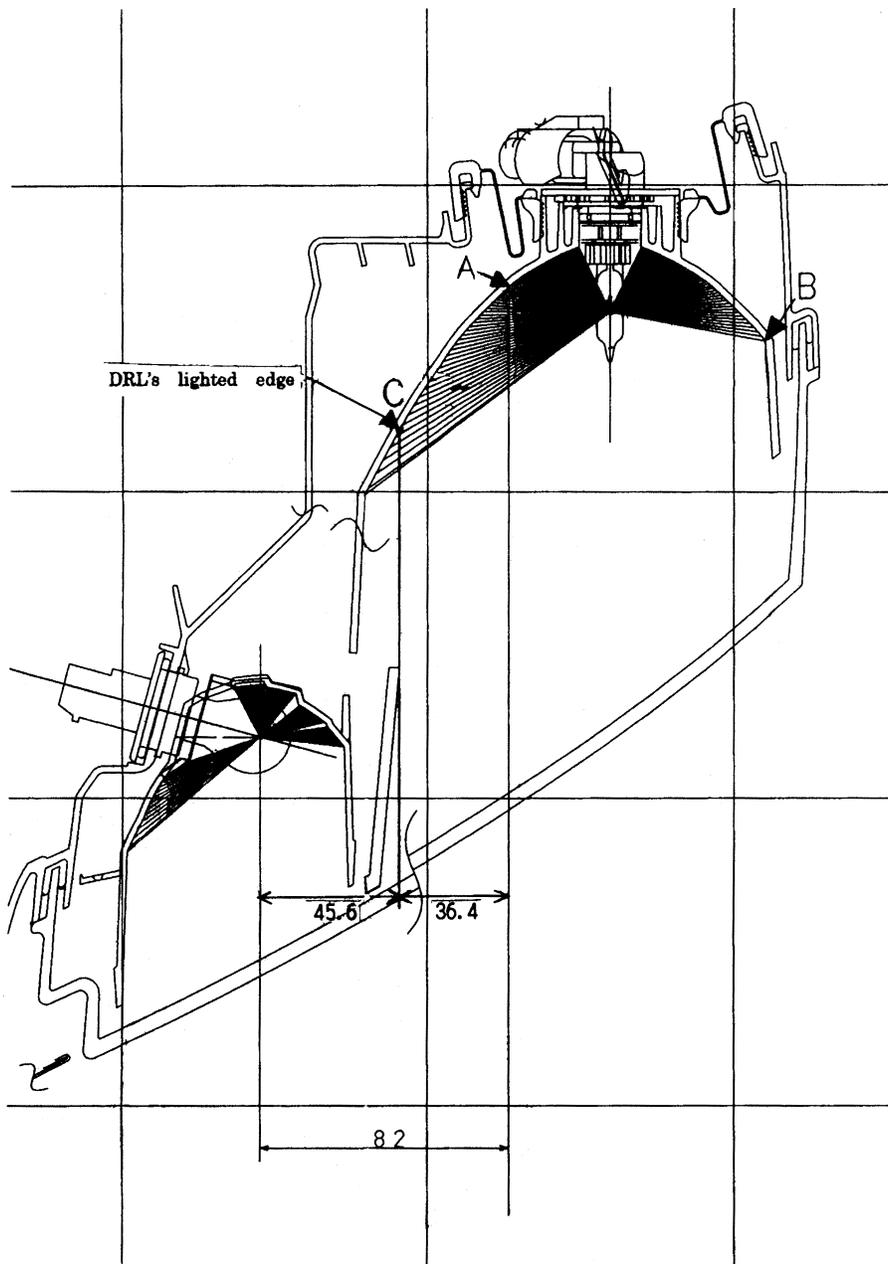
The DRLs on the Celica are provided by the upper beam headlamps operating at a lower intensity, with each lamp having a maximum luminous intensity of roughly 5,880 candelas at test point H–V (as described in FMVSS No. 108 test procedures). S5.5.11(a)(4) of FMVSS No. 108 requires that “* * * if not optically combined with a turn signal lamp, (the DRL) (shall be) located so that the distance from its lighted edge to the optical center of the nearest turn signal lamp is not less than 100 mm, unless * * * the luminous intensity of the DRL is not more than 2,600 candela any location in the beam. * * *” However, for the noncompliant Celicas the distance from the DRL’s lighted edge to the optical center of the nearest turn signal lamp is only 45.6 mm and therefore, the DRLs exceed the maximum luminous intensity specified in section 5.5.11(a)(4)(i) of FMVSS 108.

The substantial distance from the turn signal optical center (bulb filament axes) to the DRL’s lighted edge is 82 mm, exceeding 80% of the requirements. In this case, the “substantial” distance refers to the distance from the turn signal’s optical center to the actual lighted edge “A” (as given by the Figure below), although the theoretical lighted edge is point “C” (45.6mm). In the Figure, the lighted range from A to C of the reflector emits only light which is parallel to the axis of the DRL, which can only be seen by drivers in oncoming vehicles that are looking along the optical axis of the DRL. However, as one moves off center, this light is no longer visible. Therefore, the perceptible DRL’s lighted area, except for the unique case where the eye-point is on the optical axis of the DRL, is actually from A to B (as given in the Figure).
