[Docket No. 2001–SW–54–AD]

Airworthiness Directives; Bell Helicopter Textron Canada Model 407 Helicopters

ACTION: Notice of proposed rulemaking (NPRM).

Bell Helicopter Textron Canada: Docket No. 2001-SW-54-AD.

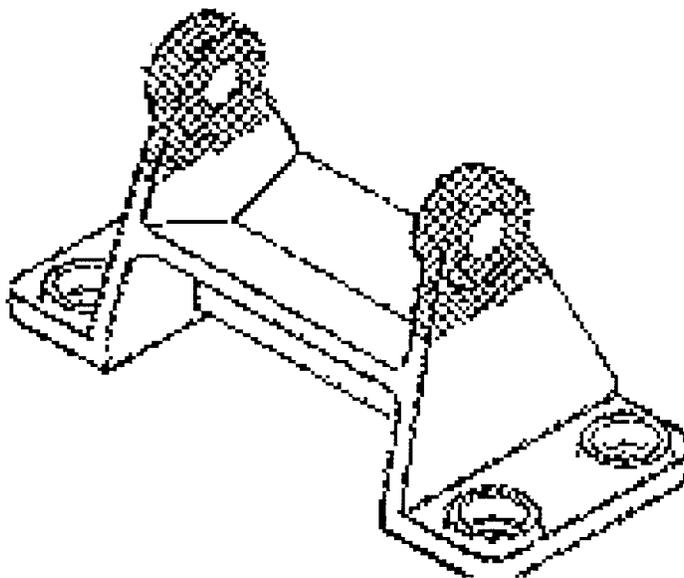
(a) Within 25 hours time-in-service (TIS) and thereafter at intervals not to exceed 25 hours TIS, visually inspect each bracket, P/N 407-040-321-101 or -103, for a crack in the shaded area shown in Figure 1 of this AD. Remove any cracked bracket from service.

Bracket P/N 407-040-321-101/-103
