Airworthiness Directives; Bell Helicopter Textron Canada Model 407 Helicopters

ACTION: Notice of proposed rulemaking (NPRM).

Bell Helicopter Textron Canada: Docket No. 2001-SW-53-AD. Supersedes AD 2000-06-10, Amendment 39-11651, Docket No. 99-SW-75-AD.

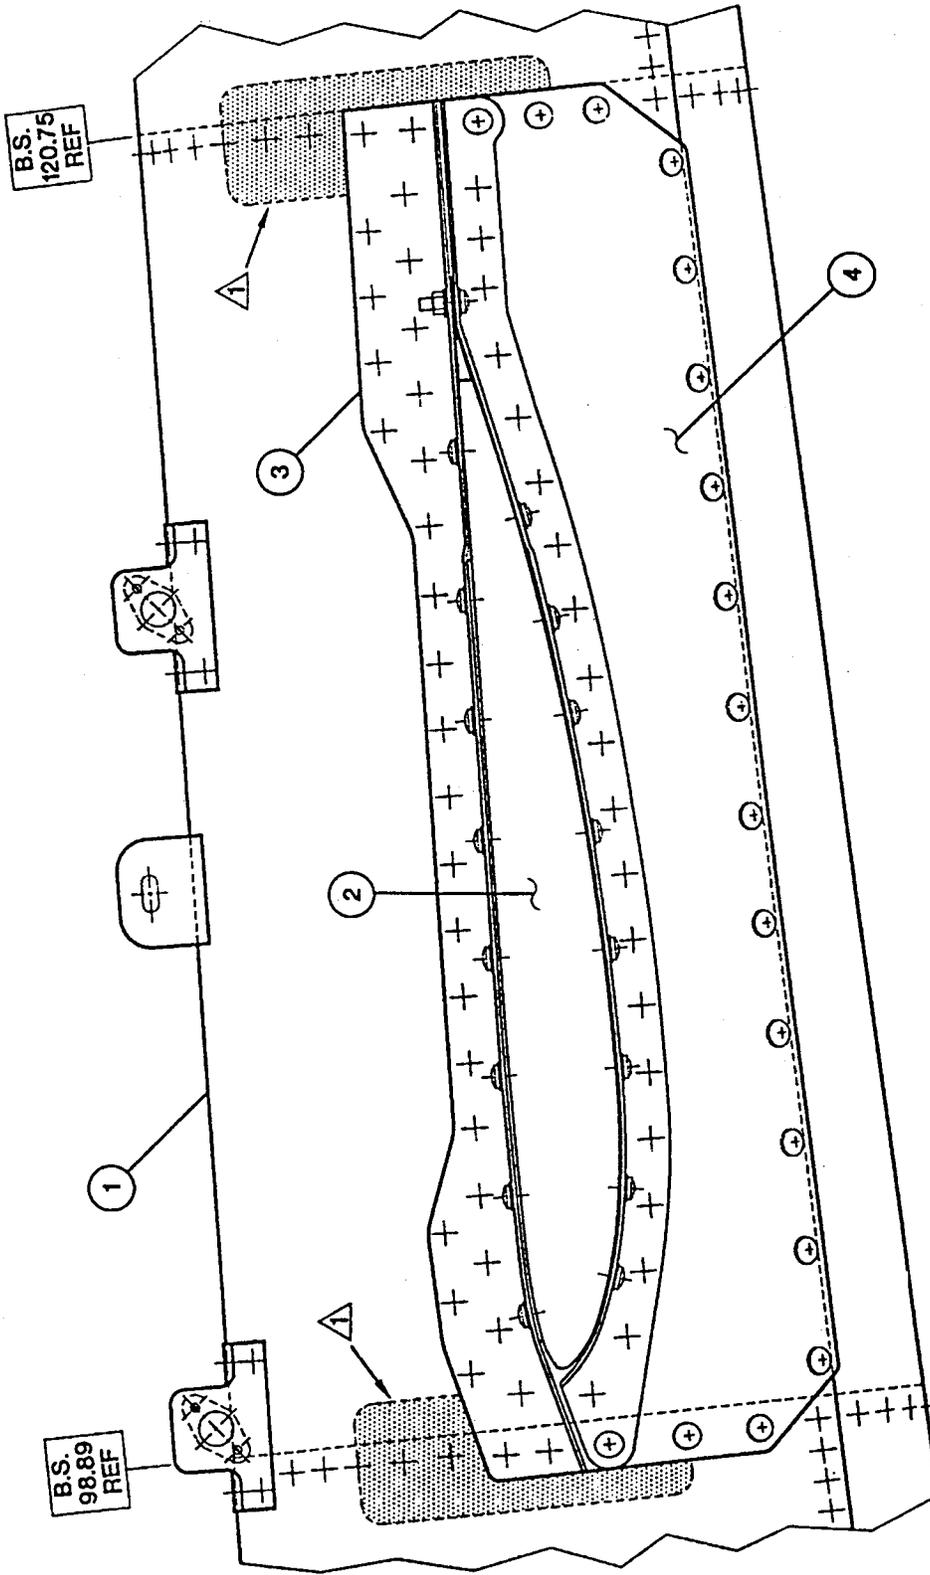
Figure 1. Preflight Check of the Tailboom

(a) Before further flight and thereafter before the first flight of each day, check the tailboom for a crack in accordance with Figure 1 of this AD. If a crack is found,

- △ Examine these areas for cracks on left side of tailboom only.
- 2. Horizontal stabilizer not shown for clarity.

remove the tailboom before further flight. An owner/operator (pilot) holding at least a private pilot certificate may perform the visual check required by this paragraph but must enter compliance with this paragraph into the helicopter records in accordance with 14 CFR 43.11 and 91.417(a)(2)(v). A pilot can perform this check because it involves only a visual check for a crack in the tailboom and is a part of a normal pilot preflight check.
