[Docket No. 2001-SW-74-AD; Amendment 39-12626; AD 2001-26-55]

Airworthiness Directives; Eurocopter France Model AS350B, AS350B1, AS350B2, AS350BA, AS350B3, AS350C, AS350D, AS350D1, AS355E, AS355F, AS355F1, AS355F2, and AS355N Helicopters

2001-26-55 Eurocopter France:

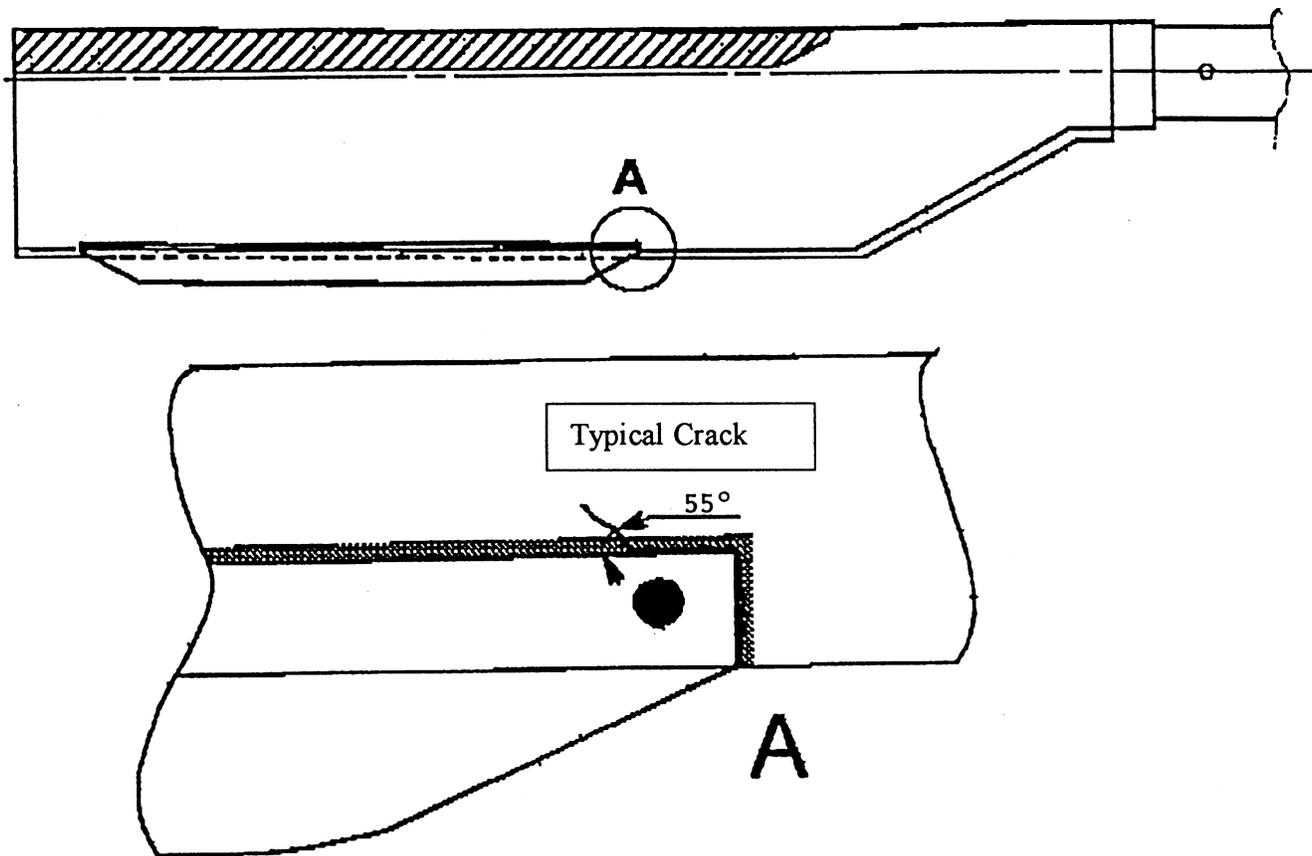
This unsafe condition is likely to exist or develop on other ECF Model AS350B, AS350B1, AS350B2, AS350BA, AS350B3, AS350C, AS350D, AS350D1, AS355E, AS355F, AS355F1, AS355F2, and AS355N helicopters of the same type designs. Therefore, the FAA issued Emergency AD 2001-26-55 to prevent failure of the blade, severe vibration, loss of the TGB, and subsequent loss of control of the helicopter. The AD requires, before further flight and thereafter before the first flight of each day or at intervals not to exceed 10 hours TIS, whichever occurs first, visually checking both sides (front and back) of each blade skin in the area of the trailing edge tab for a crack (see Area A of Figure 1 of this AD). Replacing any cracked blade is also required before further flight.

(a) Before further flight, and thereafter before the first flight of each day or at intervals not to exceed 10 hours time-in-service (TIS), whichever occurs first, visually check both sides (front and back) of each blade skin in the area of the trailing edge tab for a crack as shown in Area A of Figure 1 of this AD.

(c) If in doubt about the existence of a crack in the blade skin, clean the area and then inspect with a 6× or higher magnifying glass.

(d) If a crack is visible in the caulking, remove the caulking with 200-grit abrasive paper, taking care not to sand the skin. Inspect the blade skin for a crack using a 6× or higher magnifying glass.

(e) If a crack is found in the blade skin, replace the blade with an airworthy blade before further flight.
