[Docket No. 2001-SW-74-AD; Amendment 39-12626; AD 2001-26-55]

#### **Airworthiness Directives; Eurocopter France Model AS350B, AS350B1, AS350B2, AS350BA, AS350B3, AS350C, AS350D, AS350D1, AS355E, AS355F, AS355F1, AS355F2, and AS355N Helicopters**

#### 2001-26-55 Eurocopter France:

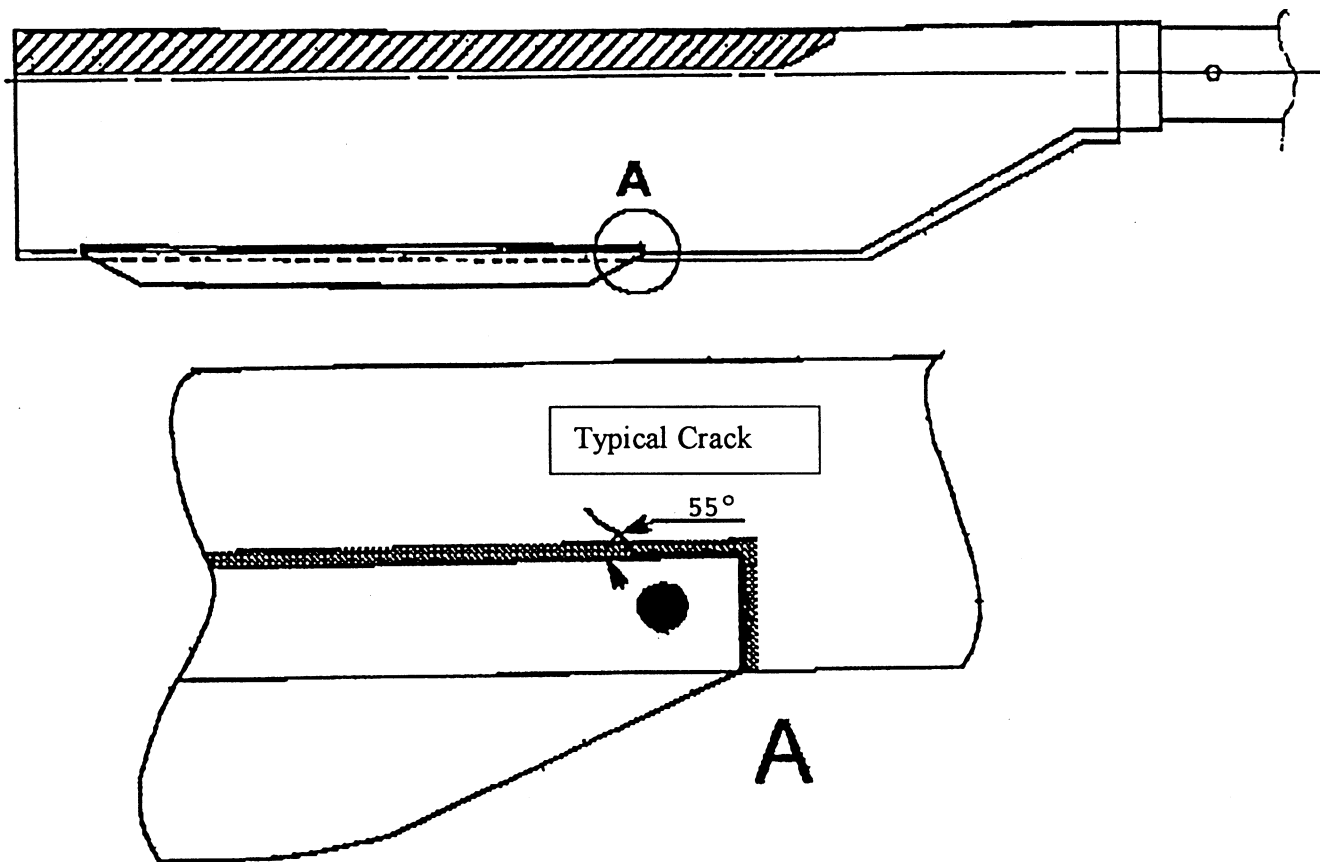
The Direction Generale de L'Aviation Civile (DGAC), which is the airworthiness authority for France, notified the FAA that an unsafe condition may exist on these helicopter models. The DGAC advises of a report where separation of a blade trailing edge section occurred due to crack growth in the blade skin. The unbalance caused by the loss of the blade section can cause the TGB to be torn off the tailboom. The DGAC classified the service telex as mandatory and issued AD No. T2001-640-089(A) and T2001-641-067(A),

(a) Before further flight, and thereafter before the first flight of each day or at intervals not to exceed 10 hours time-in-service (TIS), whichever occurs first, visually check both sides (front and back) of each blade skin in the area of the trailing edge tab for a crack as shown in Area A of Figure 1 of this AD.

(c) If in doubt about the existence of a crack in the blade skin, clean the area and then inspect with a 6× or higher magnifying glass.

(d) If a crack is visible in the caulking, remove the caulking with 200-grit abrasive paper, taking care not to sand the skin. Inspect the blade skin for a crack using a 6× or higher magnifying glass.

(e) If a crack is found in the blade skin, replace the blade with an airworthy blade before further flight.
