[Docket No. 2001-SW-17-AD; Amendment 39-12657; AD 2002-03-16]

Airworthiness Directives; Bell Helicopter Textron, Inc.-Manufactured Model OH-13E, OH-13H, and OH-13S Helicopters

2002-03-16 Continental Copters, Inc.; Gifton McCreay (Formerly Aerodyne Systems Engineering, Ltd., Formerly Texas Helicopter Corp.); Hawkeye Rotor and Wing Flight School; and Teryjon Aviation Inc.: Amendment 39-12657. Docket No. 2001-SW-17-AD. Supersedes AD 2000-18-52, Amendment 39-11984, Docket No. 2000-SW-36-AD.

TASK: EDDY CURRENT (ET) INSPECTION OF MAST THREADS FOR CRACKS

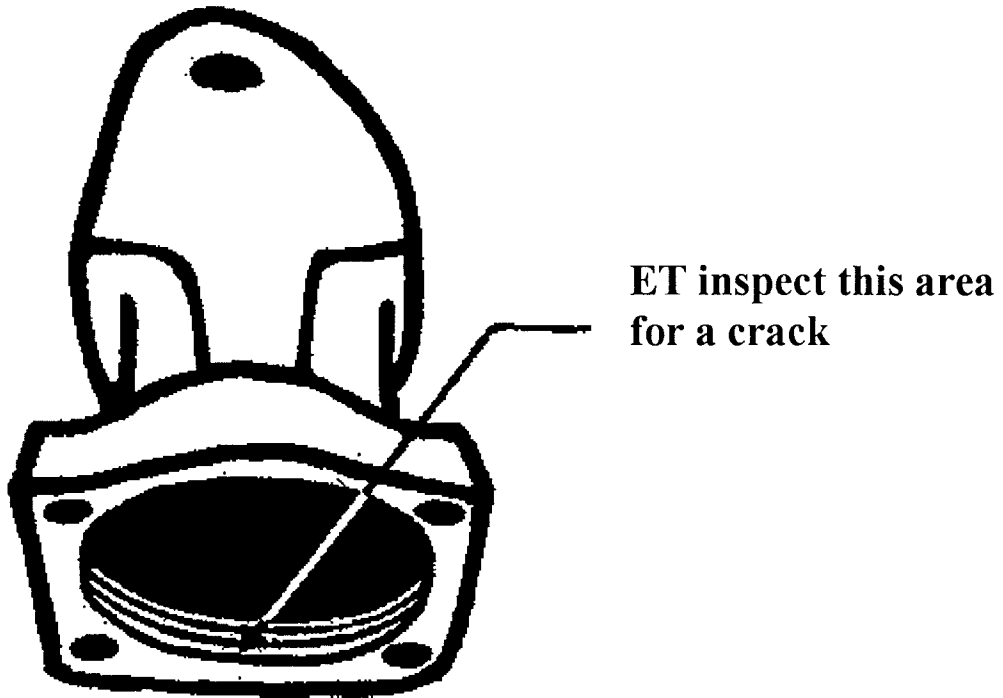
Figure 1, Appendix 1

1.1 The inboard inside diameter machined threads (reference Figure 1).

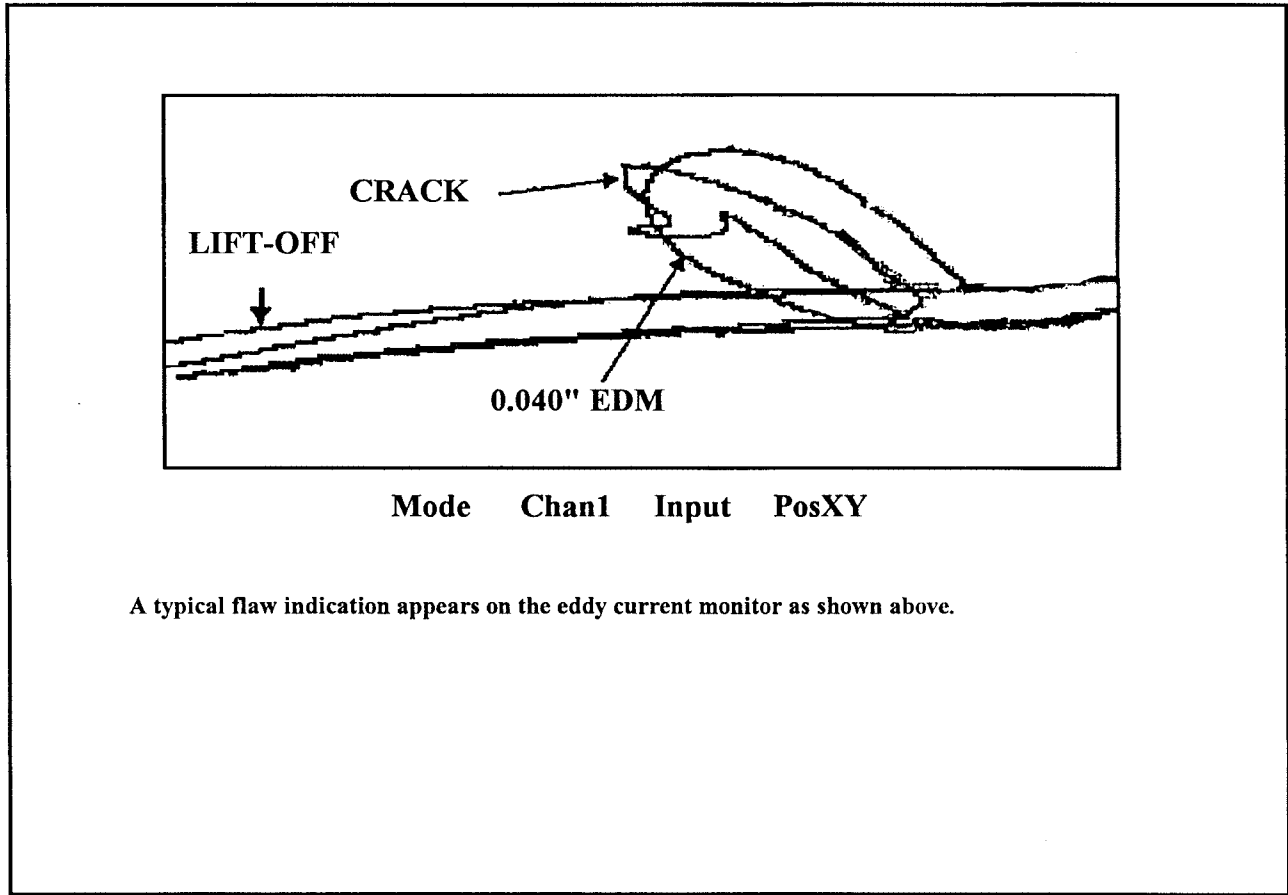
Figure 2, Appendix 1

6.1 Place the probe into the threaded area and slide it in the same direction as was done on the standard while monitoring the screen for root cracks. Moving the probe in the same direction produces a repeatable display that allows for more accurate flaw size determination. Scan the probe along each individual thread until all the threads are inspected. (See Figures 2 and 3.)

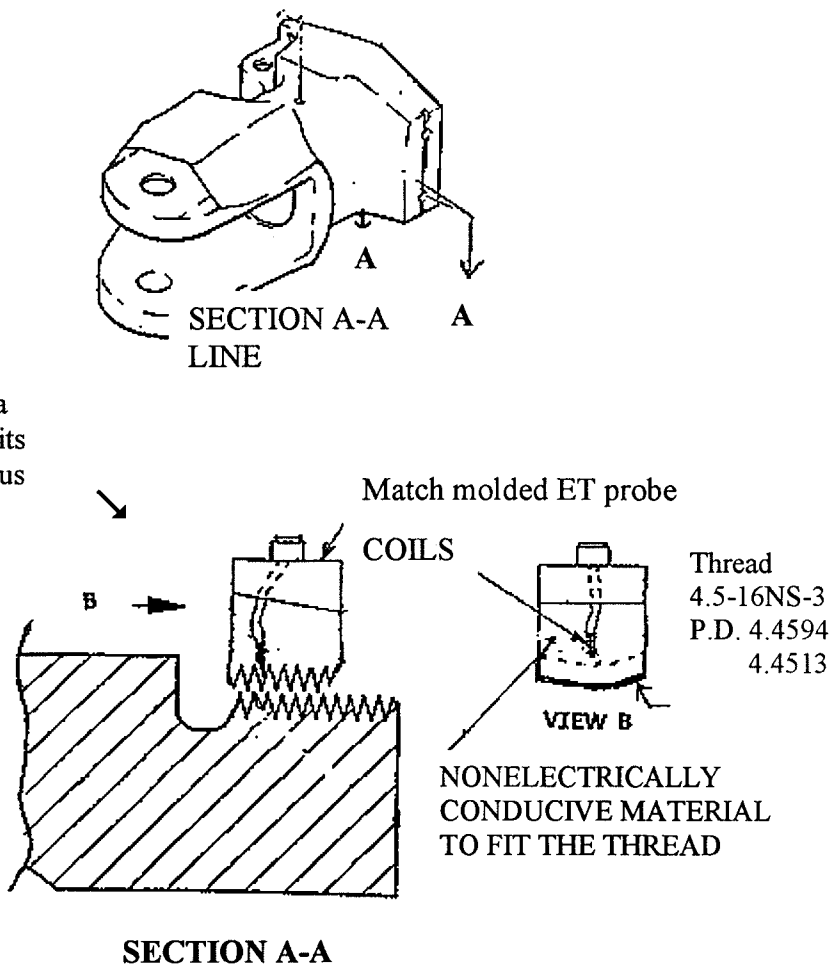
Figure 3, Appendix 1

2.2 Match molded ET probe SPC-193 (100kHz) or equivalent. (See Figure 3.)

A special eddy current probe shaped to fit the thread and containing a coil positioned so that its ferrite core is contiguous with the root of the thread.

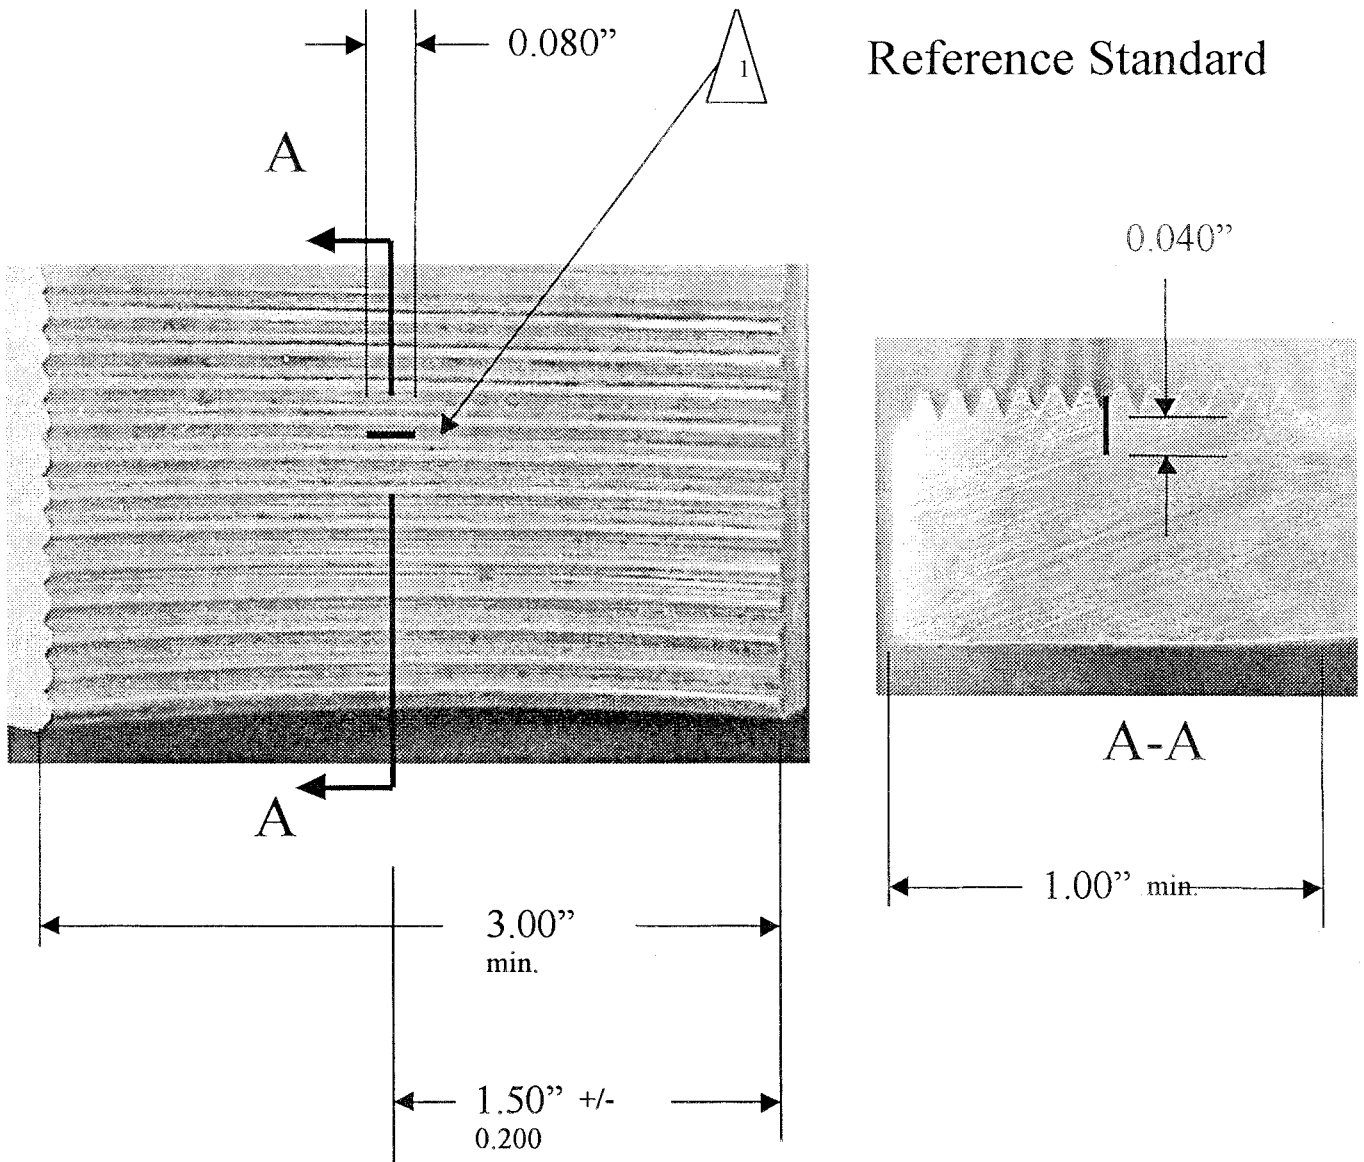
Figure 4, Appendix 1

2.3 Reference standard EC-010-021, or equivalent. (See Figures 4 and 5.)

EDM 1 place only in thread root.
Notch width shall be 0.004 max.
All other dimensions to be +/- 0.004 from indicated.

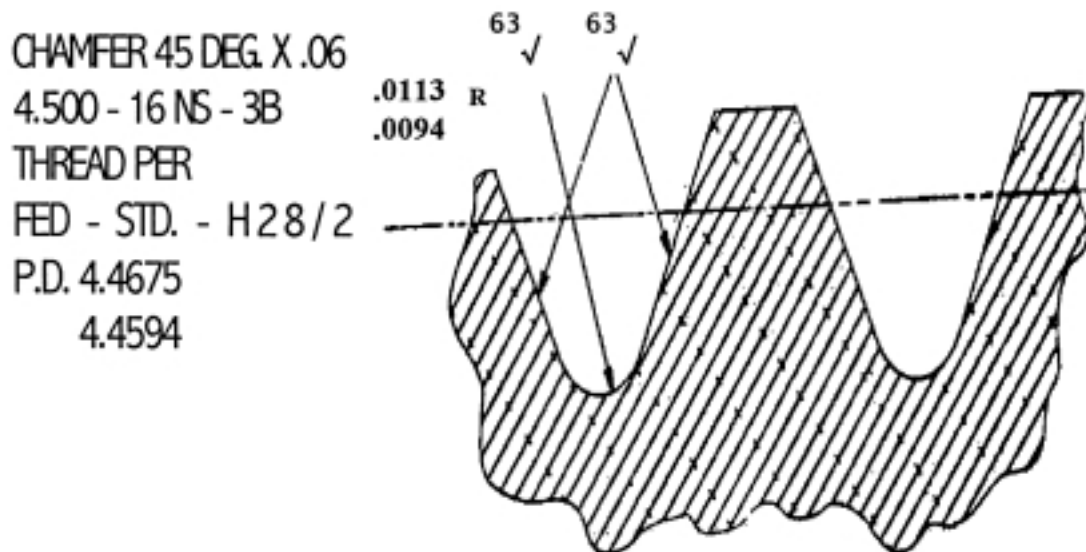
Figure 5, Appendix 1

Reference Standard
