[Docket No. 2001-SW-50-AD]

Airworthiness Directives; Eurocopter France Model EC120B, EC155B, SA330F, SA330G, SA330J, AS332C, AS332L, AS332L1, AS332L2, AS350B, AS350BA, AS350B1, AS350B2, AS350B3, AS350D, AS355E, AS355F, AS355F1, AS355F2, AS355N, AS365N2, AS365N3, SA-365N, and SA-365N1 Helicopters

ACTION: Notice of proposed rulemaking (NPRM).

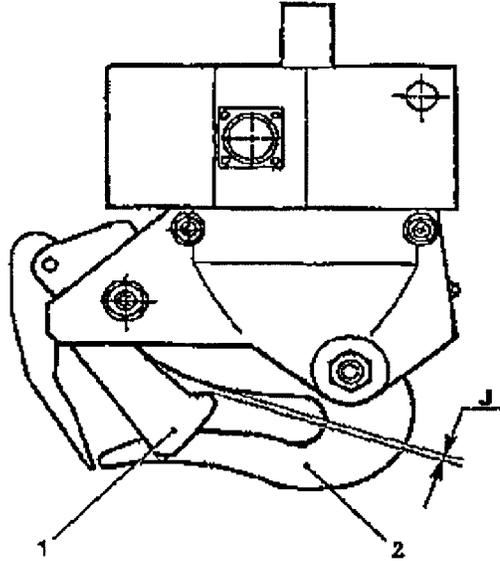
The Direction Generale De L'Aviation Civile (DGAC), the airworthiness authority for France, notified the FAA that an unsafe condition may exist on various ECF model helicopters. The DGAC advises of the discovery of an anomaly on the locking catch of certain cargo hooks that could jam the ring on the cargo hook and jeopardize the release of an underslung load.

Siren Load Release Unit
P/N AS21-5-(1 through 7)

1. Locking Catch
2. Cargo Hook

Clearance "J" must be less than 14 mm (0.55 inches)

(a) With the cargo hook in the no-load position, measure the clearance "J" in accordance with Figure 1 of this AD. Remove any cargo hook if clearance "J" (see Figure 1) is equal to or greater than 14 millimeters (0.55 inches).
