[Docket No. 2001-SW-67-AD; Amendment 39-12710; AD 2002-08-03]

Airworthiness Directives; Enstrom Helicopter Corporation Model F-28, F-28A, F-28C, F-28F, 280, 280C, 280F, and 280FX Helicopters

2002-08-03 Enstrom Helicopter

Corporation: Amendment 39-12710. Docket No. 2001-SW-67-AD. Supersedes AD 2001-22-01, Amendment 39-12479, Docket No. 2001-SW-28-AD.

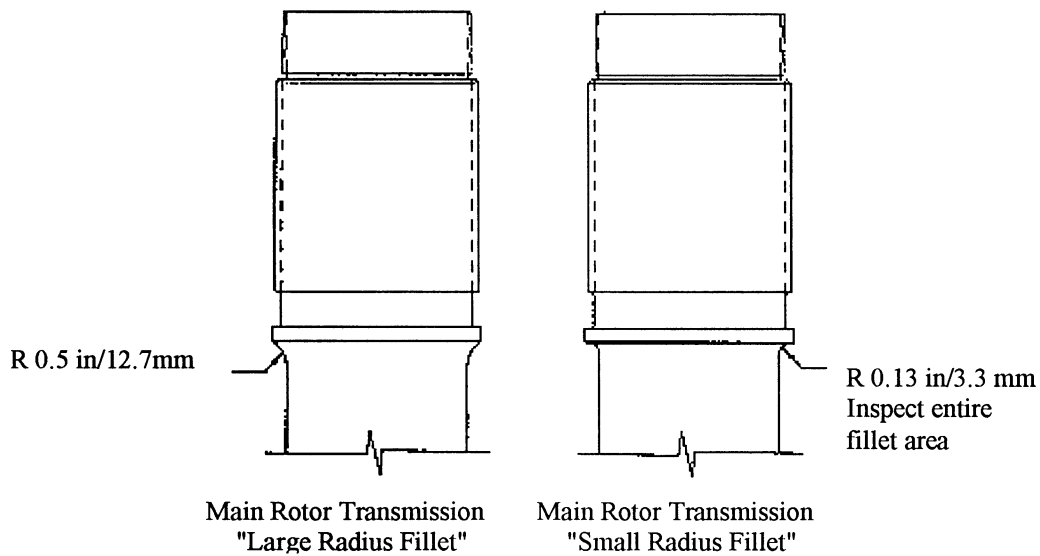
Figure 1. Main Rotor Shaft Inspection

Since the issuance of AD 2001-22-01, Amendment 39-12479, the FAA received a comment that the AD should have cited additional part numbers (part number (P/N) 28-13101-3 and P/N 28-13101-3-R) in Table 1 of the AD. Further, Figure 1 of AD 2001-22-01 contained an error—"2.7mm" is now corrected to state "12.7mm". This AD also corrects another part number and other minor typographical errors. Also, since the issuance of the previous AD, the manufacturer has revised its service information and issued Enstrom Helicopter Corporation Service Directive Bulletin No. 0094, Revision 2, dated February 15, 2002.

(a) Before further flight, determine the part number (P/N) of the main rotor transmission (transmission) and the radius of the upper fillet of the shaft (as shown in the following Figure 1):
