[Docket No. 2001-SW-58-AD; Amendment 39-12726; AD 2001-25-52]

Airworthiness Directives; Schweizer Aircraft Corporation Model 269A, 269A-1, 269B, 269C, and TH-55A Helicopters

2001-25-52 Schweizer Aircraft

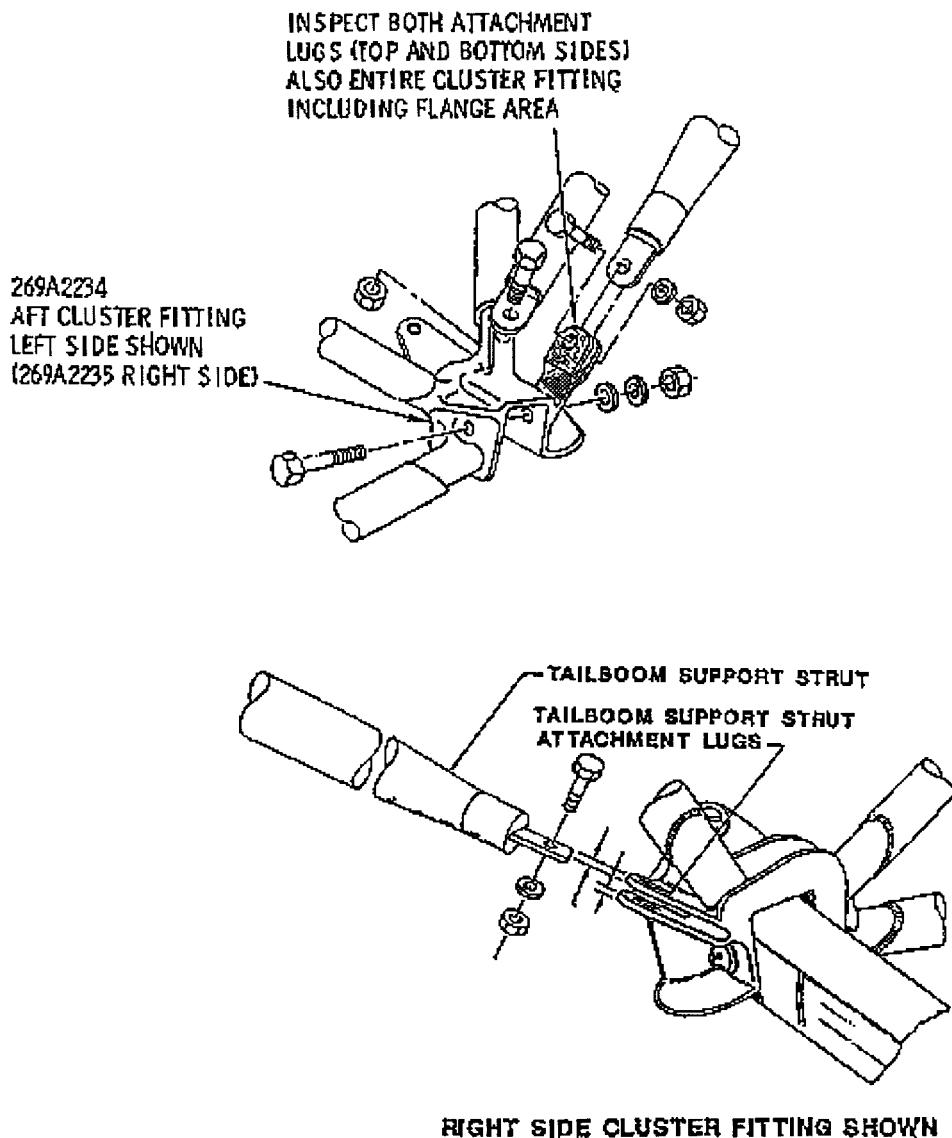
Figure 1

To prevent failure of a strut clevis lug (lug) on a center frame aft cluster fitting (cluster fitting), rotation of a tailboom into the main rotor blades, and subsequent loss of control of the helicopter, accomplish the following:

(2) Dye-penetrant inspect the lugs on each aft cluster fitting. See Figure 1.

(3) If a crack is found, before further flight, replace the cracked cluster fitting with an airworthy cluster fitting. Cluster fittings, P/N 269A2234 and 269A2235, are not eligible to replace a cracked cluster fitting.
