[Docket No. 2002-SW-04-AD; Amendment 39-12736; AD 2002-09-03]

Airworthiness Directives; Eurocopter France Model AS332L2 Helicopters

2002-09-03 Eurocopter France:

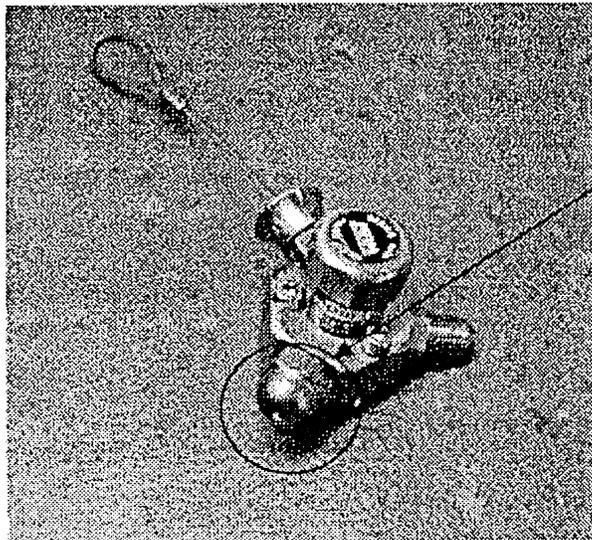
DETAIL 1

(a) Verify that the air vent is installed on the head of the inflation cylinder of each lift raft assembly as shown in FIGURE 1:

AIR VENT INSTALLED

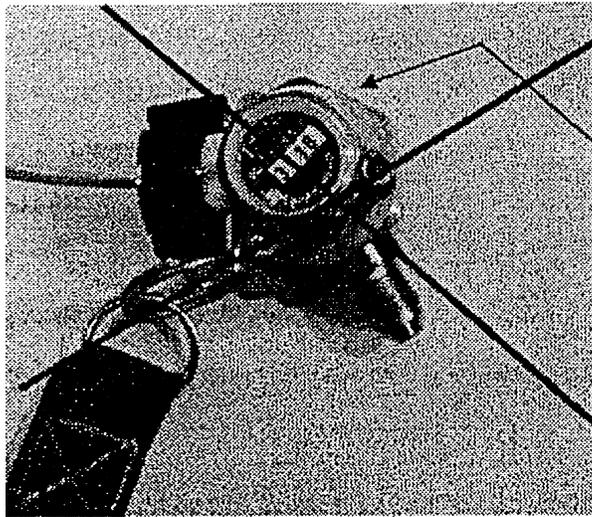
DETAIL 1

SUPPLEMENTARY INFORMATION: The Direction Generale De L'Aviation Civile (DGAC), the airworthiness authority for France, notified the FAA that an unsafe condition may exist on ECF Model AS332L2 helicopters. The DGAC advises of the discovery of a missing air vent on the head of the inflation cylinder of a life raft. Absence of an air vent on the cylinder head might lead to inadvertent life raft inflation and cause

AIR VENT NOT INSTALLED

If the air vent is missing, replace the cylinder head with an airworthy cylinder head before further flight.

(b) Replacing the cylinder head or verifying that the air vent is installed on the head of the inflation cylinder is terminating action for the requirements of this AD.
