[Docket No. 2000-SW-55-AD]

**Airworthiness Directives; Eurocopter France Model AS332C, L, L1, and L2; AS350B, BA, B1, B2, B3, and D; AS355E, F, F1, F2, and N; AS-365N2; AS 365 N3; SA330F, G, and J; SA-360C; SA-365C, C1, and C2; SA.316B and C; and SA.319B Helicopters**

**ACTION:** Notice of proposed rulemaking (NPRM).

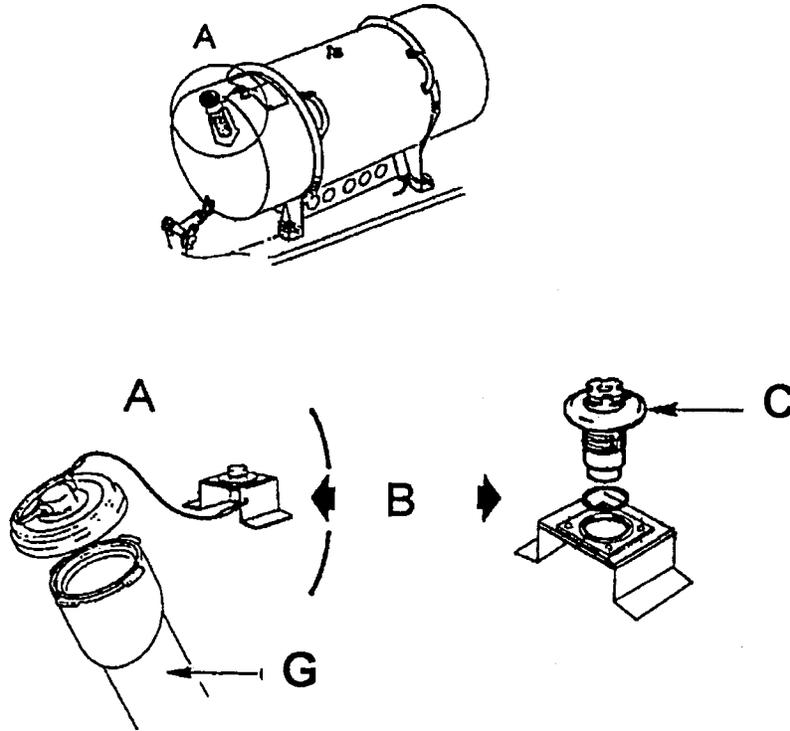
FIGURE 1 FERRY FUEL TANK

and SA.319B helicopters. The DGAC advises of the absence on several tanks of an electric bond between the electrostatic ground connector and its support. During refueling of a tank, the inadequate electrical bonding could generate an electric arc between the refueling nozzle of the tanker and the tank and could cause the tank to explode.

(a) Measure the electrical resistance between the tank electrostatic ground connector (item C) and the tank filler neck (item G) as shown in Figure 1 of this AD. If the value of the electrical resistance is more than 1.5 milliohms, refueling the tank is prohibited. See Figure 1 as follows:
