[Docket No. 2002-NE-07-AD; Amendment 39-12760; AD 2002-10-14]

Airworthiness Directives; Bombardier-Rotax GmbH 914 F Series Reciprocating Engines

2002-10-14 Bombardier-Rotax GmbH:

Amendment 39-12760. Docket No.

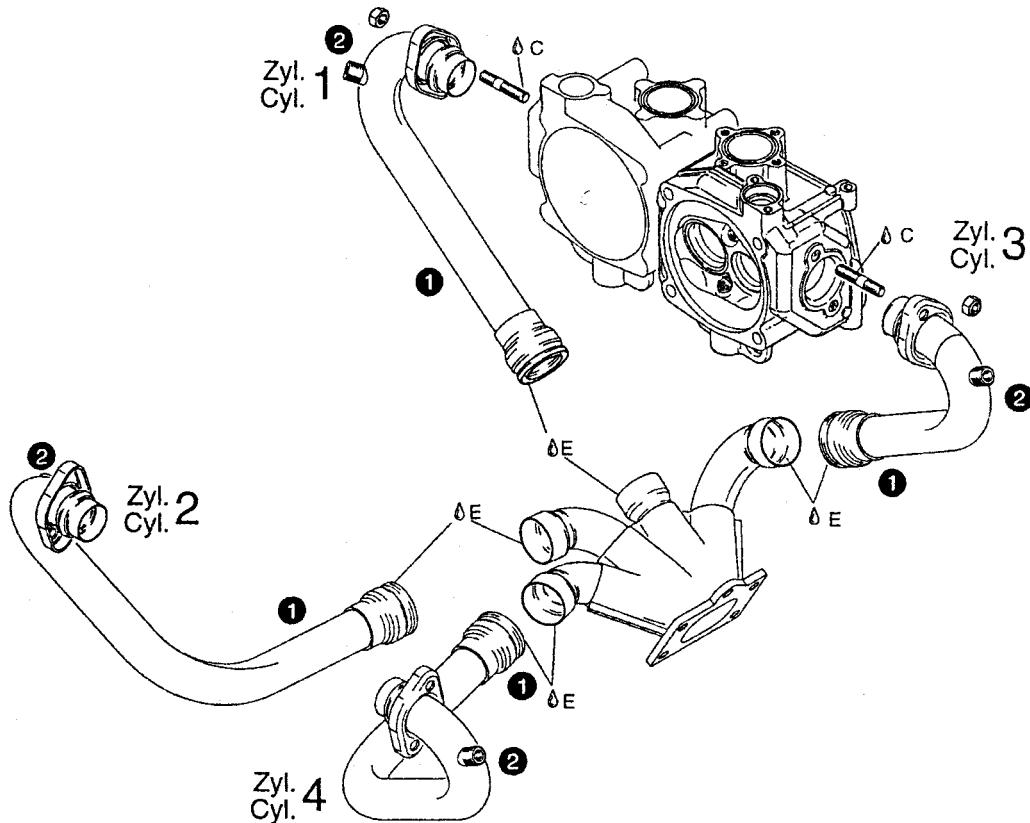
(a) Within 50 hours time-in-service (TIS) after the effective date of this AD, visually inspect the exhaust bend assemblies (item 1, Figure 1, of this AD), located between the cylinder heads and exhaust manifold assembly, for exterior traces of smoke, cracks, and damage, especially around the exhaust gas temperature (EGT) bosses (item 2). Replace any exhaust bend assembly found cracked. Figure 1 follows:

1) Exhaust Bend Assembly

2) EGT Boss

(b) Thereafter, inspect the exhaust bend assemblies every additional 50 hours TIS. Replace any exhaust manifold assembly found cracked.

(c) If any exhaust bend assembly is replaced, perform a ground test run and exhaust leakage test.
