[Docket No. 2001-SW-54-AD; Amendment 39-12770; AD 2002-11-09]

Airworthiness Directives; Bell Helicopter Textron Canada Model 407 Helicopters

Model 407 helicopters that requires visually inspecting the forward hanger bearing bracket (bracket) for a crack. This amendment is prompted by reports of cracks in the bracket. The actions specified by this AD are intended to detect a crack in the bracket, to prevent loss of tail rotor drive or control and subsequent loss of control of the helicopter.

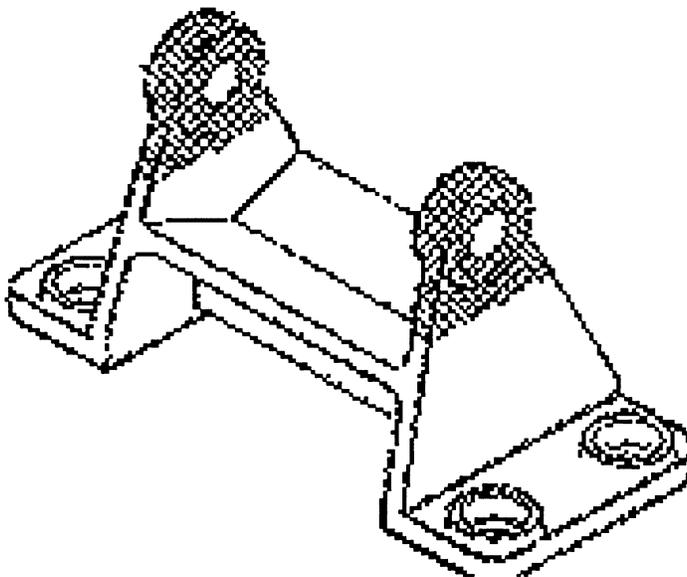
(a) Within 25 hours time-in-service (TIS) and thereafter at intervals not to exceed 25 hours TIS, visually inspect each bracket, P/N 407-040-321-101 or -103, for a crack in the shaded area shown in Figure 1 of this AD. Remove any cracked bracket from service.

Bracket P/N 407-040-321-101/-103
