[Docket No. 2002–SW–15–AD; Amendment 39–12817; AD 2002–14–17]

Airworthiness Directives; Eurocopter Deutschland GmbH Model EC135 Helicopters

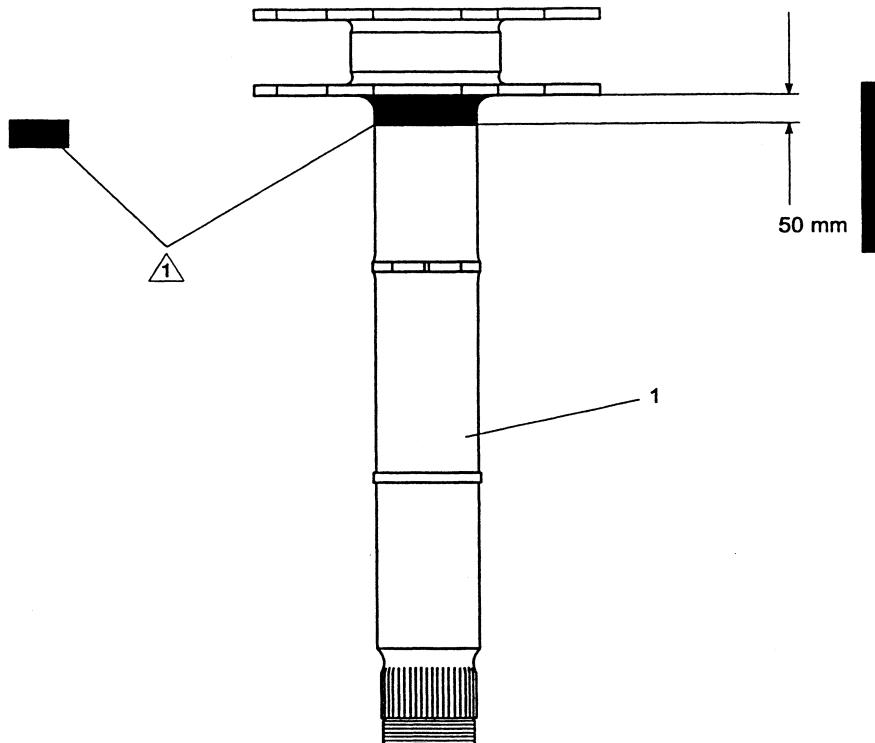
Crack inspection on main rotor hub-shaft
Figure 1

for using either a visual or dye-penetrant inspection to satisfy the repetitive inspection requirement. This amendment is prompted by the need to correct the shaft part number and increase the area of inspection, as well as add additional affected shaft P/N's. The actions specified by this AD are intended to detect fatigue cracks in the shaft that could lead to shaft failure and subsequent loss of control of the helicopter.

**Inspect marked area i.a.w. crack inspection procedure described.**

1 Main Rotor Hub-Shaft

(a) Before further flight, clean and visually inspect the shaft for cracks in the area as shown in the following Figure 1:

(b) Within 10 hours time-in-service (TIS) after accomplishing the visual inspection required by paragraph (a) of this AD, clean and dye-penetrant inspect the shaft for cracks in the area as shown in Figure 1 of this AD.

(c) Thereafter, visually inspect the shaft for cracks in accordance with paragraph (a) of this AD at intervals not to exceed 15 hours TIS, or dye-penetrant inspect the shaft for cracks in accordance with paragraph (b) of this AD at intervals not to exceed 100 hours TIS.

(d) If a crack is discovered during any shaft inspections, remove the shaft and replace it with an airworthy shaft.
