[Docket No. 2001-SW-50-AD; Amendment 39-12838; AD 2002-15-08]

Airworthiness Directives; Eurocopter France Model EC120B, EC 155B, SA330F, SA330G, SA330J, AS332C, AS332L, AS332L1, AS332L2, AS350B, AS350BA, AS350B1, AS350B2, AS350B3, AS350D, AS355E, AS355F, AS355F1, AS355F2, AS355N, AS365N2, AS 365 N3, SA-365N, and SA-365N1 Helicopters

ACTION: Final rule.

2002-15-08 Eurocopter France:

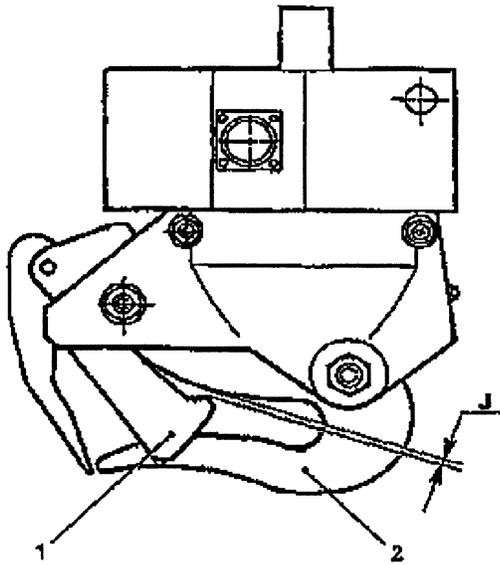
The Direction Generale De L'Aviation Civile (DGAC), the airworthiness authority for France, notified the FAA that an unsafe condition may exist on various ECF model helicopters. The DGAC advises of the discovery of an anomaly on the locking catch of certain cargo hooks that could jam the ring on the cargo hook and jeopardize the release of an underslung load.

Clearance "J" must be less than 14 mm (0.55 inches)

(a) With the cargo hook in the no-load position, measure the clearance "J" in accordance with Figure 1 of this AD. Remove any cargo hook if clearance "J" is equal to or greater than 14 millimeters (0.55 inches). See Figure 1:
