[Docket No. 2002-SW-22-AD; Amendment 39-12835; AD 2002-08-54]

Airworthiness Directives; Bell Helicopter Textron Canada Model 222, 222B, 222U, and 230 Helicopters

2002-08-54 Bell Helicopter Textron

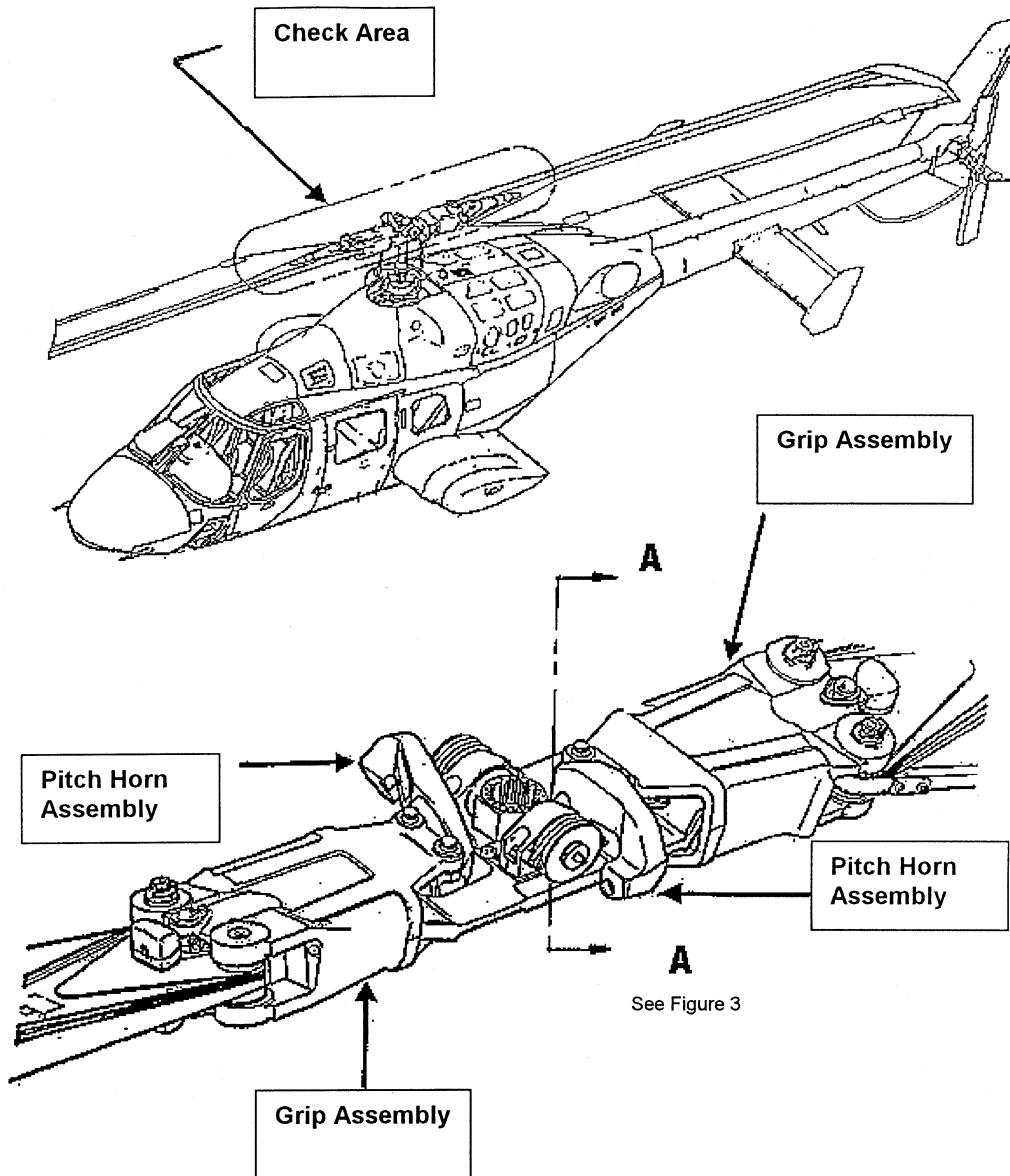
(1) Wipe clean the main rotor grip and pitch horn surfaces to remove grease and dirt in the check area as shown in Figure 1 of this AD:

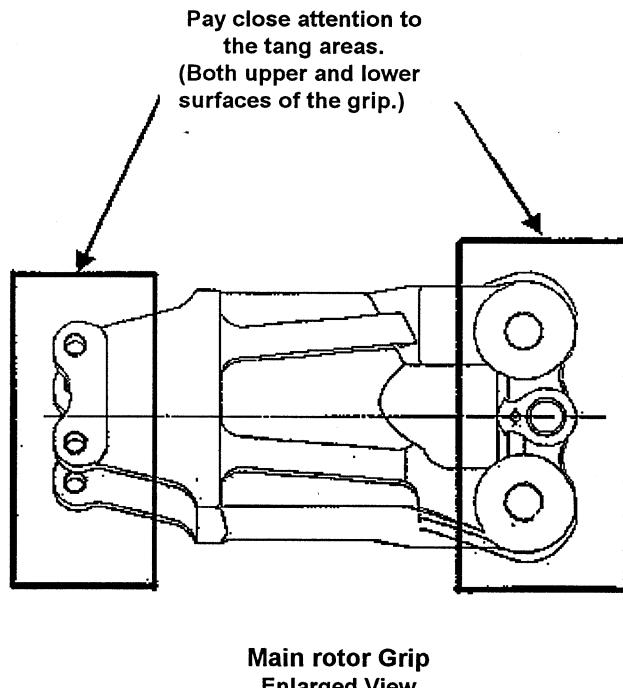
(2) Visually check both main rotor grips for a crack, paying particular attention to the inboard and outboard tangs/portions of the grip, which are in direct contact with the pitch horns and the main rotor blades. Check the area to at least 3 inches beyond the grip/pitch and grip/blade contact areas as shown in Figure 2 of this AD:

Check entire surface of the grip.

(c) If a crack is found, replace the unairworthy grip or pitch horn with an airworthy part before further flight.

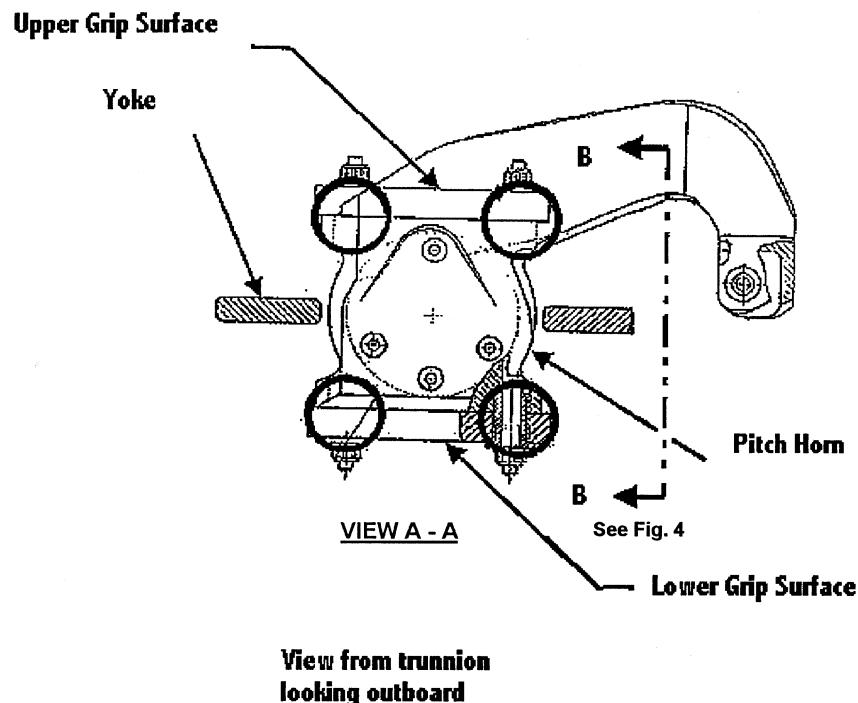
(3) Visually check all visible portions of each pitch horn for a crack. Pay particular attention to the attachment lugs of the pitch horns, which are in direct contact with the inboard tangs of the main rotor grips, as shown in Figure 3 of this AD, and the four large bolt cutouts, as shown in Figure 4 of this AD:

**All visible portions of the pitch horn must be checked.
Pay particular attention to the circled areas shown above and View B-B, Fig. 4.**
