Federal Register

[Docket No. 2002-NM-130-AD; Amendment 39-12840; AD 2002-16-01]

Airworthiness Directives; McDonnell Douglas Model DC-8-21, -31, -32, -33, -41, -42, and -43 Airplanes; and Model DC-8-50, -60, and -70 Series Airplanes; Modified per Supplemental Type Certificates SA1063SO, SA1862SO, or SA1832SO

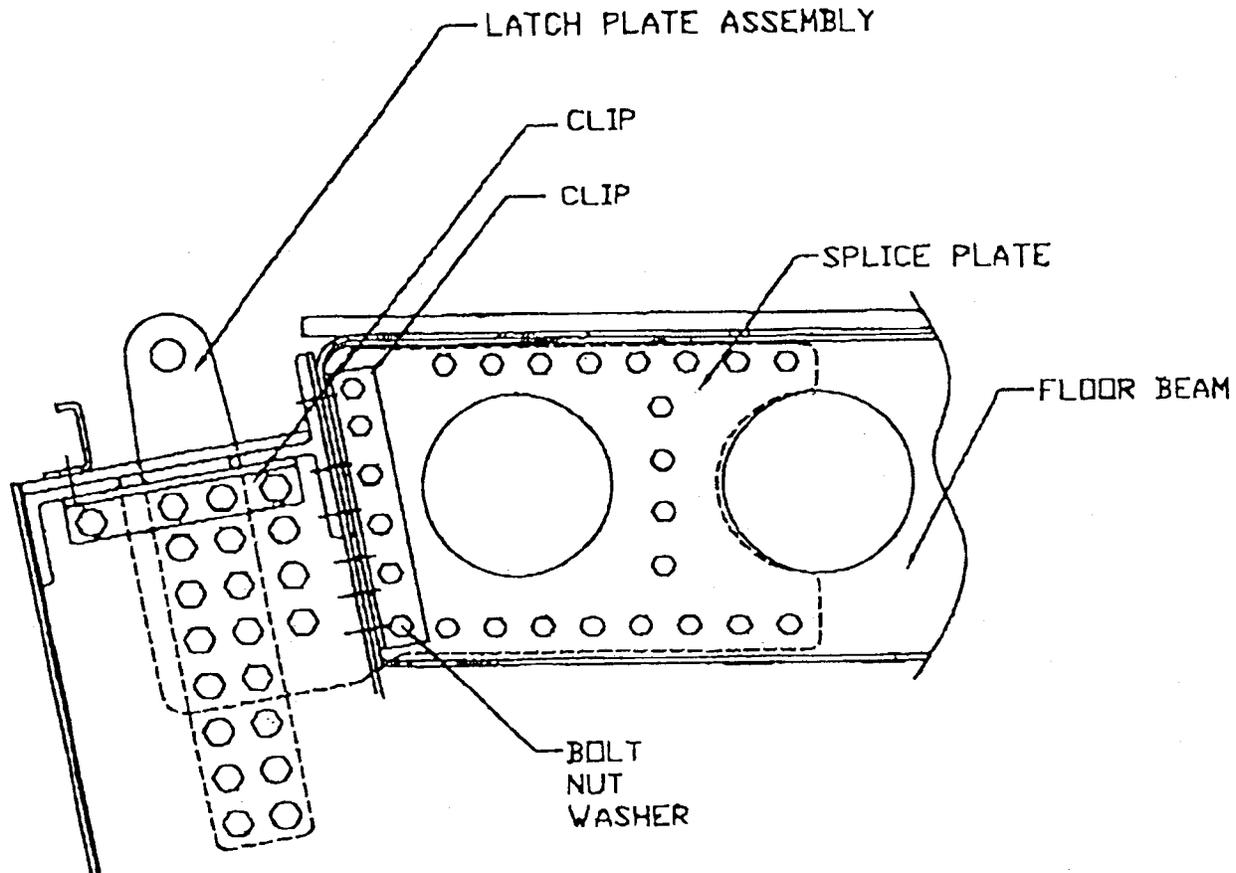
Figure 1.

Since an unsafe condition has been identified that is likely to exist or develop on other airplanes of the same type design, this AD is being issued to prevent failure of the floor beam attachments to the lower door jamb. Such failure could cause damage to the floor structure and consequent jamming of the flight control cables, and result in loss of controllability of the airplane in flight. This AD requires gaining access to the floor beam attachments to the lower door jamb within the main cargo door area; and performing repetitive inspections to detect cracking or damage of such attachments, including splice plates, angles, and clips. If any cracking or damage is found, this AD also requires extending the area of inspection 60 inches forward and aft of the main cargo door area, and replacing any cracked or damaged part with a new part. Figure 1 of Appendix 1 of this AD identifies the inspection area and parts to be inspected.

(2) Perform a detailed inspection of the main cargo door area to detect any cracking or damage of the floor beam attachments to the lower door jamb, including the splice plates, angles, and clips identified in Figure 1 of Appendix 1 of this AD. Thereafter, repeat the inspection at intervals not to exceed 2,500 flight cycles or 18 months, whichever occurs earlier.

(b) If any cracking or damage is found during any inspection required by paragraph (a)(2) of this AD, before further flight, extend the area of inspection 60 inches forward and aft of the main cargo door area, and replace any cracked or damaged part with a new part identified in Figure 1 of Appendix 1 of this AD.
