[Docket No. 2002–NE–08–AD; Amendment 39–12865; AD 2002–16–26]

Airworthiness Directives; Bombardier-Rotax GmbH Type 912 F and 914 F Series Reciprocating Engines

2002-16-26 Bombardier-Rotax GmbH:
Amendment 39-12865. Docket No. 2002-NE-08-AD.

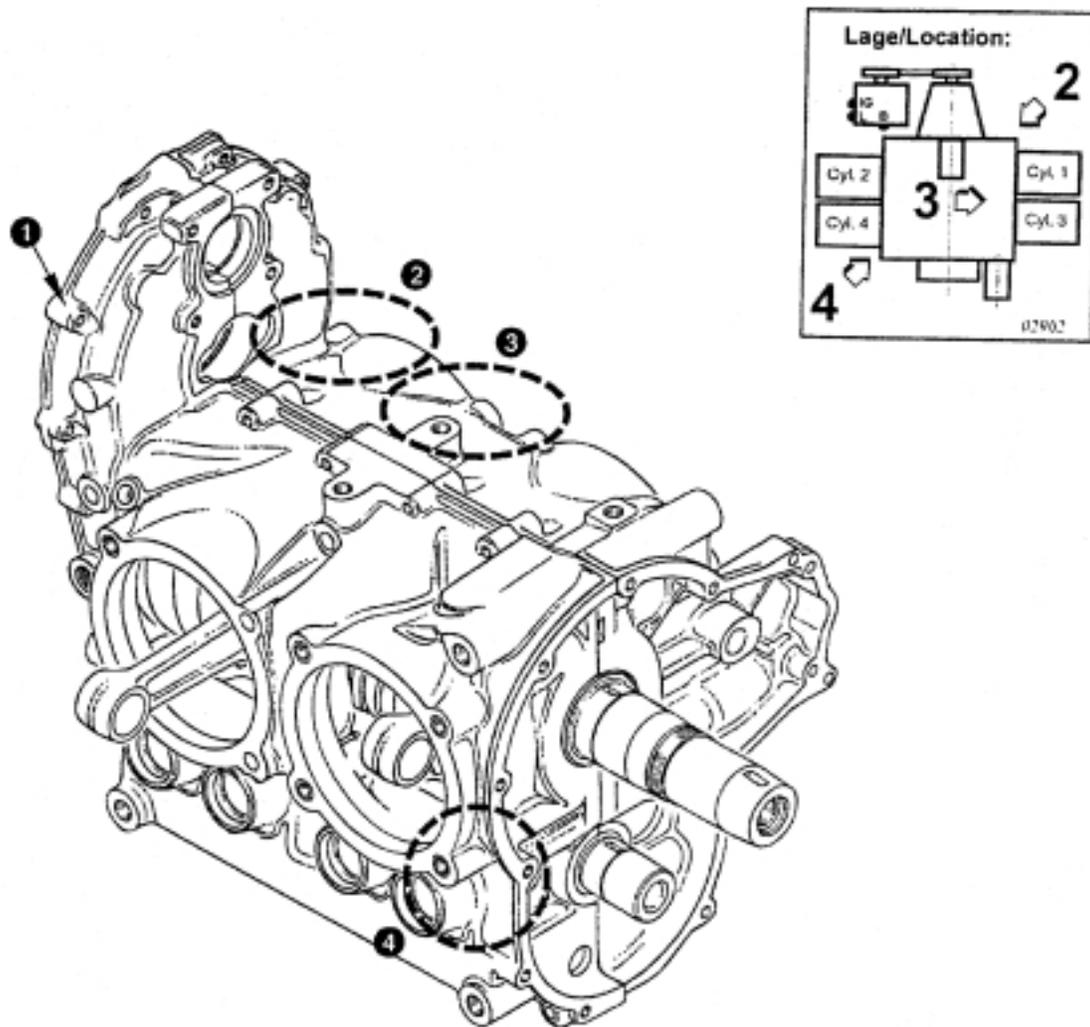
Figure 1. Engine Crankcase Inspection Areas

(1) Inspect the engine crankcase (item 1, Figure 1 of this AD) for cracks especially in the area of cylinder 1 upper side (item 2), between cylinder 1 and 3 upper side (item 3), and cylinder 4 lower side (item 4).

1. Engine Crankcase
2. Cylinder 1 Upper Side
3. Cylinder 3 Upper Side
4. Cylinder 4 Lower Side

(2) Cracks in crankcases of engines with a ROTAX cooling air baffle may not be easily visible, and oil leaks may be an indication of cracks. Visually inspect for oil leaks in areas of (item 2) and (item 3).

(3) If oil leaks are found, determine the source by either using a borescope or removing the object blocking the view such as the air baffle or accessory, and perform the inspection.

(4) If the engine crankcase is cracked, replace engine before further flight. Repair oil leaks from any other cause.

(b) Visually inspect the engine crankcase (item 1, Figure 1 of this AD) for cracks at each 100-hour, annual, or progressive inspection, or within 110 hours TIS since last inspection, whichever occurs first, in accordance with paragraph (a) of this AD.
