[Docket No. 99-SW-80-AD]

Airworthiness Directives; Bell Helicopter Textron Canada Model 206L, L-1, L-3 and L-4 Helicopters

ACTION: Supplemental notice of proposed rulemaking; reopening of comment period.

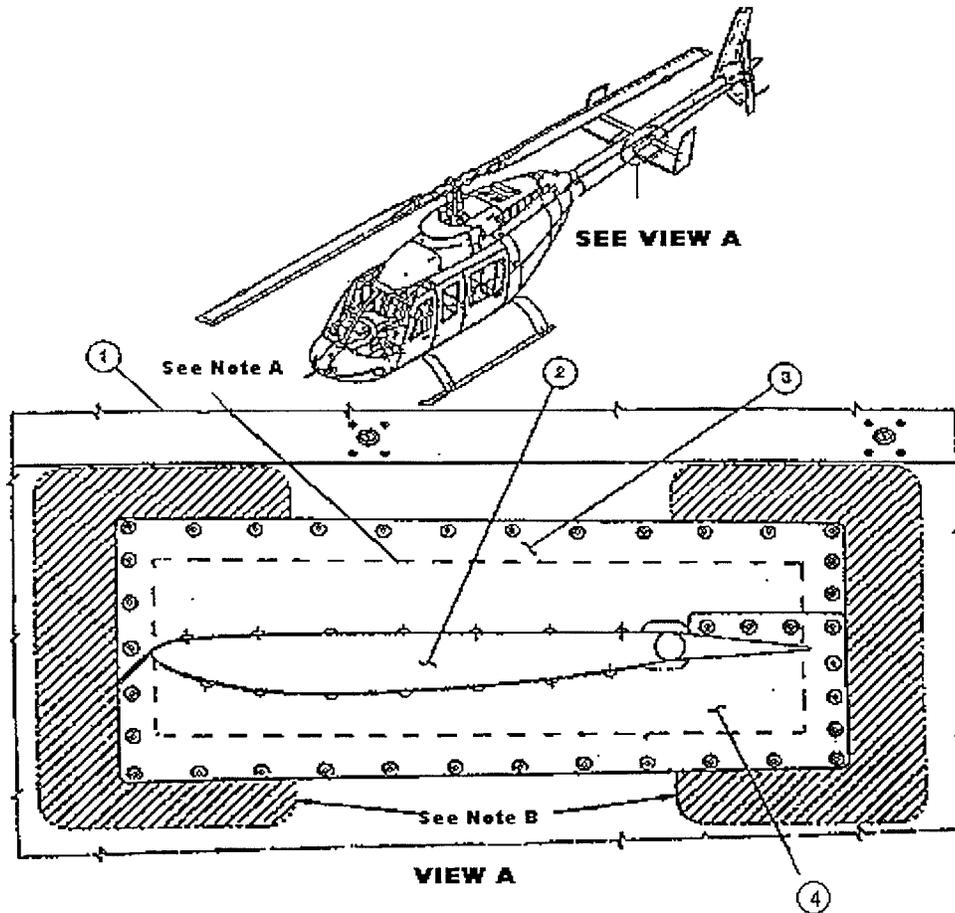
(a) Before further flight and thereafter at intervals not to exceed 10 hours time-in-service (TIS) until accomplishing a one-time fluorescent-penetrant inspection (FPI) required by paragraph (c)(2) of this AD, visually inspect for a crack in the tailboom using a 10-power or higher magnifying glass in the shaded areas as depicted in Figure 1 of this AD:

- A. Inspect entire edge of stabilizer opening on both sides of the tailboom.
- B. Inspect for a crack in these two areas on both sides of the tailboom

(2) Perform a one-time FPI of the edges of the tailboom skins for any crack around the left and right horizontal stabilizer openings as shown in Figure 1 of this AD. Remove paint and primer to inspect the edges and exterior skin surface in the skin area at least 3/4 inch around the edges of the horizontal stabilizer openings as shown in Figure 1 of this AD.

(e) Within 600 hours TIS, inspect and modify the tailboom in accordance with the Accomplishment Instructions, Parts I, II, and III of Bell Helicopter Textron Canada (BHTC) Alert Service Bulletin 206L-99-115, Revision F, dated April 14, 2001 (ASB).

(g) If a crack is found during any check or inspection required by this AD, before further flight, replace the cracked tailboom with an airworthy tailboom modified according to the requirements of paragraph (e) of this AD or with an airworthy tailboom, P/N 206-033-004-181.
