[Docket No. 2000-SW-55-AD; Amendment 39-12898; AD 2002-20-03]

Airworthiness Directives; Eurocopter France Model AS332C, L, L1, and L2; AS350B, BA, B1, B2, B3, and D; AS355E, F, F1, F2, and N; AS-365N2; AS 365 N3; SA330F, G, and J; SA-360C; SA-365C, C1, and C2; SA.316B and C; and SA.319B Helicopters

ACTION: Final rule.

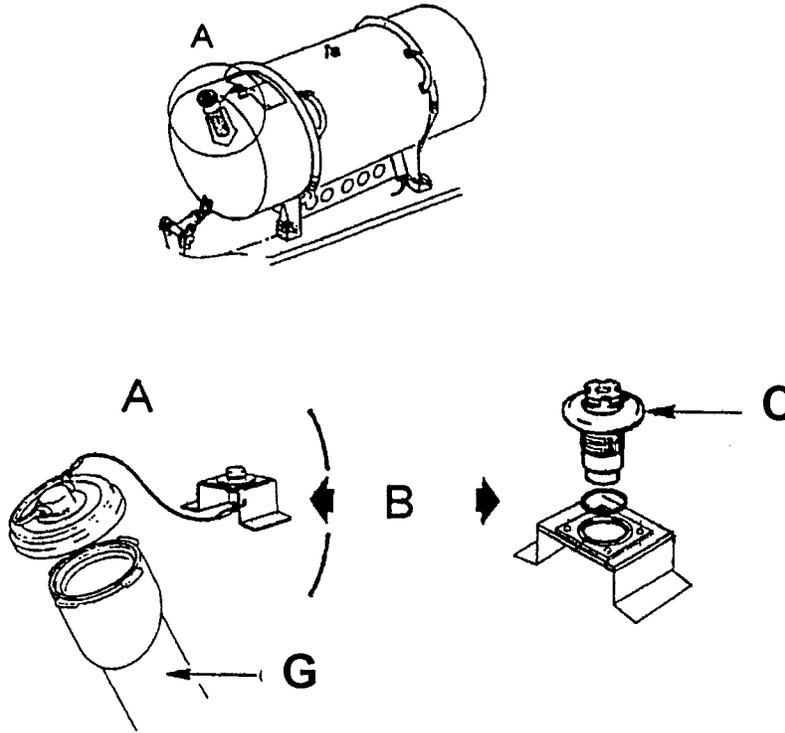
FIGURE 1 FERRY FUEL TANK

To prevent refueling a tank that is not adequately electrically bonded, which could generate an electric arc between the refueling nozzle and the tank, causing a fuel tank explosion, accomplish the following:

(a) Measure the electrical resistance between the tank electrostatic ground connector (item C) and the tank filler neck (item G) as shown in Figure 1 of this AD. If the value of the electrical resistance is more than 1.5 milliohms, refueling the tank is prohibited. See Figure 1 as follows:
