[Docket No. 2002-SW-46-AD; Amendment 39-12910; AD 2002-21-04]

Airworthiness Directives; Agusta S.p.A. Model A119 Helicopters

2002-21-04 Agusta S.p.A.: Amendment 39-12910. Docket No. 2002-SW-46-AD. Supersedes Emergency AD 2002-17-52, Docket No. 2002-SW-43-AD and EAD 2002-14-51, Docket No. 2002-SW-35-AD.

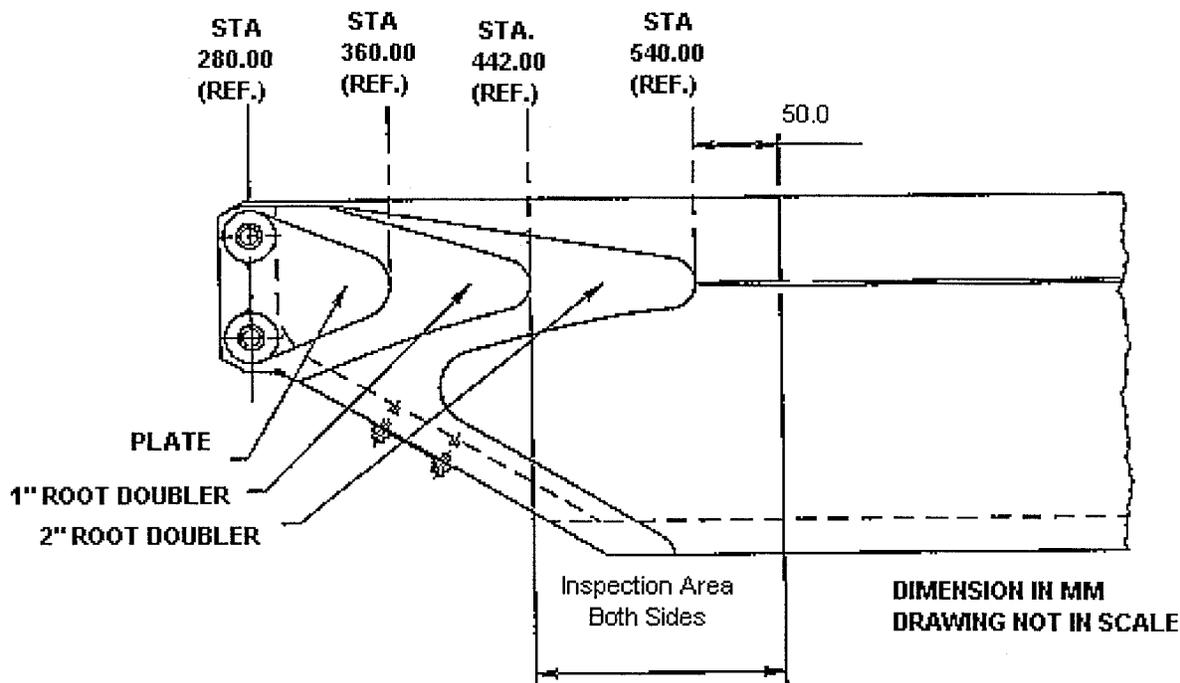
FIGURE 1

(b) Before each start of the helicopter engine, visually check both sides of each tail rotor blade for a crack in the area depicted in Figure 1 of this AD. An owner/operator (pilot) holding at least a private pilot certificate may perform this visual check and must enter compliance with this paragraph into the aircraft maintenance records in accordance with 14 CFR 43.11 and 91.417(a)(2)(v). See Figure 1:

Part Number 109-8132-01-111 Tail Rotor Blade

Note 2: Paint irregularities on the tail rotor blade may be due to a crack.

(c) Within 25 hours time-in-service (TIS), and thereafter at intervals not to exceed 25 hours TIS, and any time an increase in vibration levels occur, using a 5x or higher magnifying glass, visually inspect each tail rotor blade for a crack in accordance with the Compliance Instructions, Part III, paragraphs 1. through 5., of the BT. Reporting to Agusta Service Engineering is not required. If you are unable to determine by the visual inspection whether there is a crack, dye penetrant inspect the tail rotor blade for a crack in accordance with the Compliance Instructions, Part III, paragraph 6., of the BT.

(d) Replace any cracked tail rotor blade with an airworthy blade before further flight.
