[Docket No. 2000–CE–44–AD; Amendment 39–12920; AD 2002–21–13]

Airworthiness Directives; Raytheon Aircraft Company Beech Models 35, 35R, A35, and B35 Airplanes

SUMMARY: This amendment supersedes Airworthiness Directive (AD) 98–13–02, which currently requires operating limitations on Raytheon Aircraft Company (Raytheon) Beech Models 35, 35R, A35, and B35 airplanes. This AD is the result of Raytheon developing inspection and modification procedures that, when accomplished on the affected airplanes, will eliminate the need for the operating limitations. This AD retains the operating limitations for the affected airplanes until the recently developed inspection and modification procedures are accomplished. This AD also requires repetitive inspections of the fuselage structure. The actions

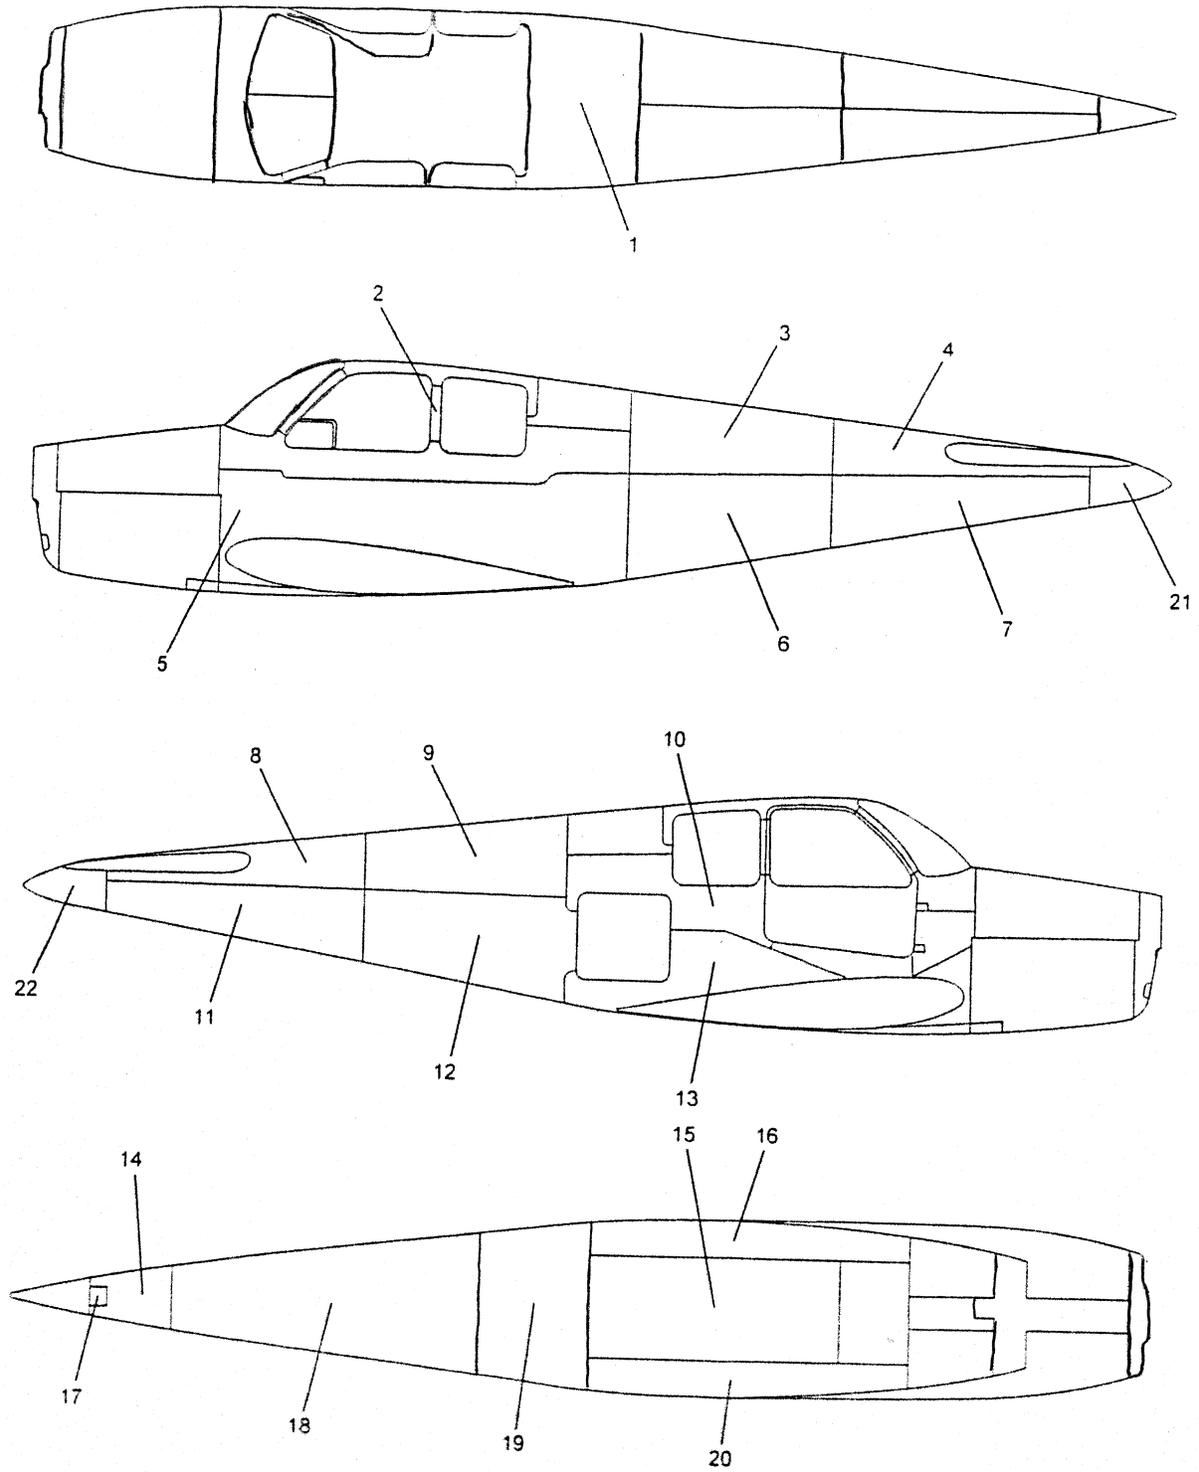
Figure 1

(5) Visually inspect the empennage, aft fuselage, and ruddervator control system for damage: (i) Part of this is an inspection of the aft fuselage skin for wrinkles or cracks. Specific skin thicknesses are presented in Figures 1 and 2 of this AD. The skin thickness measurement is not repetitive. (ii) The inspection and setting of the travels on the elevator and elevator trim tabs are not repetitive. (iii) Repair or replace any damaged parts and set the elevator controls, rudder and tab system controls, cable tensions, and rigging.	Inspect within the next 100 hours TIS after the last inspection required by AD 94-20-04 or within the next 25 hours TIS after December 10, 2002 (the effective date of this AD), whichever occurs later, and thereafter at intervals not to exceed 100 hours TIS, except for the skin thickness measurement and the inspection and setting of the travels on the elevator and elevator trim tabs, which are one-time actions. Accomplish any repairs, replacements, and adjustments prior to further flight after the applicable inspection.	Accomplish the inspection and repairs or replacements in accordance with the procedures in paragraphs (5)(a) through (5)(f) of the ACCOMPLISHMENT INSTRUCTIONS section of Raytheon Service Bulletin No. SB 27-3358, Issued: February, 2000, and use a digital ultrasonic skin tester or equivalent skin tester or direct methods that utilize calipers and micrometers. Specific skin thicknesses are contained in Figures 1 and 2 of this AD.

Skin Thickness – Raytheon Aircraft (Beech) Models 35, 35R, A35, and B35
