#### 14 CFR Part 39

[Docket No. 2002–SW–42–AD; Amendment 39–12936; AD 2002–17–51]

#### Airworthiness Directives; Agusta S.p.A. Model A109E Helicopters

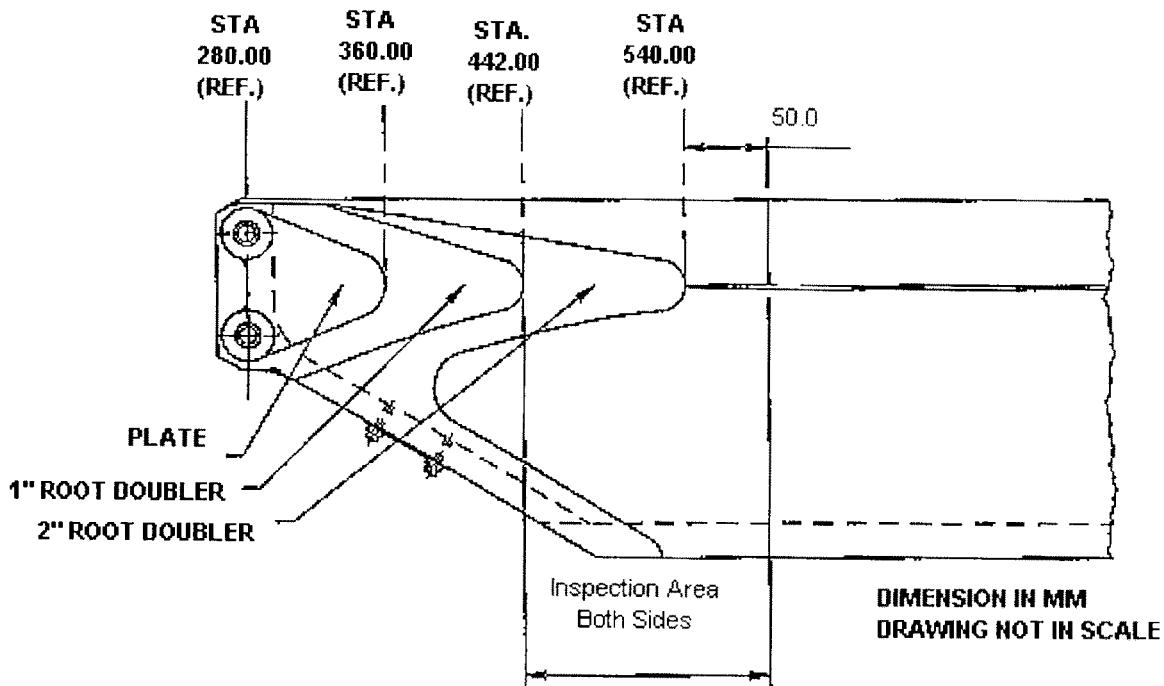
**FIGURE 1**

(b) Before each start of the helicopter engines, visually check both sides of each tail rotor blade for a crack in the area depicted in Figure 1 of this AD. And owner/operator (pilot) holding at least a private pilot certificate may perform this visual check and must enter compliance with this paragraph into the aircraft maintenance records in accordance with 14 CFR 43.11 and 91.417(d)(2)(v). See Figure 1:

**Part Number 109-8132-01-111 Tail Rotor Blade**

**Note 2:** Paint irregularities on the tail rotor blade may be due to a crack.

(c) Within 25 hours time-in-service (TIS), and thereafter at intervals not to exceed 25 hours TIS, and anytime there is an increase in vibration levels, using a 5x or higher magnifying glass, visually inspect each tail rotor blade for a crack before further flight in accordance with the Compliance Instructions, Part III, paragraphs 1. through

5., of the BT. Reporting to Agusta Service Engineering is not required. If you are unable to determine by the visual inspection whether there is a crack, dye penetrant inspect the tail rotor blade for a crack in accordance with the Compliance Instructions, Part III, paragraph 6., of the BT.

(d) Replace any cracked tail rotor blade with an airworthy blade before further flight.
