DEPARTMENT OF TRANSPORTATION

Federal Aviation Administration

[Docket No. 2002–SW–42–AD; Amendment 39–12936; AD 2002–17–51]

Airworthiness Directives; Agusta S.p.A. Model A109E Helicopters

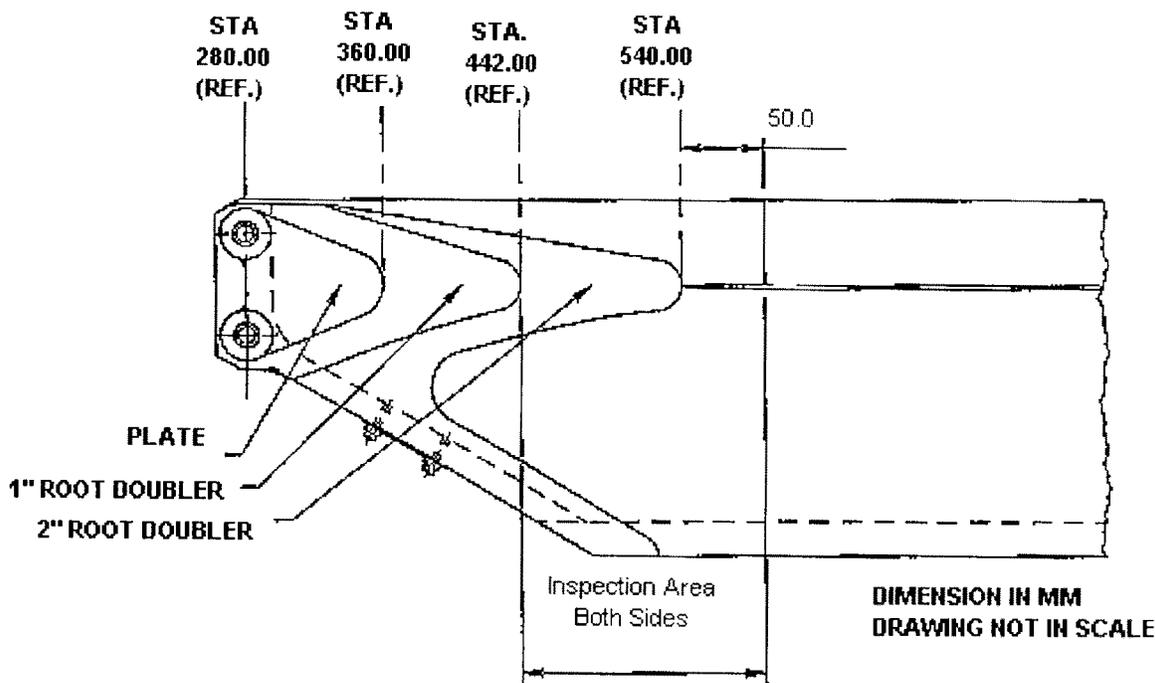
FIGURE 1

(b) Before each start of the helicopter engines, visually check both sides of each tail rotor blade for a crack in the area depicted in Figure 1 of this AD. And owner/operator (pilot) holding at least a private pilot certificate may perform this visual check and must enter compliance with this paragraph into the aircraft maintenance records in accordance with 14 CFR 43.11 and 91.417(d)(2)(v). See Figure 1:

Part Number 109-8132-01-111 Tail Rotor Blade

Note 2: Paint irregularities on the tail rotor blade may be due to a crack.

(d) Replace any cracked tail rotor blade with an airworthy blade before further flight.
