[Docket No. 2002-SW-48-AD; Amendment 39-12982; AD 2002-21-51]

#### Airworthiness Directives; Eurocopter France Model AS355E, F, F1, F2, and N Helicopters

#### 2002-21-51 Eurocopter France:

*Applicability:* Model AS355E, F, F1, F2, and N helicopters, with a main gearbox (MGB) lubrication pump (pump), part number 355A32-0700-00, -01, -01M, installed, certificated in any category.

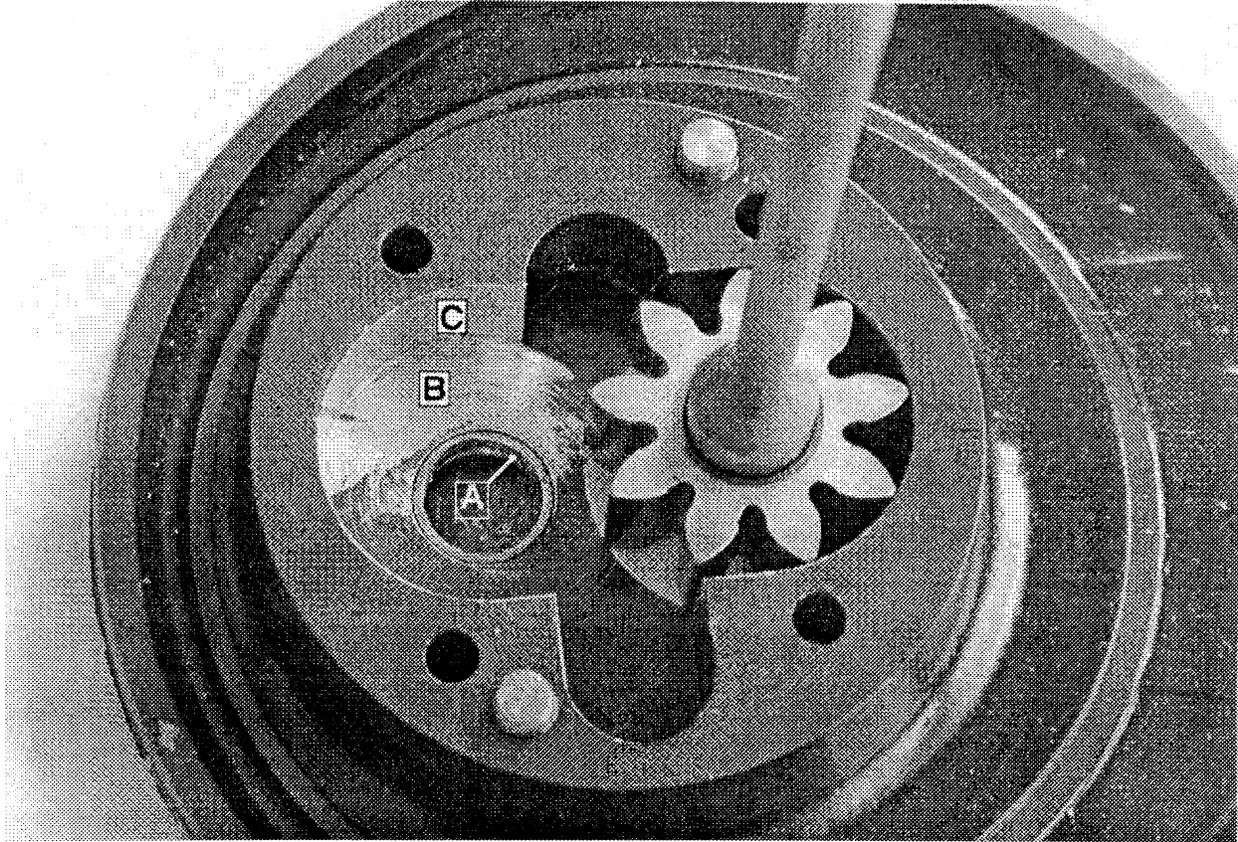
**Figure 1**

- (i) Crank pin play,
- (ii) Out of round bronze bushing (A of Figure 1),

- (iii) Offset of the driven gear pinion,
- (iv) Metal chips, or
- (v) Wear (C of Figure 1).

**Note 3:** If wear occurs in B only in Figure 1, replacing the MGB and the pump is not necessary.

(3) While inspecting the pump, if you find any of the following, replace the MGB and the pump with an airworthy MGB and pump before further flight:
