[Docket No. 99–SW–80–AD; Amendment 39–12983; AD 2002–25–07]

Airworthiness Directives; Bell Helicopter Textron Canada Limited Model 206L, L–1, L–3, and L–4 Helicopters

ACTION: Final rule.

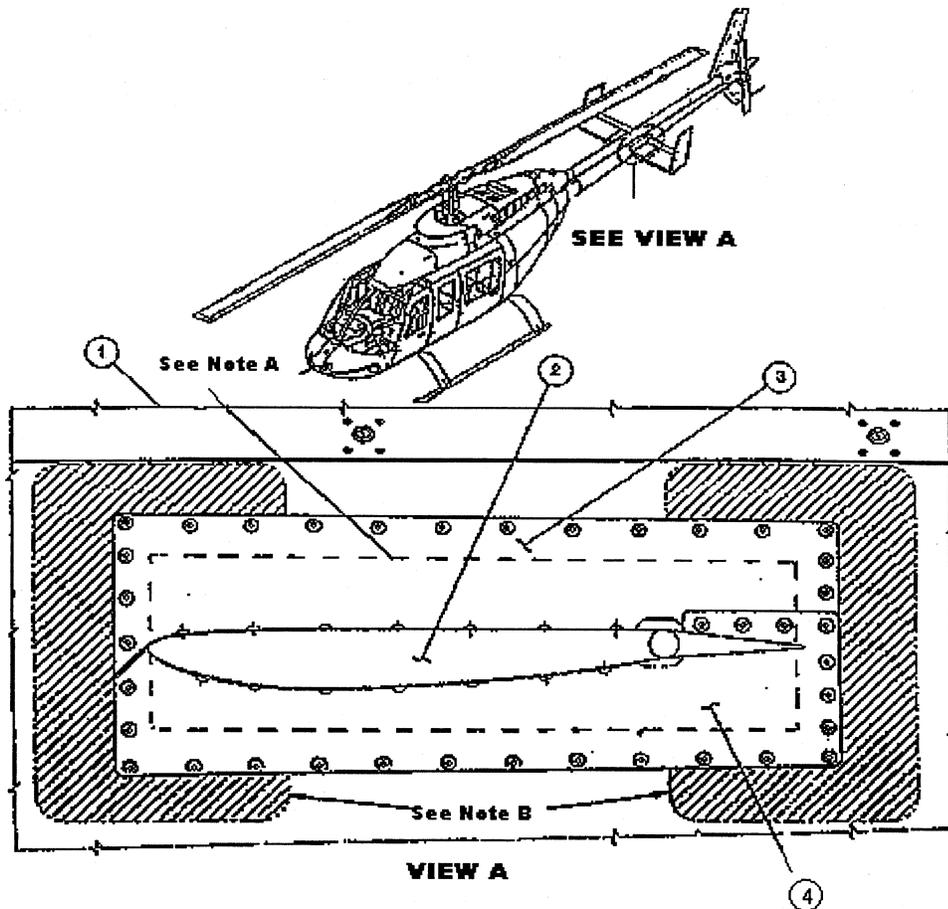
Figure 1**BILLING CODE 4910-13-C**

To detect a crack in the tailboom skin and to prevent separation of the tailboom from the helicopter and subsequent loss of control of the helicopter, accomplish the following:

(a) Before further flight and thereafter at intervals not to exceed 10 hours time-in-service (TIS) until accomplishing a one-time fluorescent-penetrant inspection (FPI) required by paragraph (c)(2) of this AD, visually inspect for a crack in the tailboom using a 10-power or higher magnifying glass in the shaded areas as depicted in Figure 1 of this AD:

- A. Inspect entire edge of stabilizer opening on both sides of the tailboom.
- B. Inspect for a crack in these two areas on both sides of the tailboom

(2) Perform a one-time FPI of the edges of the tailboom skins for any crack around the left and right horizontal stabilizer openings as shown in Figure 1 of this AD. Remove paint and primer to inspect the edges and

exterior skin surface in the skin area at least 3/4 inch around the edges of the horizontal stabilizer openings as shown in Figure 1 of this AD.

(2) Visually inspect the entire edge of the horizontal stabilizer opening on both sides of the tailboom for any crack using a 10-power or higher magnifying glass as shown in Figure 1 of this AD.

(g) If a crack is found during any check or inspection required by this AD, before further flight, replace the cracked tailboom with an airworthy tailboom modified according to the requirements of paragraph (e) of this AD or with an airworthy tailboom, P/N 206-033-004-181.
