[Docket No. 2001-SW-40-AD; Amendment 39-13022; AD 2002-13-05 R1]

Airworthiness Directives; MD Helicopters, Inc. Model 369D, 369E, 369F, and 369FF Helicopters

ACTION: Final rule.

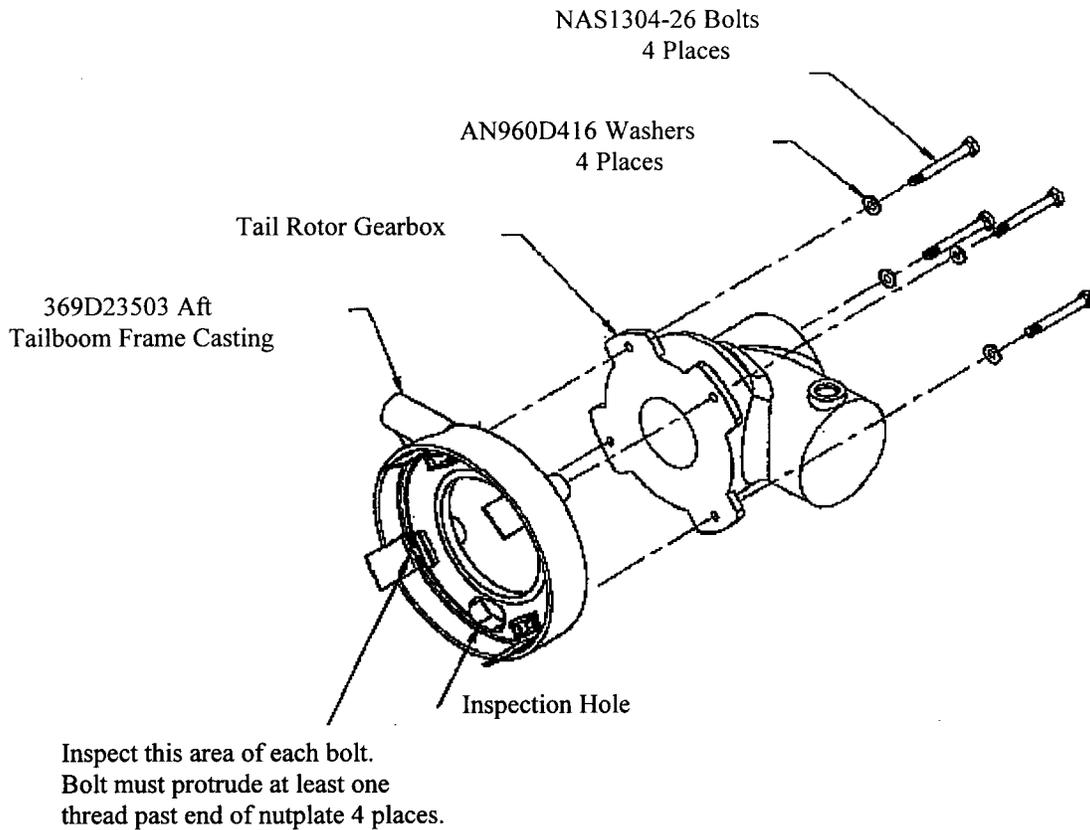
Figure 1 - Inspection Location

concern was valid. We are now reducing the applicability of AD 2002-13-05 to include only certain tailboom S/N's and parts that are modified in accordance with either STC SH5055NM or SH4801NM. We are also correcting the P/N for the washer to P/N AN960D416 in Figure 1 of this AD and clarifying that a slippage mark needs to be reapplied to each bolt regardless of the outcome of the required torque test.

(2) Remove the tailboom control rod and determine the number of bolt threads protruding from each nutplate on the internal surface of the aft tailboom frame casting, P/N 369D23503, as shown in Figure 1 of this AD. At least one thread must protrude. If more than four threads protrude, add an additional washer, P/N AN960D416, under the bolt head. Torque the bolt to 100–110 in-lbs, and reapply a slippage mark. *See Figure 1:*

(b) Between 2 and 10 hours TIS after accomplishing the requirements of paragraph (a) of this AD, inspect the torque on each bolt by applying 100 in-lbs. If any bolt movement occurs, retorque the bolt to 100–110 in-lbs. Reapply a slippage mark to the bolt regardless of the outcome of the torque test. Reinspect the torque between 2 and 10 hours TIS thereafter until no bolt movement occurs.
