## **DEPARTMENT OF TRANSPORTATION**

**[Docket No. 2002-NM-128-AD]**

#### **Airworthiness Directives; Boeing Model 747-400 Series Airplanes Equipped With General Electric Model CF6-80C2 Series Engines**

**ACTION:** Notice of proposed rulemaking (NPRM).

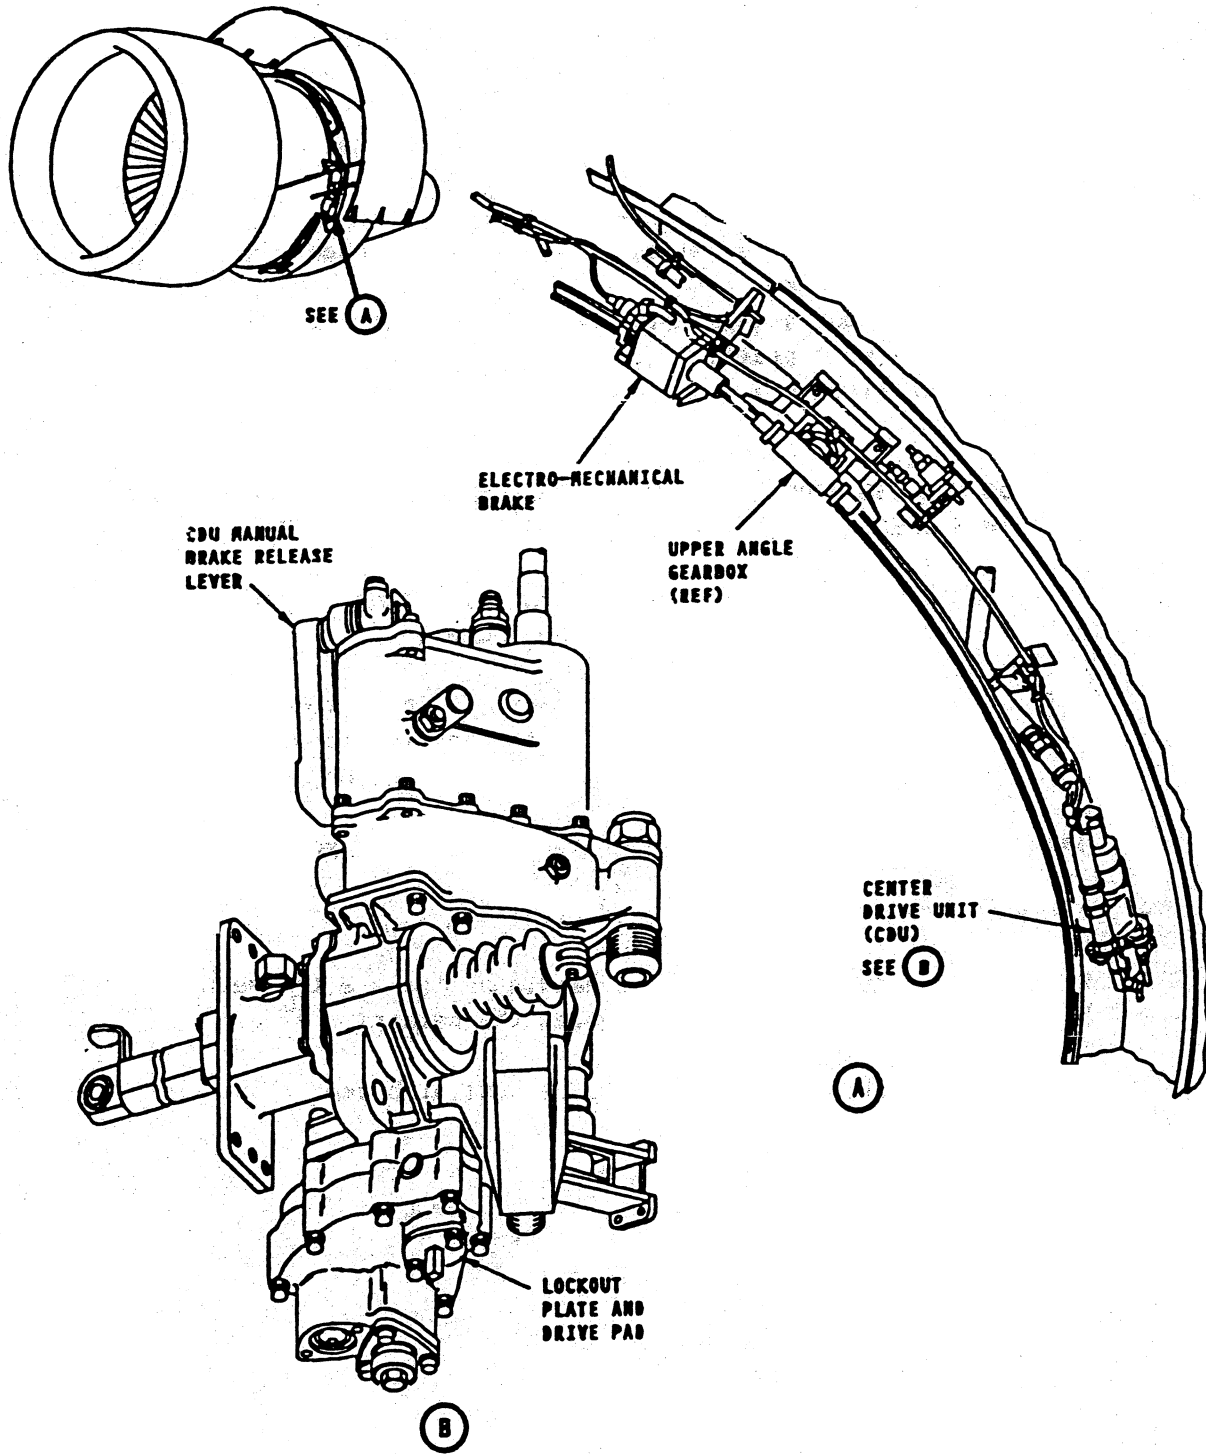
**Electro-Mechanical Brake and CDU Cone Brake Torque Check  
Figure 1**

1. This procedure contains steps to do a check of the holding torque of the CDU cone brake.

**Caution:** Do not use more than 100 pound-inches of torque when you do this check. Excessive torque will damage the CDU.

(8) If the torque is less than 15 pound-inches, you must replace the CDU.
